# ACCESSIBILITY ASSESSMENT

145366.21R000-009.160

July 14, 2021

Housing Authority of Prince George's County - Administrative Office  
9200 Basil Court  
Largo, Maryland 20774

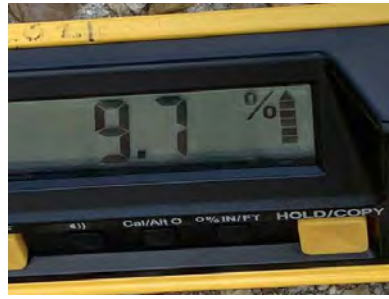
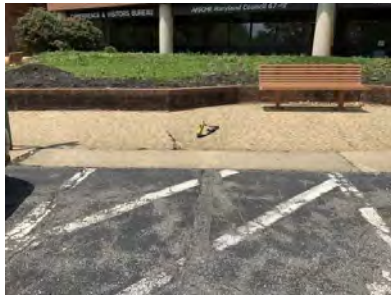
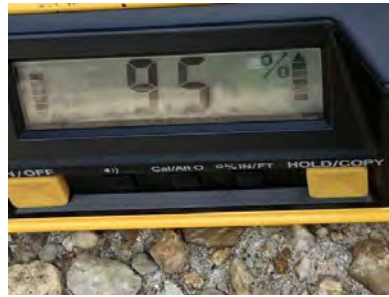
1 38.915538608644084,-76.84614484292221

<b>Assembly</b>	Exterior Access Route
<b>Type</b>	Exterior Accessible Route
<b>ADA Standard</b>	403.3
<b>Barrier Detail</b>	The accessible route has cross slopes greater than 1:50 (2%).
<b>Location Description</b>	Curb Ramp CR1
<b>Observed</b>	Jun 14, 2021 by Ouraccessibleworld@gmail.com

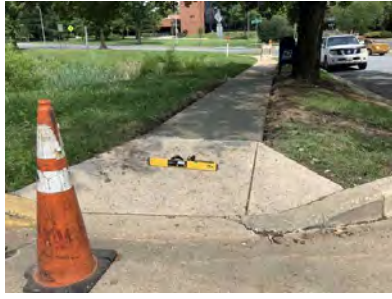
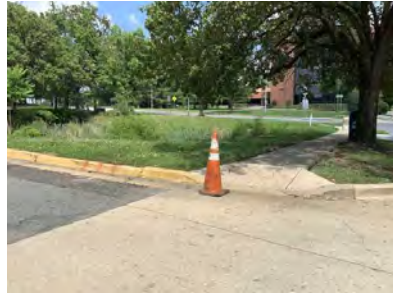
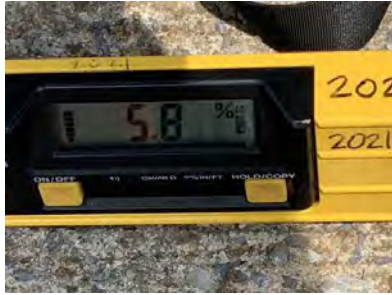
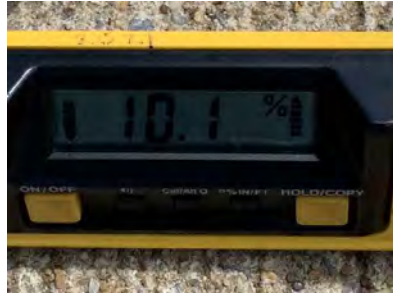
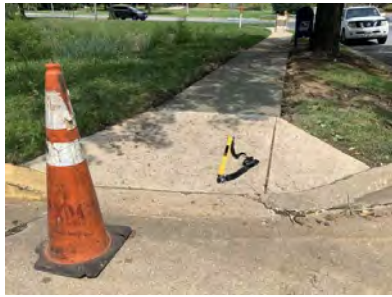
62 38.915042695134154,-76.84631070552254

<b>Assembly</b>	Exterior Access Route
<b>Type</b>	Curb Ramp
<b>ADA Standard</b>	405.2; Table 405.2; 406; 406.2
<b>Barrier Detail</b>	The curb ramp does not meet the slope requirements.
<b>Location Description</b>	Curb Ramp CR2
<b>Observed</b>	Jun 14, 2021 by Ouraccessibleworld@gmail.com
<b>Site Conditions</b>	The curb ramp has a running slope of 10.1% and a cross slope of 5.8%.

The curb ramp should be removed and replaced with a compliant curb ramp with no greater than the maximum allowable slopes of a ramp. Curb ramp runs shall have a running slope not steeper than 1:12 (8.33%). Cross slope of curb ramp runs shall not be steeper than 1:48. The running slope in new construction shall be 1:12 (8.33%) maximum. [EXCEPTION: In existing sites, buildings, and facilities built before 1/26/92, ramps and curb ramps shall be permitted to have running slopes steeper than 1:12 where such slopes are necessary due to space limitations. In facilities built before 1/26/92, the running slope can be 1:10 to 1:8 (10% to 12.5%) for a maximum rise of 3" OR 1:10 to 1:12 (8.3% to 10%) for a maximum rise of 6".] Where flares are provided, flare slopes shall not be greater than 1:10 (10%). [EXCEPTION: In alterations, where there is no landing at the top of curb ramps, curb ramp flares shall be provided and shall not be steeper than 1:12.]

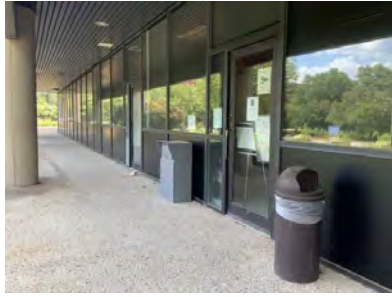
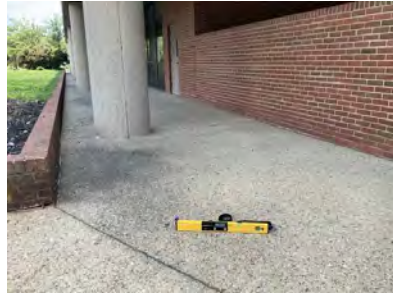
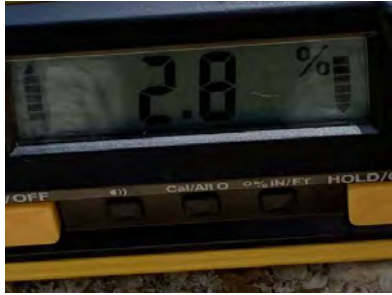
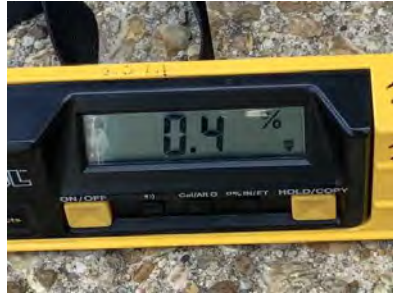
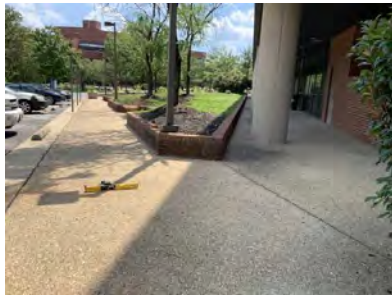
59 38.91559160859855,-76.84623232887077

<b>Assembly</b>	Exterior Access Route
<b>Type</b>	Exterior Accessible Route
<b>ADA Standard</b>	403.3
<b>Barrier Detail</b>	The accessible route has cross slopes greater than 1:50 (2%).
<b>Location Description</b>	From Accessible Parking Spaces P1-P5 to Suite 107
<b>Observed</b>	Jun 14, 2021 by Ouraccessibleworld@gmail.com

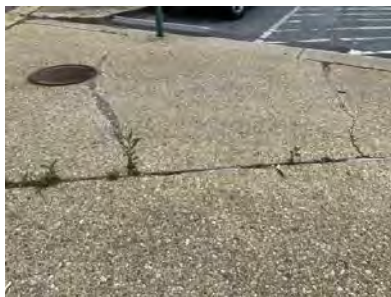
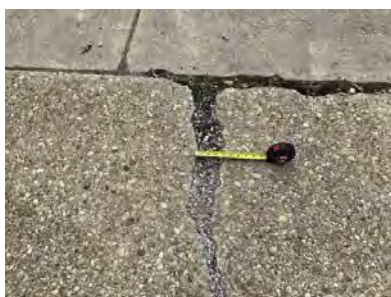
Photos for Barrier ID: AX240545

Assembly	Exterior Access Route
Type	Exterior Accessible Route
ADA Standard	302.3
Barrier Detail	The accessible route has gaps in the surface greater than 1/2" wide.
Location Description	From Accessible Parking Spaces P6 through 14 to Entrance
Observed	Jun 14, 2021 by Ouraccessibleworld@gmail.com
Site Conditions	There are gaps in the surface up to 4" wide.

Repair the accessible route to eliminate openings in the surface greater than 1/2" wide. This barrier must be removed in conjunction with barrier ID 240546. The cost of this barrier removal is covered under ID 240546 and therefore, the cost of this ID is shown as \$0. Openings in the ground surface of the accessible route shall not allow passage of a sphere more than 1/2" diameter. Elongated openings shall be placed so that the long dimension is perpendicular to the dominant direction of travel.

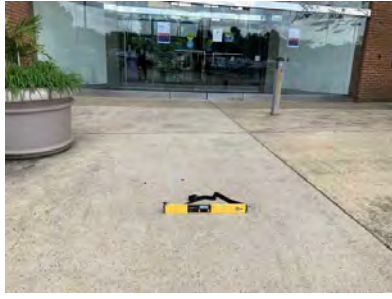
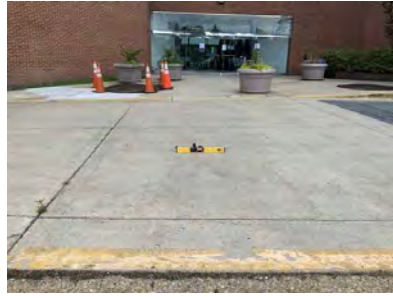
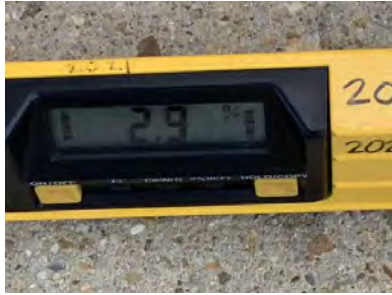
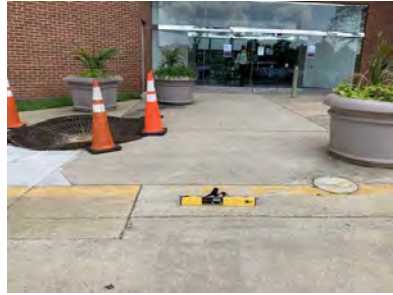
68 38.91572108714661,-76.84669189203072

<b>Assembly</b>	Exterior Access Route
<b>Type</b>	Exterior Accessible Route
<b>ADA Standard</b>	403.3
<b>Barrier Detail</b>	The accessible route has cross slopes greater than 1:50 (2%).
<b>Location Description</b>	From Accessible Parking Spaces P6 through 14 to Entrance
<b>Observed</b>	Jun 14, 2021 by Ouraccessibleworld@gmail.com

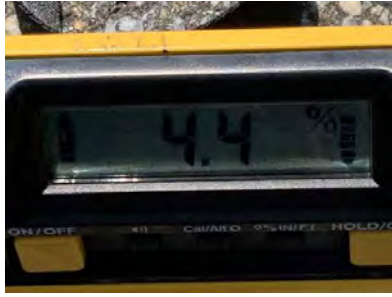
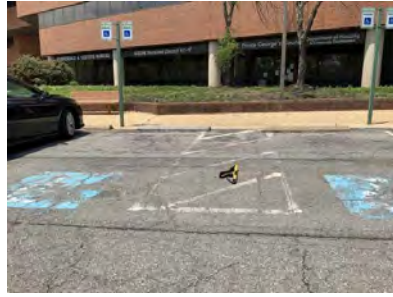
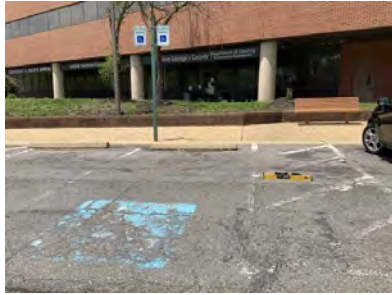
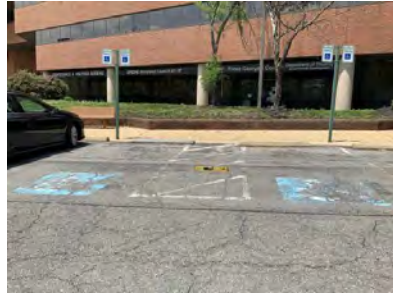
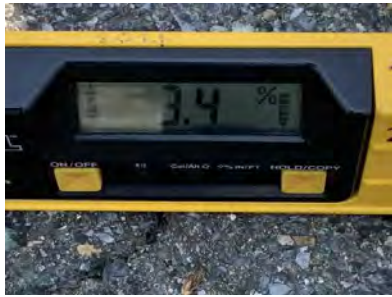
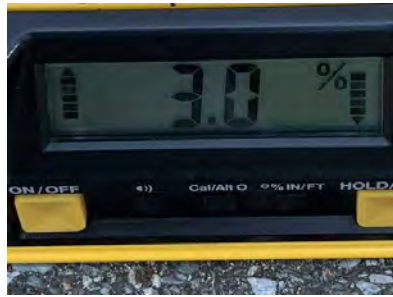
3 38.91548134785456,-76.84611495948982

**Site Conditions** The standard access aisles have cross slopes of up to 3.4%.

Remove and replace with an adjacent access aisle that is at least 60" wide and has a slope of maximum 1:50 (2%) in all directions. [EXCEPTION: Slopes not steeper than 1:48 (2.08%) shall be permitted.] Changes in level are not permitted. Parking spaces and access aisles serving them shall be compliant. Access aisles shall be at the same level as the parking spaces they serve. Width measurements shall be made from the centerline of the markings. [EXCEPTION: Where parking spaces or access aisles are not adjacent to another parking space or access aisle, measurements shall be permitted to include the full width of the line defining the parking space or access aisle.] The quantity and order of magnitude cost estimate provided for this barrier are limited to the extent of the area identified as non-compliant. Additional costs that may be associated with removal of the barrier are not included.

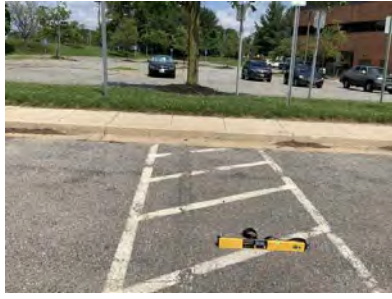
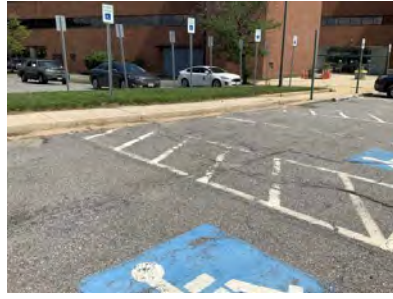
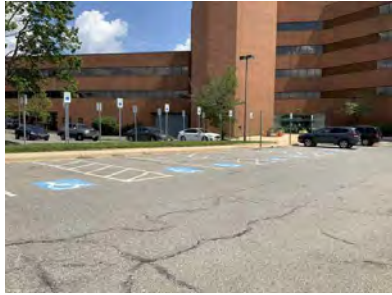
Photos for Barrier ID: AX240541

<b>Assembly</b>	Exterior Access Route
<b>Type</b>	Curb Ramp
<b>ADA Standard</b>	406.2
<b>Barrier Detail</b>	A curb ramp is not provided where the accessible route crosses a curb.
<b>Location Description</b>	Parking Lot 1 Access Aisles at Accessible Parking Spaces P6 to P14
<b>Observed</b>	Jun 14, 2021 by Ouraccessibleworld@gmail.com
<b>Site Conditions</b>	A curb ramp is not provided where the access aisles join the accessible route.

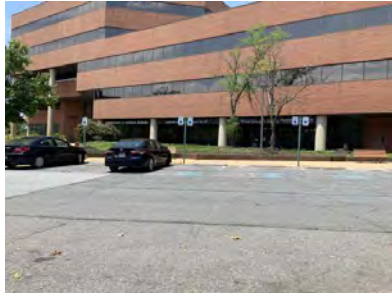
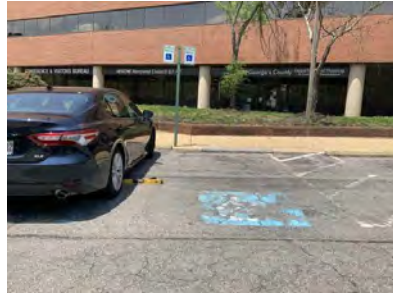
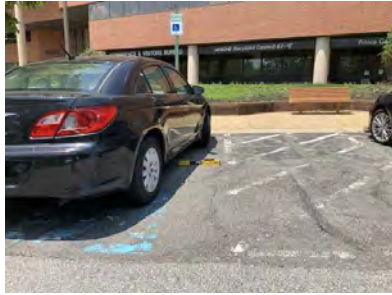
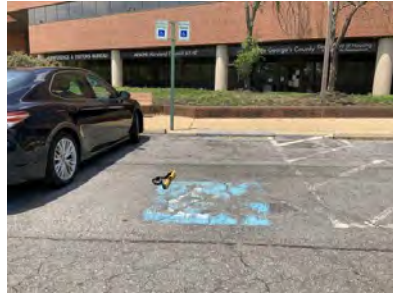
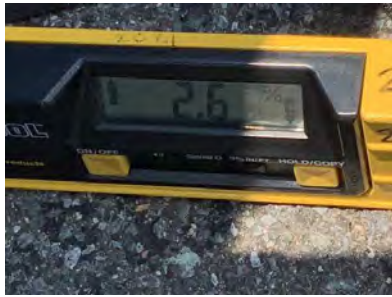
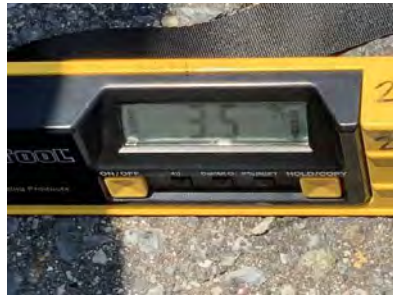
75 38.915441043478395,-76.84618254232788

<b>Assembly</b>	Accessible Parking
<b>Type</b>	Parking Space-Van
<b>ADA Standard</b>	502.4
<b>Barrier Detail</b>	The parking space slope is greater than 1:50 (2%).
<b>Location Description</b>	Parking Lot 1 Accessible Parking Space P1-5
<b>Observed</b>	Jun 14, 2021 by Ouraccessibleworld@gmail.com

Remove and replace with a van space which has a slope of maximum 1:50 (2%) in all directions. [EXCEPTION: Slopes not steeper than 1:48 (2.08%) shall be permitted.] Changes in level are not permitted. Parking spaces and access aisles serving them shall be compliant. Width measurements shall be made from the centerline of the markings. [EXCEPTION: Where parking spaces or access aisles are not adjacent to another parking space or access aisle, measurements shall be permitted to include the full width of the line defining the parking space or access aisle.] The quantity and order of magnitude cost estimate provided for this barrier are limited to the extent of the area identified as non-compliant. Additional costs that may be associated with removal of the barrier are not included.

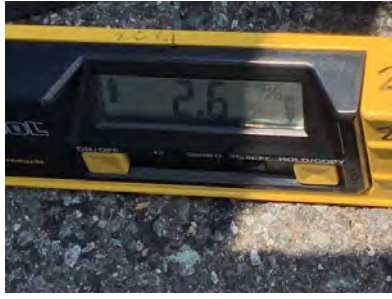
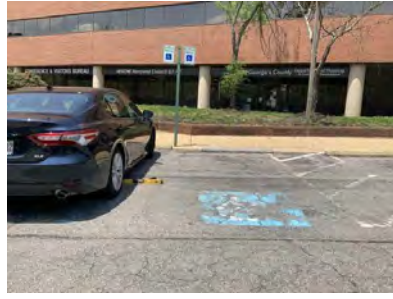
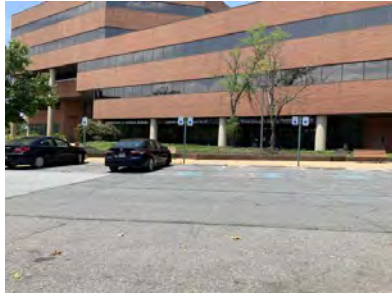
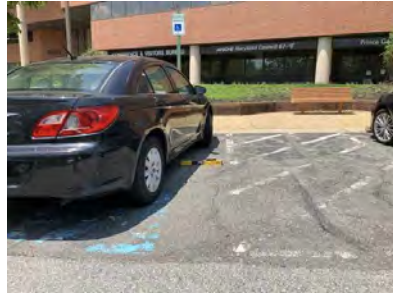
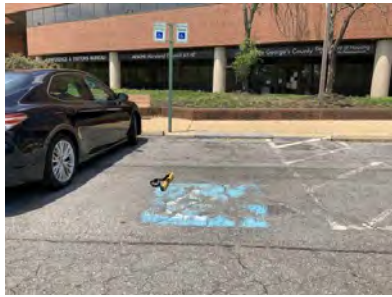
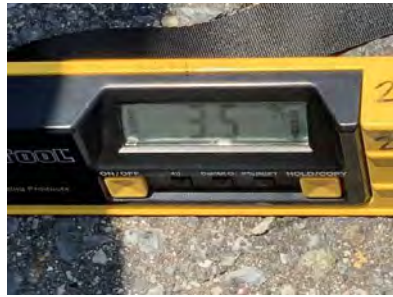
76 38.915441043478395,-76.84618254232788

Assembly	Accessible Parking
Type	Parking Space-Car
ADA Standard	502.4
Barrier Detail	The access aisle slope is greater than 1:50 (2%).
Location Description	Parking Lot 1 Accessible Parking Space P1-5
Observed	Jun 14, 2021 by Ouraccessibleworld@gmail.com

Remove and replace with an adjacent access aisle that is at least 60" wide and has a slope of maximum 1:50 (2%) in all directions. [EXCEPTION: Slopes not steeper than 1:48 (2.08%) shall be permitted.] Changes in level are not permitted. Parking spaces and access aisles serving them shall be compliant. Access aisles shall be at the same level as the parking spaces they serve. Width measurements shall be made from the centerline of the markings. [EXCEPTION: Where parking spaces or access aisles are not adjacent to another parking space or access aisle, measurements shall be permitted to include the full width of the line defining the parking space or access aisle.] The quantity and order of magnitude cost estimate provided for this barrier are limited to the extent of the area identified as non-compliant. Additional costs that may be associated with removal of the barrier are not included.

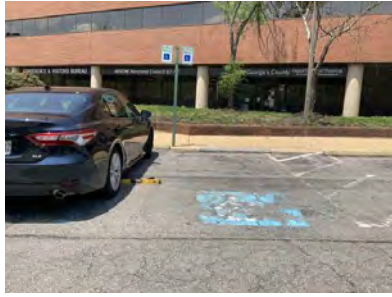
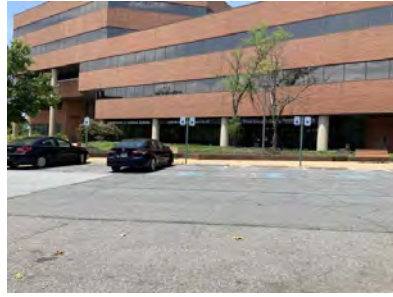
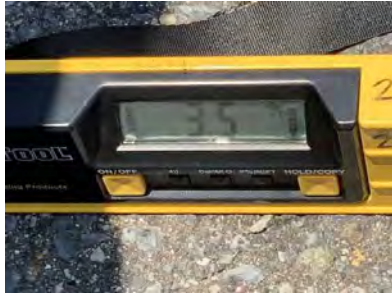
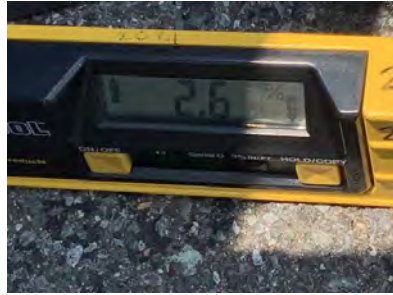
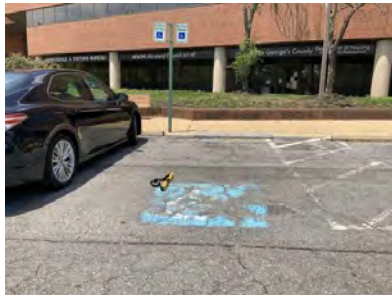
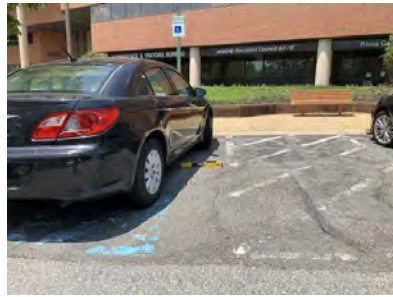
78 38.915441043478395,-76.84618254232788

<b>Assembly</b>	Accessible Parking
<b>Type</b>	Parking Space-Van
<b>ADA Standard</b>	502.4
<b>Barrier Detail</b>	The access aisle slope is greater than 1:50 (2%).
<b>Location Description</b>	Parking Lot 1 Accessible Parking Space P1-5
<b>Observed</b>	Jun 14, 2021 by Ouraccessibleworld@gmail.com

Remove and replace with an adjacent access aisle that has a slope of maximum 1:50 (2%) in all directions. [EXCEPTION: Slopes not steeper than 1:48 (2.08%) shall be permitted.] Changes in level are not permitted. Parking spaces and access aisles serving them shall be compliant. Access aisles shall be at the same level as the parking spaces they serve. Measurements shall be made to the centerline of the stripe. Where accessible stalls and aisles are not adjacent to another stall or aisle, measurements shall be permitted to include the full width of the line defining the accessible parking space or aisle. The quantity and order of magnitude cost estimate provided for this barrier are limited to the extent of the area identified as non-compliant. Additional costs that may be associated with removal of the barrier are not included.

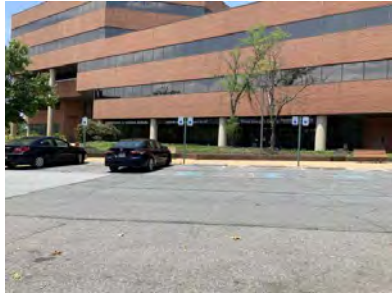
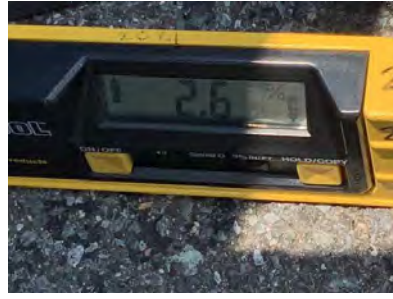
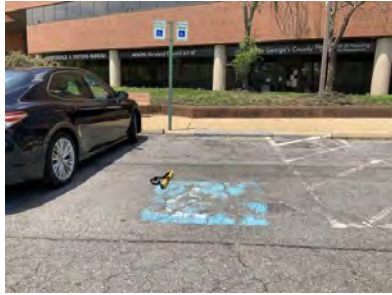
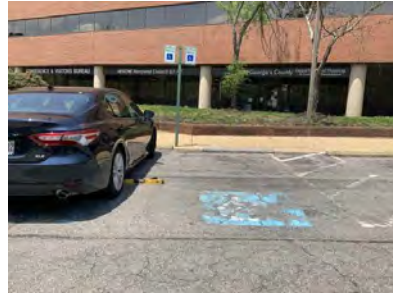
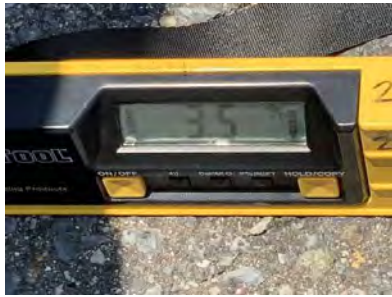
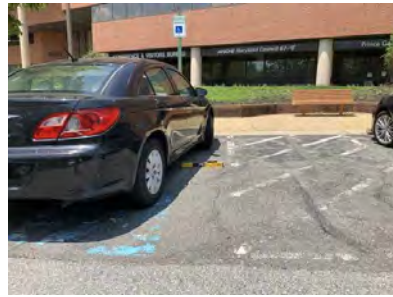
69 38.915441043478395,-76.84618254232788

<b>Assembly</b>	Accessible Parking
<b>Type</b>	Parking Space-Van
<b>ADA Standard</b>	State of MD 05.07.D (2)(a)and (b),(3) & (6)
<b>Barrier Detail</b>	MARYLAND: Compliant signage is not provided at the space.
<b>Location Description</b>	Parking Lot 1 Accessible Parking Space P5
<b>Observed</b>	Jun 14, 2021 by Ouraccessibleworld@gmail.com

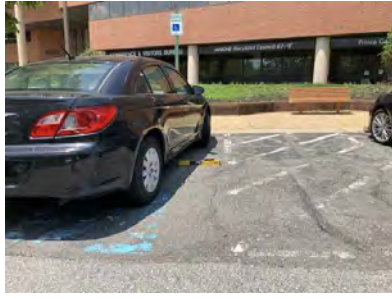
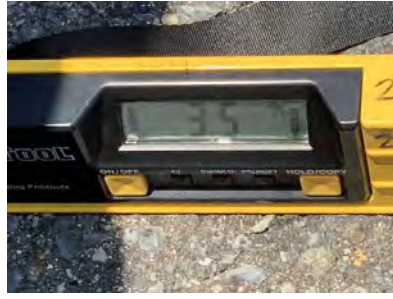
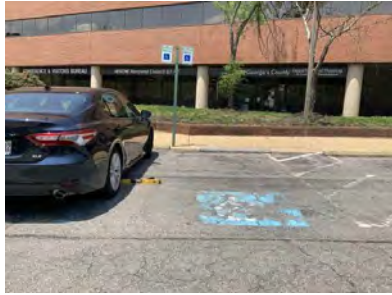
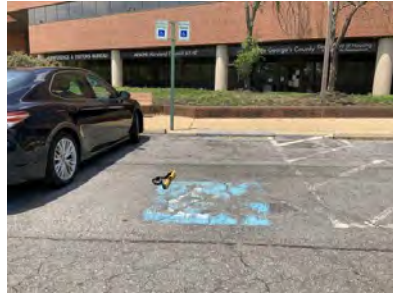
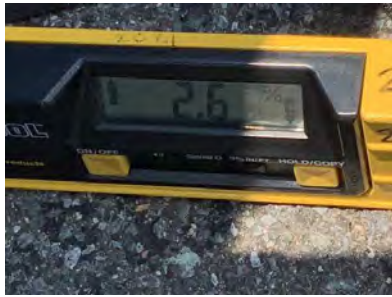
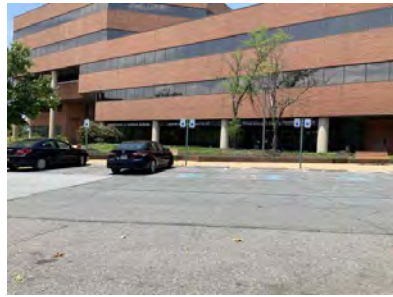
74 38.915441043478395,-76.84618254232788

Assembly	Accessible Parking
Type	Parking Space-Car
ADA Standard	502.4
Barrier Detail	The slope of the parking space is greater than 1:50 (2%).
Location Description	Parking Lot 1 Accessible Parking Spaces P1-5
Observed	Jun 14, 2021 by Ouraccessibleworld@gmail.com

Remove and replace with a parking space that has no more than 1:50 (2%) slope in all directions. [EXCEPTION: Slopes not steeper than 1:48 (2.08%) shall be permitted.] Changes in level are not permitted. Parking spaces and access aisles shall be level with surface slopes not exceeding 1:50 in all directions. Parking spaces and access aisles serving them shall be compliant. Access aisles shall be at the same level as the parking spaces they serve. The quantity and order of magnitude cost estimate provided for this barrier are limited to the extent of the area identified as non-compliant. Additional costs that may be associated with removal of the barrier are not included.

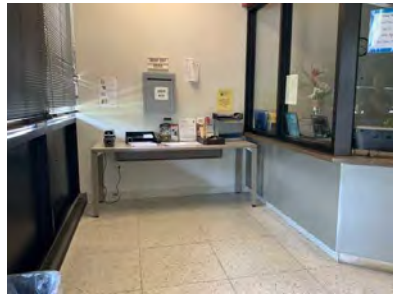
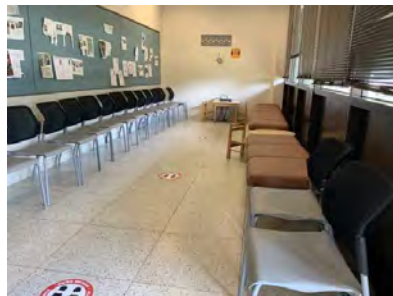
**Photos for Barrier ID: AX240524**

<b>Location Description</b>	1st Floor Lobby
<b>Observed</b>	Jun 14, 2021 by Ouraccessibleworld@gmail.com
<b>Site Conditions</b>	The drop box slot is mounted at 58" above the floor.
