ACCESSIBILITY ASSESSMENT

145366.21R000-002.160

ADA TITLE II ASSESSMENT

Newton Green
5300 Newton Street
Bladensburg, Maryland 20710

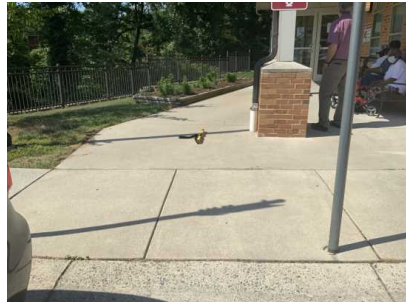
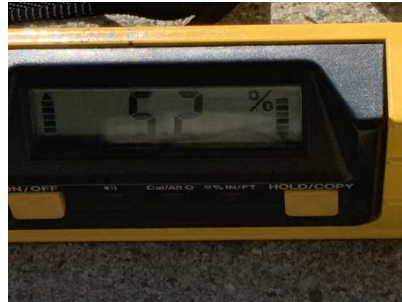
Photos for Barrier ID: AX239832

Assembly	Exterior Access Route
Type	Exterior Accessible Route
ADA Standard	403.3
Barrier Detail	The accessible route has running slopes greater than 1:20 (5%).
Location Description	Main Entrance
Observed	May 18, 2021 by Ouraccessibleworld@gmail.com

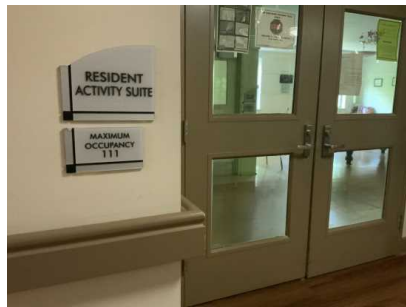
Photos for Barrier ID: AX239868

Assembly	Interior Access Route
Type	Signage
ADA Standard	703.2; 216.2; 703.3; 703.5

Location Description	Room 111
Observed	May 18, 2021 by Ouraccessibleworld@gmail.com
Site Conditions	The provided signage does not have tactile characters.

Remove and replace signage with compliant signage. Raised characters shall be compliant and shall be duplicated in Braille. Raised characters shall be as follows: Depth: Raised characters shall be 1/32" minimum above their background. Case: Characters shall be uppercase. Style: Characters shall be sans serif. Characters shall not be italic, oblique, script, highly decorative, or of other unusual forms. Character Proportions: Characters shall be selected from fonts where the width of the uppercase letter "O" is 55 % minimum and 110 % maximum of the height of the uppercase letter "I". Character Height: Character height measured vertically from the baseline of the character shall be 5/8" minimum and 2" maximum based on the height of the uppercase letter "I". [EXCEPTION: Where separate raised and visual characters with the same information are provided, raised character height shall be permitted to be 1/2" minimum.] Tactile characters on signs shall be located 48" minimum above the finish floor or ground surface, measured from the baseline of the lowest tactile character and 60" maximum above the finish floor or ground surface, measured from the baseline of the highest tactile character. Where a tactile sign is provided at a door, the sign shall be located alongside the door at the latch side. Where a tactile sign is provided at double doors with one active leaf, the sign shall be located on the inactive leaf. Where a tactile sign is provided at double doors with two active leaves, the sign shall be located to the right of the right hand door. Where there is no wall space at the latch side of a single door or at the right side of double doors, signs shall be located on the nearest adjacent wall. Signs containing tactile characters shall be located so that a clear floor space of 18" minimum by 18" minimum, centered on the tactile characters, is provided beyond the arc of any door swing between the closed position and 45 degree open position. [EXCEPTION: Signs with tactile characters shall be permitted on the push side of doors with closers and without hold-open devices.]

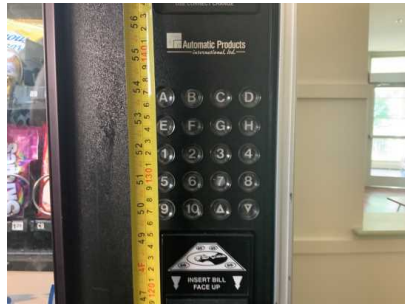
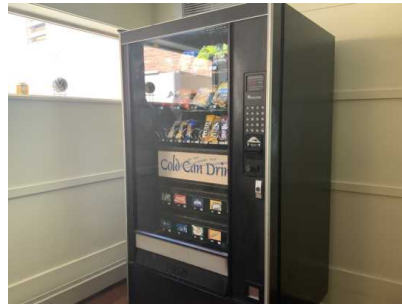
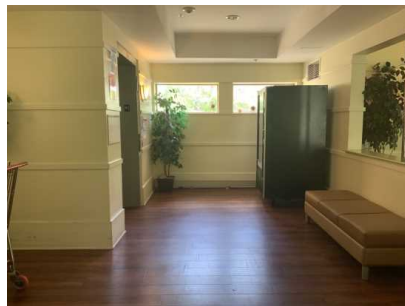
Photos for Barrier ID: AX239854

Assembly	Common Areas
Type	Vending Machine
ADA Standard	228.1; 305; 308; 309
Barrier Detail	The vending machines have operable parts which are not within reach range.
Location Description	Vending machine
Observed	May 18, 2021 by Ouraccessibleworld@gmail.com
Site Conditions	The vending machine has controls up to 54" above the floor.

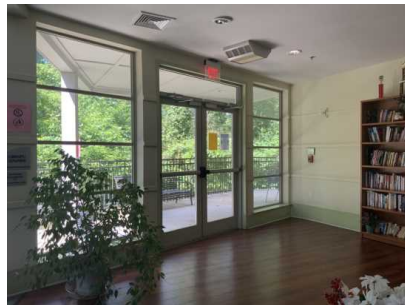
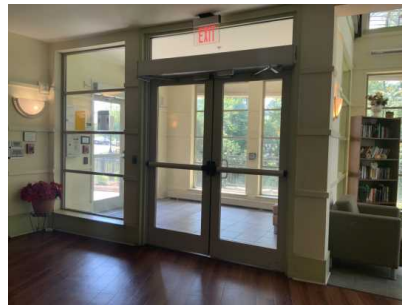
Photos for Barrier ID: AX239861

Assembly	Interior Access Route
Type	Signage
ADA Standard	216.4, 703.1, 703.4
Barrier Detail	Means of egress signage is not provided.
Location Description	Lobby
Observed	May 18, 2021 by Ouraccessibleworld@gmail.com

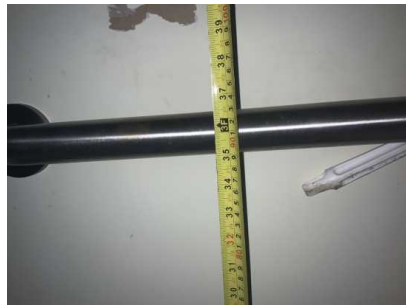
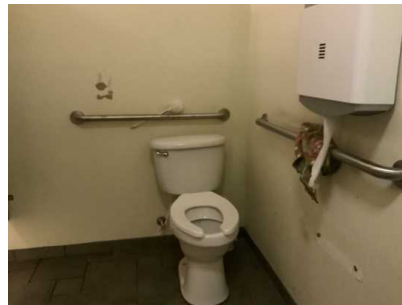
Photos for Barrier ID: AX239872

Assembly	Restroom
Type	Restroom/Bathroom-Water Closet
ADA Standard	604.5.2
Barrier Detail	The grab bars at the water closet are not compliant.
Location Description	Lobby Men's and Women's
Observed	May 18, 2021 by Ouraccessibleworld@gmail.com
Site Conditions	The grab bars in the restrooms are mounted at 36-1/2" above the floor.

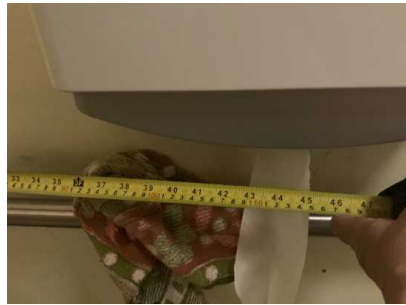
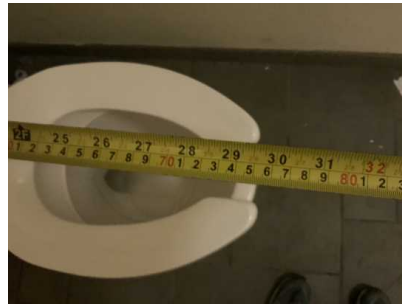
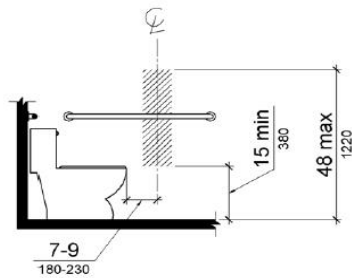
Photos for Barrier ID: AX239874

Assembly	Restroom
Type	Restroom/Bathroom-Water Closet
ADA Standard	604.7, 604.9, 609.3
Barrier Detail	The toilet paper dispenser is not at a compliant location.
Location Description	Lobby Men's and Women's Restroom
Observed	May 18, 2021 by Ouraccessibleworld@gmail.com

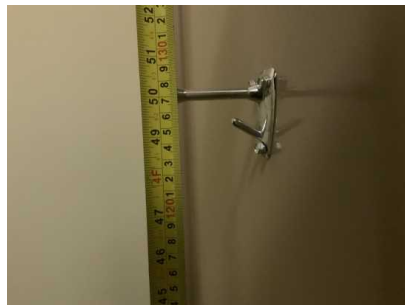
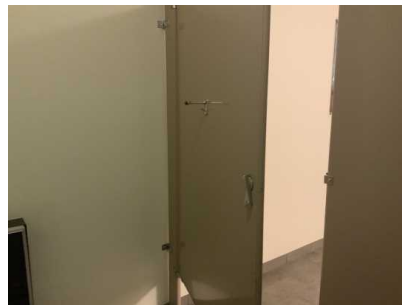
Photos for Barrier ID: AX239875

Assembly	Restroom
Type	Restroom/Bathroom-Coat Hook
ADA Standard	308
Barrier Detail	The coat hook is not within an allowable reach range.
Location Description	Lobby Men's and Women's Restroom
Observed	May 18, 2021 by Ouraccessibleworld@gmail.com
Site Conditions	The coat hook is mounted at 50" above the floor.

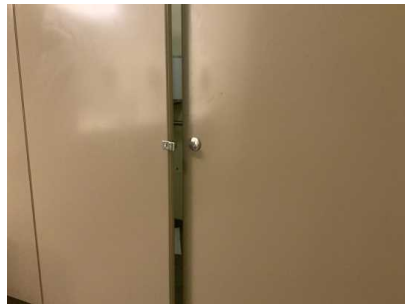
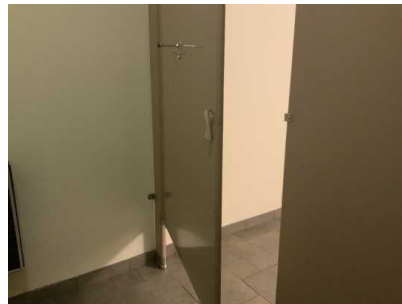
Photos for Barrier ID: AX239876

Assembly	Restroom
Type	Restroom/Bathroom-Toilet Stall
ADA Standard	309, 404.2.7, 604.8.1.2
Barrier Detail	The wheelchair stall door is not compliant.
Location Description	Lobby Men's and Women's Restroom
Observed	May 18, 2021 by Ouraccessibleworld@gmail.com
Site Conditions	Loop handles are not provided on both sides of the stall door.

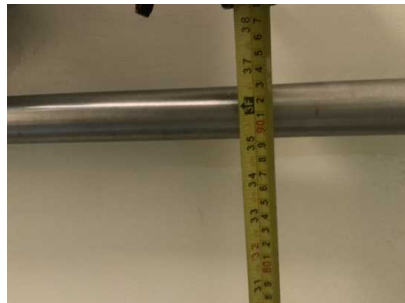
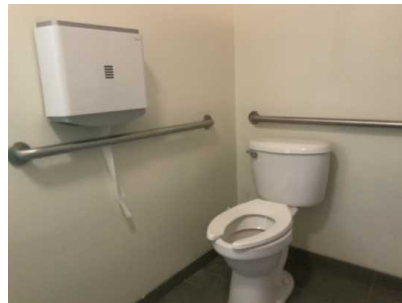
Photos for Barrier ID: AX239880

Assembly	Restroom
Type	Restroom/Bathroom-Water Closet
ADA Standard	604.5.2
Barrier Detail	The grab bars at the water closet are not compliant.
Location Description	Lobby Women's Restroom
Observed	May 18, 2021 by Ouraccessibleworld@gmail.com
Site Conditions	The grab bars are mounted up to 36-1/2" above the floor.

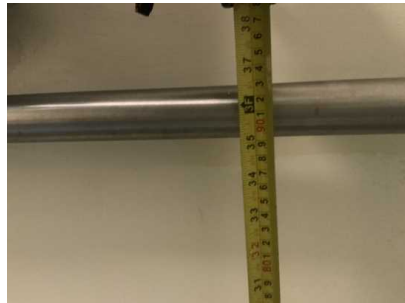
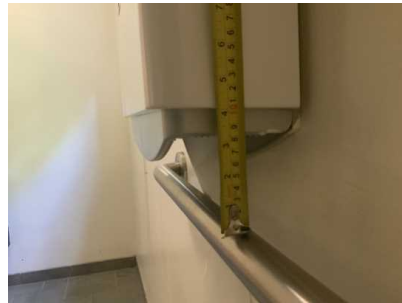
Photos for Barrier ID: AX240470

Assembly	Restroom
Type	Restroom/Bathroom-Water Closet
ADA Standard	604.7, 604.9, 609.3
Barrier Detail	The toilet paper dispenser is not at a compliant location.
Location Description	Lobby Women's Restroom
Observed	May 18, 2021 by Ouraccessibleworld@gmail.com
Site Conditions	The toilet paper dispenser is mounted 3" above the side grab bar.
