ACCESSIBILITY ASSESSMENT

ADA TITLE II ASSESSMENT

Owens Road
1100 Owens Road
Oxen Hill, Maryland 20745

July 14, 2021

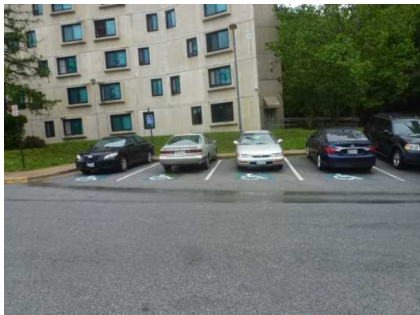
Photos for Barrier ID: AX241405

Assembly	Accessible Parking
Type	Parking Space-Car
ADA Standard	UFAS 4.6.3
Barrier Detail	An access aisle is not provided.
Location Description	Parking Lot A - Space P1-A, P1-B, P1-C, P1-D
Observed	May 16, 2018 by silloyd
Site Conditions	The parking space does not have an access aisle.

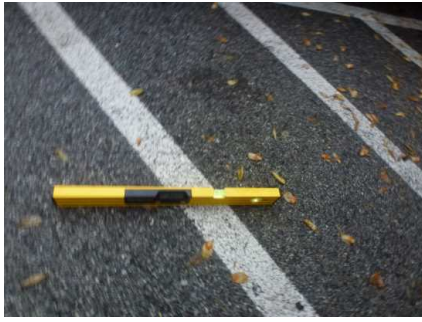
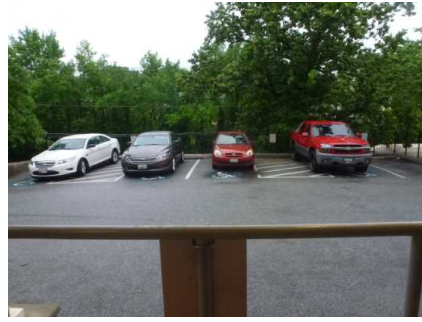
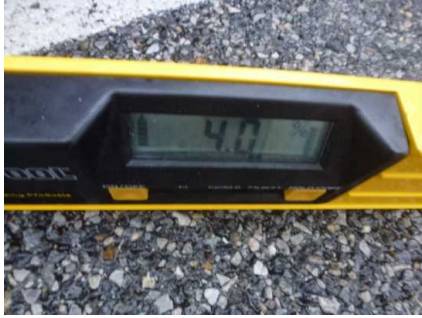
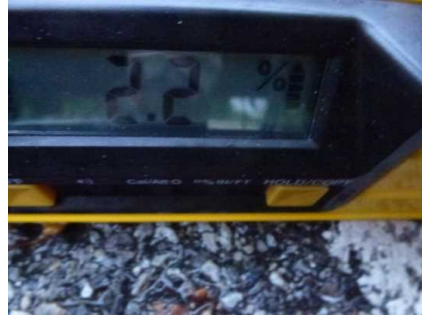
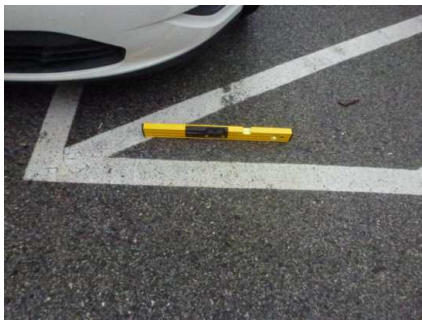
Assembly	Accessible Parking
Type	Parking Space-Car
ADA Standard	UFAS 4.6.3
Barrier Detail	The slope of the parking space is more than 2% running/cross slope.
Location Description	Parking Lot A - Space P2-A, P2-D
Observed	May 16, 2018 by siloyd

Remove and replace with a parking space that has no more than 2% slope in all directions. Parking spaces and access aisles shall be level with surface slopes not exceeding 1:50 in all directions. Parking access aisles shall be part of an accessible route to the building or facility entrance. Parked vehicle overhangs shall not reduce the clear width of an accessible circulation route. The quantity and order of magnitude cost estimate provided for this barrier are limited to the extent of the area identified as non-compliant. Additional costs that may be associated with removal of the barrier are not included.

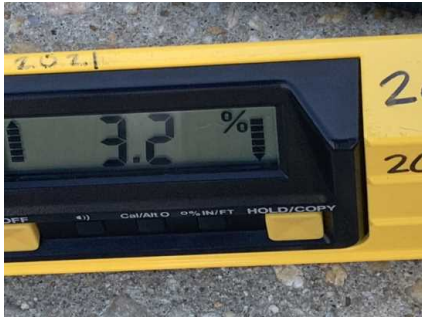
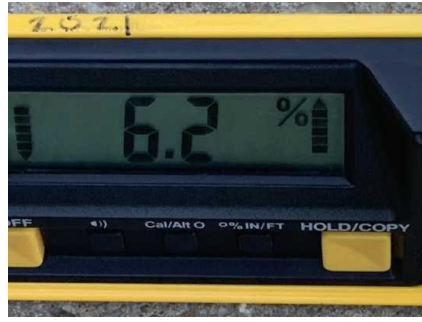
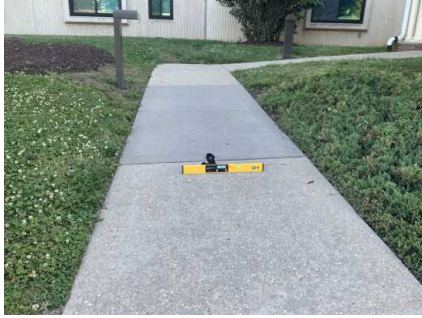
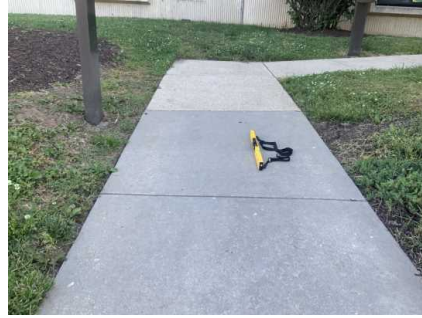
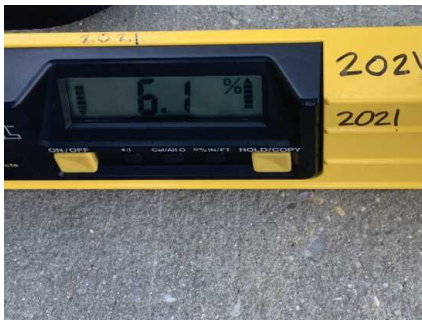
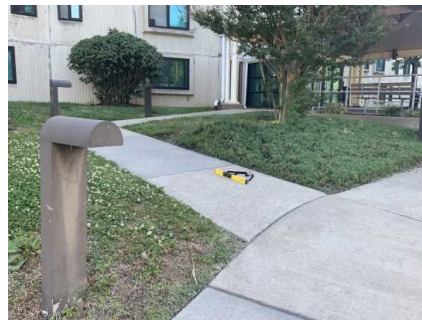
Assembly	Exterior Access Route
Type	Exterior Accessible Route
ADA Standard	403.3
Barrier Detail	The accessible route has cross slopes greater than 1:50 (2%).
Location Description	Sidewalk to Entrance on North Side from Stair ST1
Observed	May 20, 2021 by Ouraccessibleworld@gmail.com

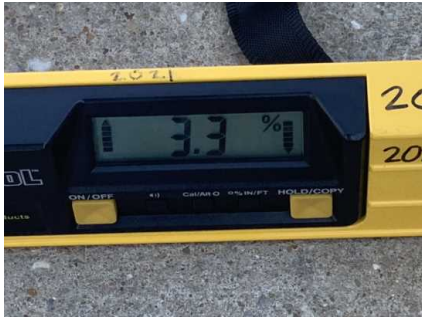
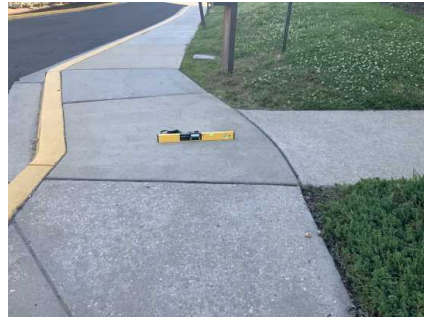
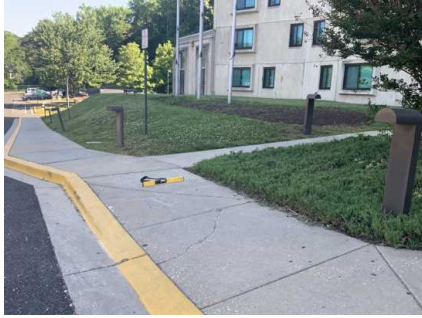
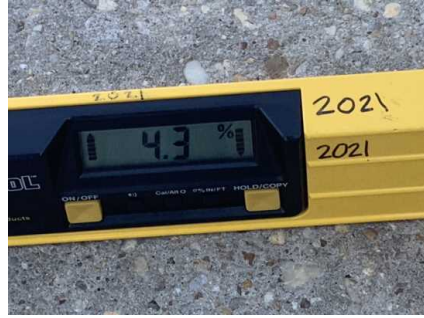
Assembly	Exterior Access Route
Type	Exterior Accessible Route
ADA Standard	304; 403.5.2
Barrier Detail	A compliant turning space is not provided at a change of direction.
Location Description	Sidewalk to Street - top landing
Observed	May 20, 2021 by Ouraccessibleworld@gmail.com

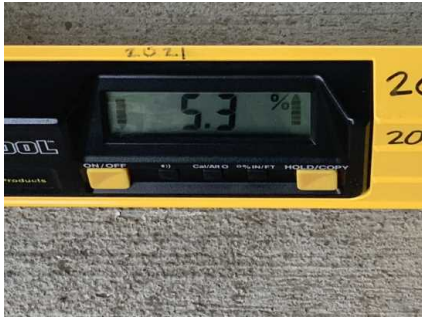
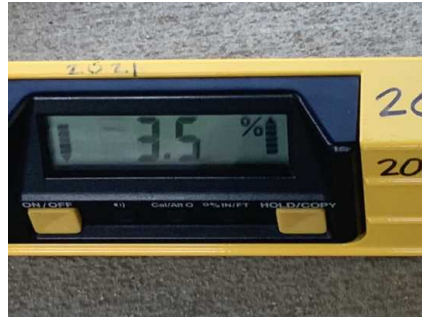
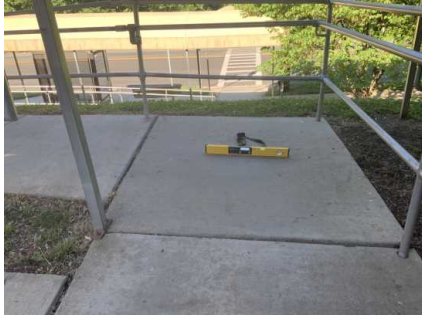
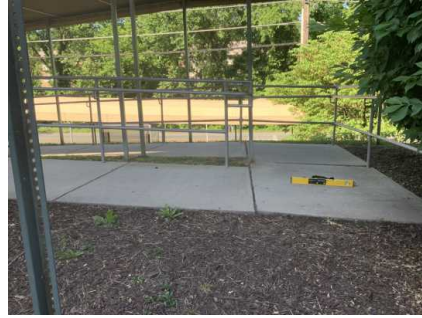
Assembly	Exterior Access Route
Type	Exterior Accessible Route
ADA Standard	304; 403.5.2
Barrier Detail	A compliant turning space is not provided at a change of direction.
Location Description	Sidewalk to Street street landing
Observed	May 21, 2021 by Ouraccessibleworld@gmail.com

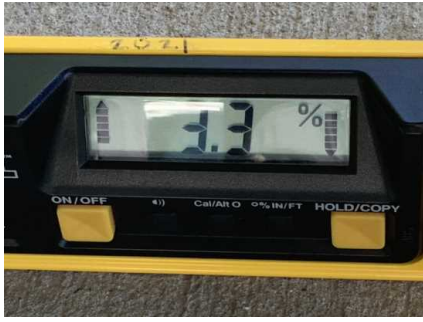
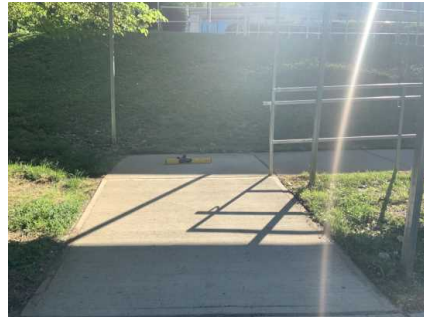
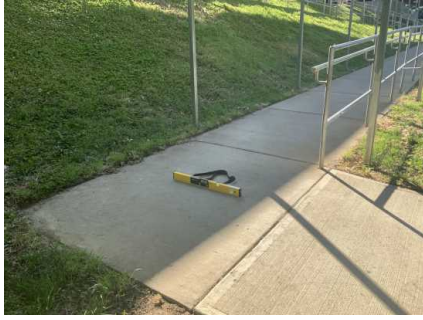
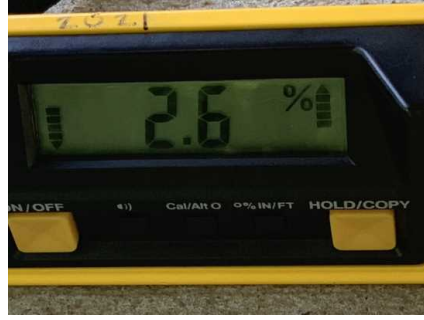
Assembly	Exterior Access Route
Type	Ramp
ADA Standard	405, 505
Barrier Detail	The ramp is required but not provided.
Location Description	Sidewalk to Street street landing
Observed	May 20, 2021 by Ouraccessibleworld@gmail.com

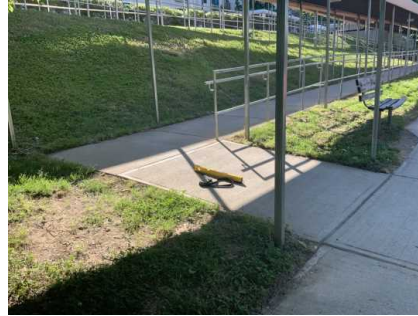
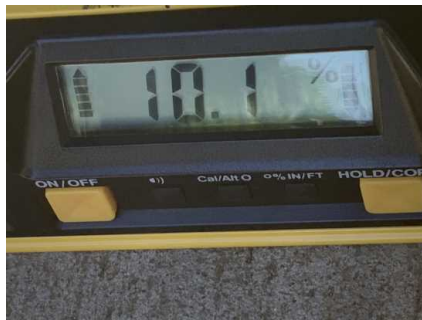
Assembly	Exterior Access Route
Type	Ramp
ADA Standard	405.8 and 505
Barrier Detail	The ramp run has a rise greater than 6"; however, handrails are not provided.
Location Description	Sidewalk to Street street landing
Observed	May 20, 2021 by Ouraccessibleworld@gmail.com
Site Conditions	The ramp has a rise of 12" and does not have handrails.

Provide compliant handrails or provide ramp runs with maximum 6" rise. Handrails are required on ramp runs which rise more than 6". Replace with continuous handrails at a consistent height above the ramp on both sides of the ramp. Inside handrails on switchback or dogleg stairs and ramps shall be continuous between runs. Top of gripping surfaces of handrails shall be 34" minimum and 38" maximum vertically above ramp surfaces. Handrails shall be at a consistent height above ramp surfaces. Clearance between handrail gripping surfaces and adjacent surfaces shall be 1-1/2" minimum. Handrail gripping surfaces shall be continuous along their length and shall not be obstructed along their tops or sides. The bottoms of handrail gripping surfaces shall not be obstructed for more than 20% of their length. Where provided, horizontal projections shall occur 1-1/2" minimum below the bottom of the handrail gripping surface. [EXCEPTIONS: 1. Where handrails are provided along walking surfaces with slopes not steeper than 1:20, the bottoms of handrail gripping surfaces shall be permitted to be obstructed along their entire length where they are integral to crash rails or bumper guards. 2. The distance between horizontal projections and the bottom of the gripping surface shall be permitted to be reduced by 1/8" for each 1/2" of additional handrail perimeter dimension that exceeds 4".] Handrail gripping surfaces with a circular cross section shall have an outside diameter of 1-1/4" minimum and 2" maximum. Handrail gripping surfaces with a non-circular cross section shall have a perimeter dimension of 4" minimum and 6-1/4" maximum, and a cross-section dimension of 2-1/4" maximum. Handrail gripping surfaces and any surfaces adjacent to them shall be free of sharp or abrasive elements and shall have rounded edges. Handrails shall not rotate within their fittings. Handrail gripping surfaces shall extend beyond and in the same direction of ramp runs. [EXCEPTIONS: 1. Extensions shall not be required for continuous handrails at the inside turn of switchback or dogleg ramps AND 3. In alterations, full extensions of handrails shall not be required where such extensions would be hazardous due to plan configuration.] Ramp handrails shall extend horizontally above the landing for 12" minimum beyond the top and bottom of ramp runs. Extensions shall return to a wall, guard, or the landing surface, or shall be continuous to the handrail of an adjacent ramp run.

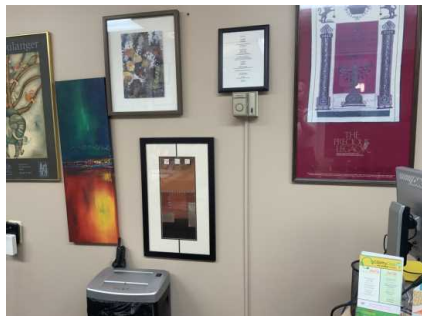
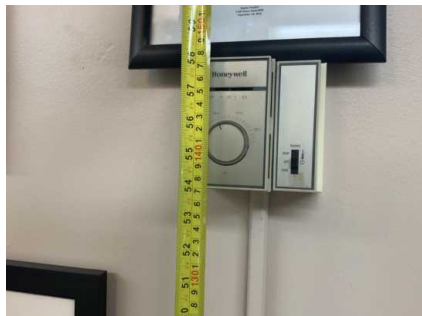
Photos for Barrier ID: AX239969

Location Description	Office
Observed	May 20, 2021 by Ouraccessibleworld@gmail.com
Site Conditions	The thermostat is mounted 55-1/2" above the floor.

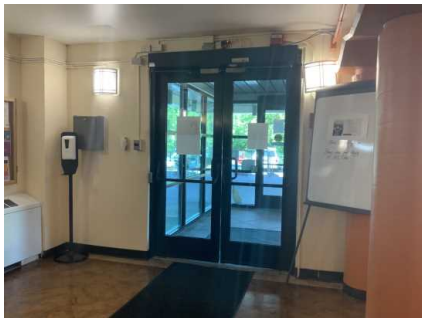
Photos for Barrier ID: AX239972

Assembly	Interior Access Route
Type	Signage
ADA Standard	216.4, 703.1, 703.4
Barrier Detail	Means of egress signage is not provided.
Location Description	Lobby
Observed	May 20, 2021 by Ouraccessibleworld@gmail.com
Site Conditions	Means of egress signage with tactile characters is not provided at the exit.

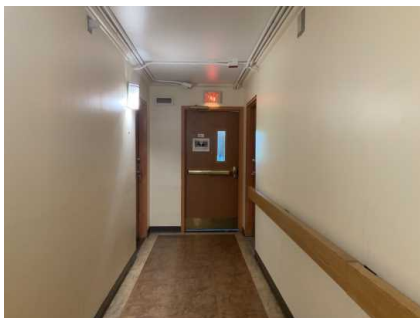
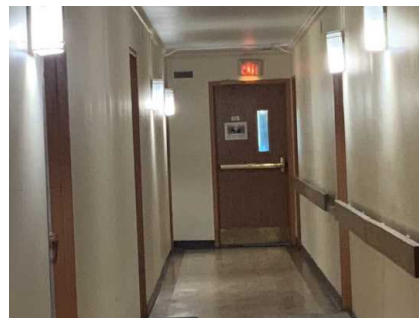
Photos for Barrier ID: AX239977

Assembly	Interior Access Route
Type	Signage
ADA Standard	216.4, 703.1, 703.4
Barrier Detail	Means of egress signage is not provided.
Location Description	Throughout Building
Observed	May 20, 2021 by Ouraccessibleworld@gmail.com
Site Conditions	Means of egress signage with tactile characters is not provided at the exits.

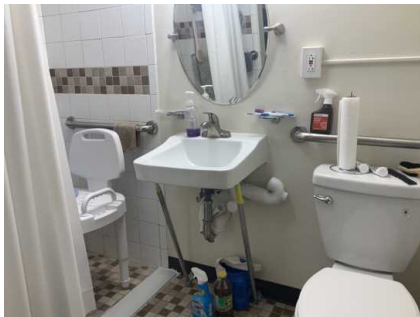
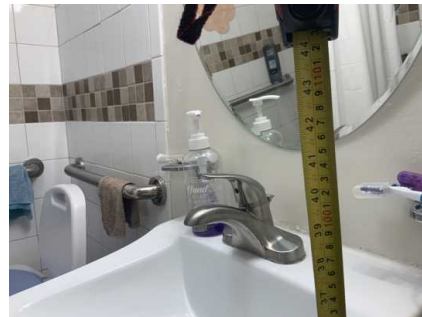
Photos for Barrier ID: AX239985

Location Description	Unit 601
Observed	May 20, 2021 by Ouraccessibleworld@gmail.com
Site Conditions	The bottom of the reflective surface of the mirror is 41" above the floor.
