ACCESSIBILITY ASSESSMENT

145366.21R000-007.160

ADA TITLE II ASSESSMENT

Rollingcrest Village
5631 Sargent Road
Hyattsville, Maryland 20782

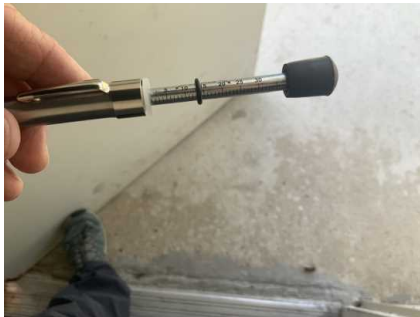
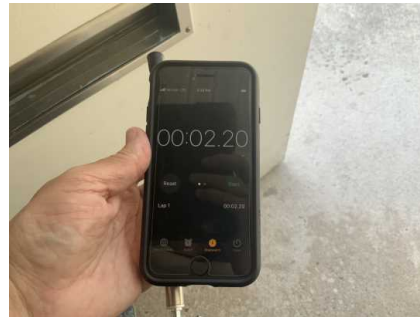
Photos for Barrier ID: AX239910

Assembly	Accessible Parking
Type	Parking Space-Car
ADA Standard	UFAS 4.6.3
Barrier Detail	The slope of the standard car access aisle is greater than 1:50 (2%).
Location Description	Parking Lot - P1
Observed	May 20, 2021 by Ouraccessibleworld@gmail.com

Remove and replace with an adjacent access aisle that is at least 60" wide and has a maximum slope of 1:50 (2%) in all directions. Parking spaces and access aisles shall be level with surface slopes not exceeding 1:50 in all directions. Parking access aisles shall be part of an accessible route to the building or facility entrance. Parked vehicle overhangs shall not reduce the clear width of an accessible circulation route. The quantity and order of magnitude cost estimate provided for this barrier are limited to the extent of the area identified as non-compliant. Additional costs that may be associated with removal of the barrier are not included.

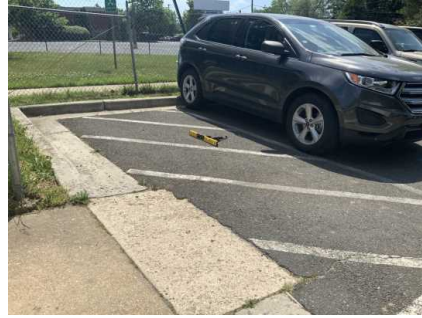
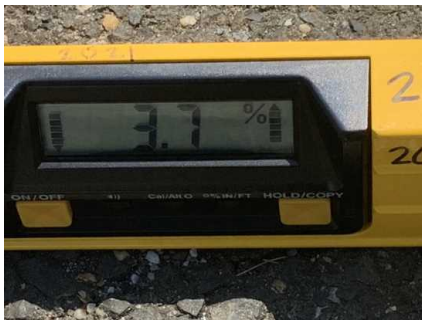
Assembly	Accessible Parking
Type	Parking Space-Car
ADA Standard	UFAS 4.6.3
Barrier Detail	The slope of the standard car parking space is greater than 1:50 (2%).
Location Description	Parking Lot - P1
Observed	May 20, 2021 by Ouraccessibleworld@gmail.com
Site Conditions	The parking space has a running and cross slope of up to 2.8%

Remove and replace with a parking space that has no more than 1:50 (2%) slope in all directions. Parking spaces for disabled people shall be at least 96" wide and shall have an adjacent access aisle 60" wide minimum (see Fig. 9). [EXCEPTION: If accessible parking spaces for vans are provided, each should have an adjacent access aisle at least 96" wide.] Parking access aisles shall be part of an accessible route to the building or facility entrance. Two accessible parking spaces may share a common access aisle. Parked vehicle overhangs shall not reduce the clear width of an accessible circulation route. Parking spaces and access aisles shall be level with surface slopes not exceeding 1:50 in all directions. The quantity and order of magnitude cost estimate provided for this barrier are limited to the extent of the area identified as non-compliant. Additional costs that may be associated with removal of the barrier are not included.

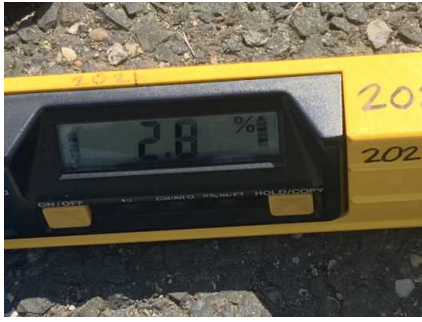
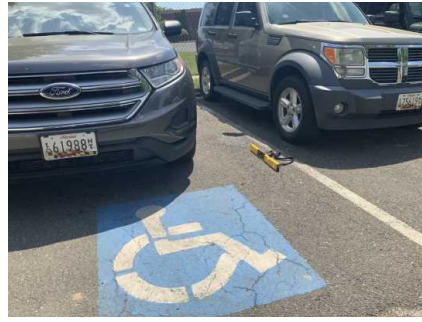
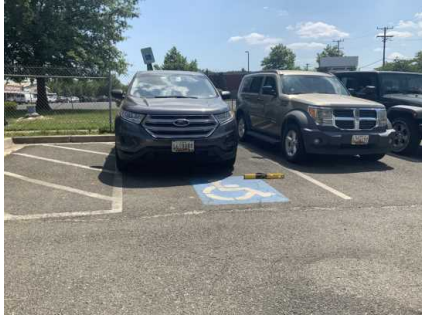
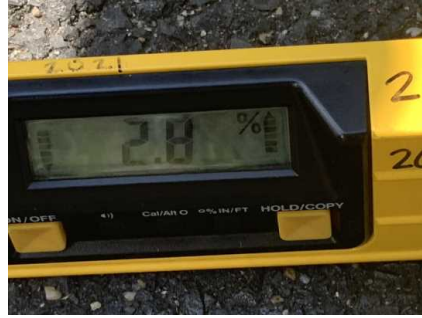
20 +38.959541, -76.985789

Assembly	Accessible Parking
Type	Parking Space-Car
ADA Standard	UFAS 4.6.3
Barrier Detail	The slope of the standard car parking space is greater than 1:50 (2%).
Location Description	Parking Lot A - Space P2-A
Observed	May 14, 2018 by siloyd
Site Conditions	The cross slope is 2.9% and the running slope is 3.3%.

Remove and replace with a parking space that has no more than 1:50 (2%) slope in all directions. Parking spaces for disabled people shall be at least 96" wide and shall have an adjacent access aisle 60" wide minimum (see Fig. 9). [EXCEPTION: If accessible parking spaces for vans are provided, each should have an adjacent access aisle at least 96" wide.] Parking access aisles shall be part of an accessible route to the building or facility entrance. Two accessible parking spaces may share a common access aisle. Parked vehicle overhangs shall not reduce the clear width of an accessible circulation route. Parking spaces and access aisles shall be level with surface slopes not exceeding 1:50 in all directions. The quantity and order of magnitude cost estimate provided for this barrier are limited to the extent of the area identified as non-compliant. Additional costs that may be associated with removal of the barrier are not included.

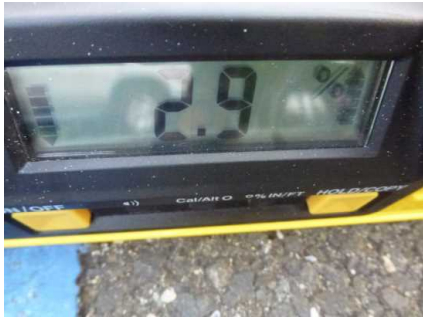
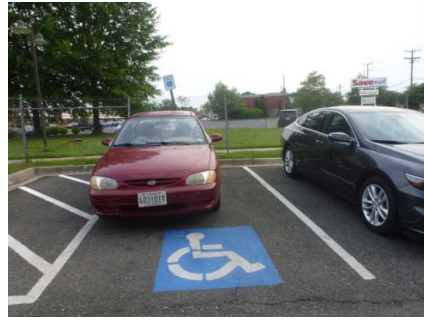
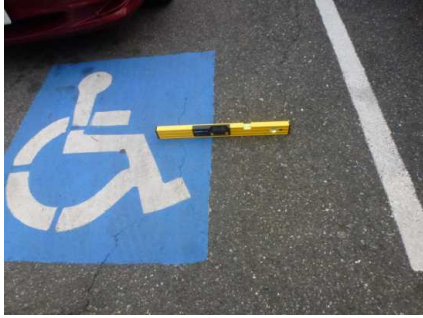
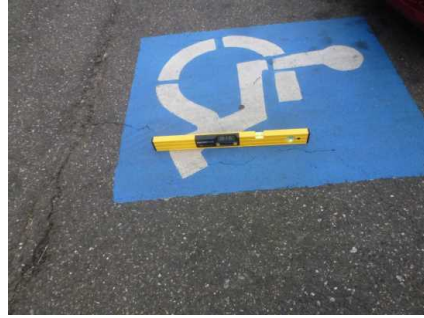
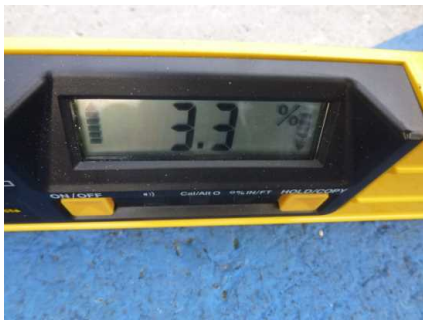
76 38.95955250665634,-76.98582229819965

Assembly	Accessible Parking
Type	Parking Space-Car
ADA Standard	UFAS 4.6.3
Barrier Detail	The slope of the standard car access aisle is greater than 1:50 (2%).
Location Description	Parking Lot A - Space P2-A
Observed	May 14, 2018 by siloyd
Site Conditions	The cross slope is 8.2% and the running slope is 2.8%.

Remove and replace with an adjacent access aisle that is at least 60" wide and has a maximum slope of 1:50 (2%) in all directions. Parking spaces and access aisles shall be level with surface slopes not exceeding 1:50 in all directions. Parking access aisles shall be part of an accessible route to the building or facility entrance. Parked vehicle overhangs shall not reduce the clear width of an accessible circulation route. The quantity and order of magnitude cost estimate provided for this barrier are limited to the extent of the area identified as non-compliant. Additional costs that may be associated with removal of the barrier are not included.

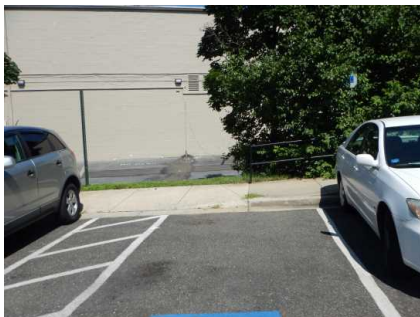
Photos for Barrier ID: AX241415

Assembly	Accessible Parking
Type	Parking Space-Van
ADA Standard	UFAS 4.6.3
Barrier Detail	The slope of the van access aisle is greater than 2%.
Location Description	Parking Lot B - Space P1-B
Observed	May 7, 2018 by ouraccessibleworld

Remove and replace with an adjacent access aisle that is at least 96" wide and has maximum 1:50 (2%) slope in all directions. Parking spaces for disabled people shall be at least 96" wide and shall have an adjacent access aisle 60" wide minimum (see Fig. 9). [EXCEPTION: If accessible parking spaces for vans are provided, each should have an adjacent access aisle at least 96" wide.] Parking access aisles shall be part of an accessible route to the building or facility entrance. Two accessible parking spaces may share a common access aisle. Parked vehicle overhangs shall not reduce the clear width of an accessible circulation route. Parking spaces and access aisles shall be level with surface slopes not exceeding 1:50 in all directions. The quantity and order of magnitude cost estimate provided for this barrier are limited to the extent of the area identified as non-compliant. Additional costs that may be associated with removal of the barrier are not included.

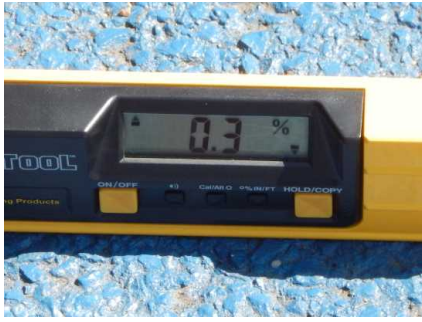
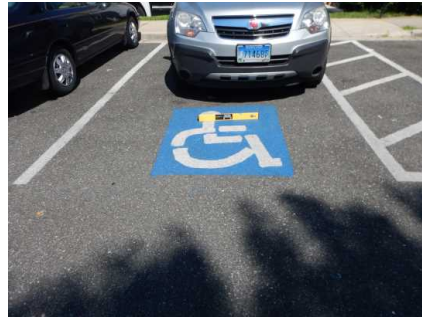
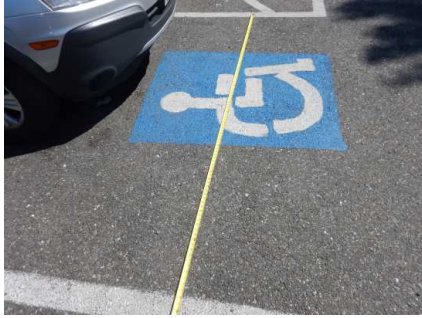
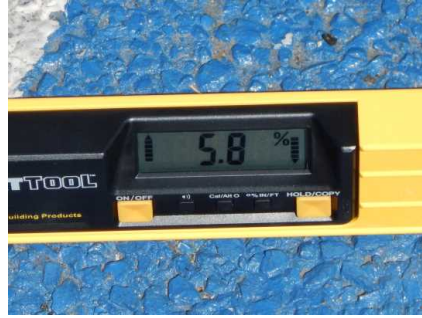
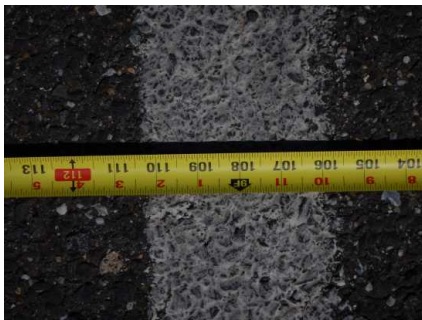
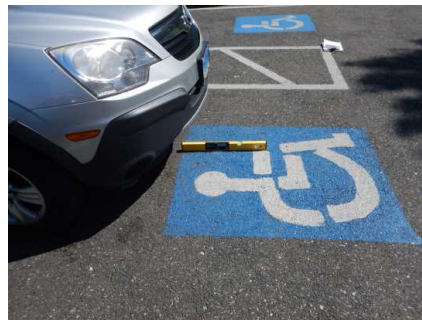
116 38.95797048576778,-76.98529086011888

Assembly	Accessible Parking
Type	Parking Space-Car
ADA Standard	UFAS 4.6.3
Barrier Detail	The slope of the standard car parking space is greater than 1:50 (2%).
Location Description	Parking Lot B - Space P2-B
Observed	May 7, 2018 by ouraccessibleworld

Remove and replace with a parking space that has no more than 1:50 (2%) slope in all directions. Parking spaces for disabled people shall be at least 96" wide and shall have an adjacent access aisle 60" wide minimum (see Fig. 9). [EXCEPTION: If accessible parking spaces for vans are provided, each should have an adjacent access aisle at least 96" wide.] Parking access aisles shall be part of an accessible route to the building or facility entrance. Two accessible parking spaces may share a common access aisle. Parked vehicle overhangs shall not reduce the clear width of an accessible circulation route. Parking spaces and access aisles shall be level with surface slopes not exceeding 1:50 in all directions. The quantity and order of magnitude cost estimate provided for this barrier are limited to the extent of the area identified as non-compliant. Additional costs that may be associated with removal of the barrier are not included.

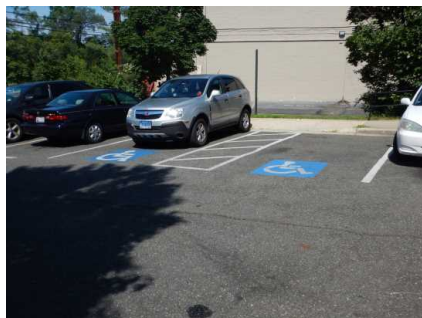
Photos for Barrier ID: AX241414

Assembly	Accessible Parking
Type	Parking Space-Van
ADA Standard	State of MD 05.07.D (2)(a)and (b),(3) & (6)
Barrier Detail	MARYLAND: Compliant signage is not provided at the space.
Location Description	Parking Lot B - Spaces P1-B
Observed	May 8, 2018 by ouraccessibleworld

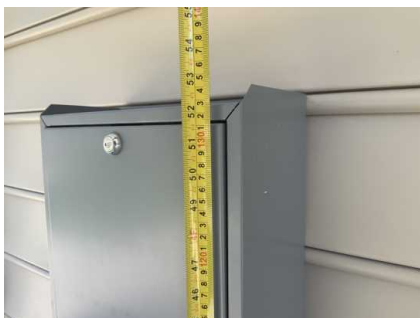
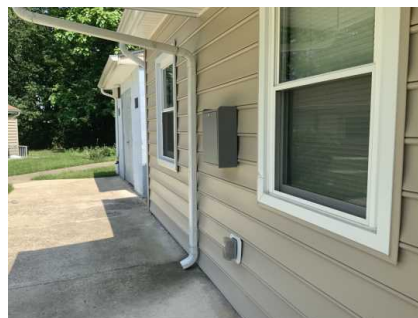
Photos for Barrier ID: AX239895

Assembly	Interior Access Route
Type	Protruding Object
ADA Standard	UFAS 4.4.1
Barrier Detail	The object protrudes more than 4" from the wall.
Location Description	Office
Observed	May 20, 2021 by Ouraccessibleworld@gmail.com

Lower object so that the bottom leading edge is maximum 27" above finish floor, replace with a non-protruding model, or install cane detectors. Objects projecting from walls (for example, telephones) with their leading edges between 27" and 80" above the finished floor shall protrude no more than 4" into walks, halls, corridors, passageways, or aisles (see Fig. 8(a)). Objects mounted with their leading edges at or below 27" above the finished floor may protrude any amount (see Fig. 8(a) and (b)). Free-standing objects mounted on posts or pylons may overhang 12" maximum from 27" to 80" above the ground or finished floor (see Fig. 8(c) and (d)). Protruding objects shall not reduce the clear width of an accessible route or maneuvering space (see Fig. 8(e)). Ensure objects do not protrude more than 4" into the accessible route when mounted at 27" or above from the finished floor to their leading edge. Wall- and post-mounted cantilevered units shall have a clear knee space between the bottom of the apron and the floor or ground at least 27" high, 30" wide, and 17" to 19" deep. Such units shall also have a minimum clear floor space 30" by 48" to allow a person in a wheelchair to approach the unit facing forward.

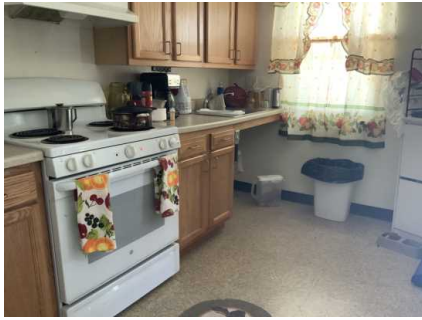
Assembly	Residential Dwelling
Type	Kitchen Cabinets
ADA Standard	UFAS 4.2.6, 4.34.6.10
Barrier Detail	
The kitchen cabinet shelving, shelf areas, and drawers are not within reach range.	
Location Description	Unit 5631, 5641, 5655, 5657
Observed	May 20, 2021 by Ouraccessibleworld@gmail.com
Site Conditions	The lower shelf of the upper cabinets is mounted at 52" above the floor.
Resolution	
<p>Configure the shelving to provide at least one accessible shelf in each cabinet, shelf area and drawers. Cabinets, drawers, and shelf areas shall comply. Provide clear floor space at least 30" by 48" that allows either a forward or a parallel approach. Cabinets shall have the following features:(1) Maximum height shall be 48" for at least one shelf of all cabinets and storage shelves mounted above work counters (see Fig. 50). (2) Door pulls or handles for wall cabinets shall be mounted as close to the bottom of cabinet doors as possible. Door pulls or handles for base cabinets shall be mounted as close to the top of cabinet doors as possible. Shelving shall be located no higher than 48" for an unobstructed side approach or 48" for an unobstructed frontal only approach. If the clear floor space only allows forward approach to an object, the maximum high forward reach allowed shall be 48" (see Figure 5(a)). The minimum low forward reach is 15". If the high forward reach is over an obstruction, where the horizontal obstruction is less than 20" the maximum high forward reach is 48". Where the horizontal obstruction is from 20" to maximum 25", the high forward reach shall be 44" maximum. Forward obstructed reaches shall comply with Figure 5(b). If the clear floor space allows parallel approach by a person in a wheelchair, the maximum high side reach allowed shall be 54", and the low side reach shall be no less than 9" above the floor (Figure 6(a) and (b)). If the side reach is over an obstruction, the maximum horizontal reach shall be 24" and the high side reach shall be 46" maximum. Side obstructed clearances shall be as shown in Figure 6(c).</p>

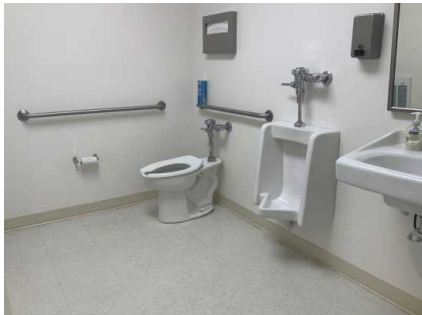
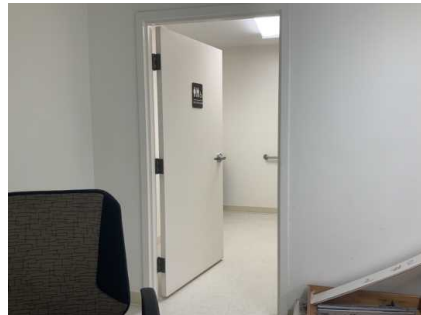
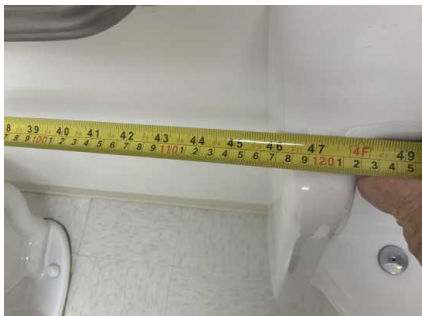
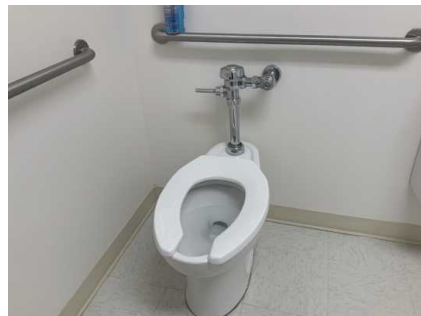
Photos for Barrier ID: AX239902

Assembly	Restroom
Type	Controls And Dispensers
ADA Standard	606.1; 309.3
Barrier Detail	The height of controls are not compliant.
Location Description	Office Restroom
Observed	May 20, 2021 by Ouraccessibleworld@gmail.com
Site Conditions	The seat cover dispenser is mounted at 58" above the floor.

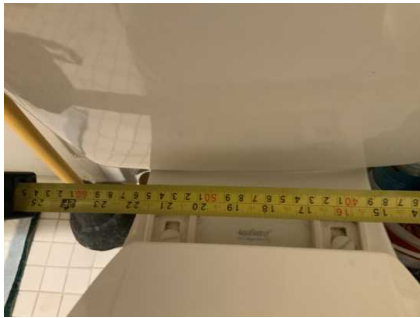
Photos for Barrier ID: AX239944

Assembly	Residential Dwelling
Type	Restroom/Bathroom-Water Closet
ADA Standard	UFAS 4.16.2, Fig. 28, 4.34.5.2(1); Fig. 47(a)
Barrier Detail	The centerline of the water closet is not exactly 18" from the side wall.
Location Description	Unit 5641
Observed	May 20, 2021 by Ouraccessibleworld@gmail.com
Site Conditions	The centerline of the water closet is 18-1/2" from the side wall.
Resolution	
Relocate the centerline of the water closet so that it is exactly 18" from the side wall. Clear floor space at the water closet shall be as shown in Figure 28, and Figure 47(a) for adaptable units. The water closet may be located with the clear area at either the right or left side of the toilet.	
Quantity	
1 EA	
Priority	3
