March 9, 2017

Re: **Lead (Pb) Screening Inspection**
Suitland Shopping Center
4646 & 4670 Suitland Road
Suitland, MD 20746

One Source Environmental Project Number: 134-004A LBP

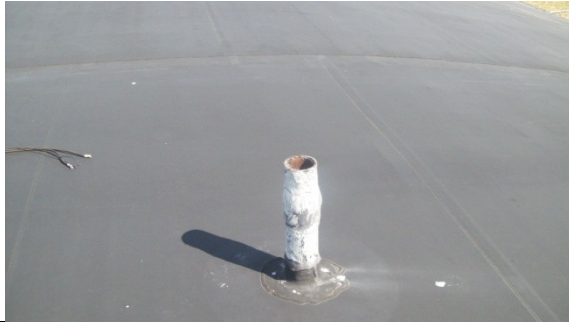
Photo #1:	4646 Roof Elevated Lead on Vent pipe
-----------	---

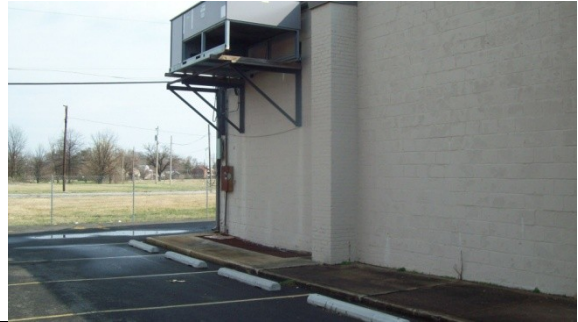
Photo #2:	4646 Exterior Side B LBP on Wall
-----------	-------------------------------------

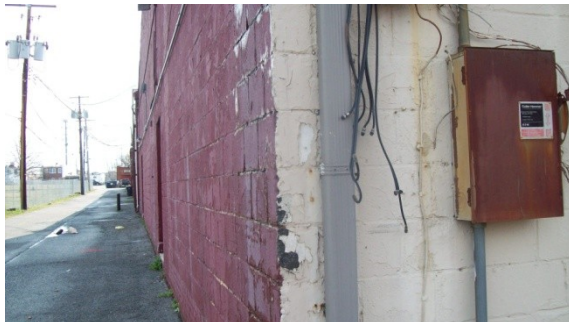
Photo #3:	4646 Exterior Sides B and C LBP on Wall
-----------	--

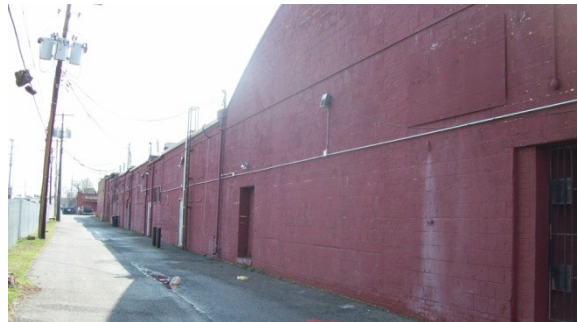
Photo #4:	4646 Exterior Side C LBP on Wall
-----------	-------------------------------------

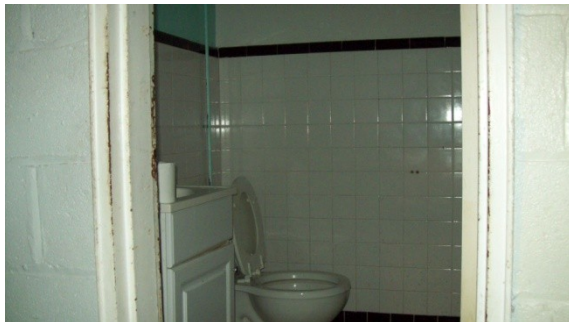
Photo #5:	4646 Basement Bathroom Black Ceramic Border Tile Elevated Lead
-----------	--

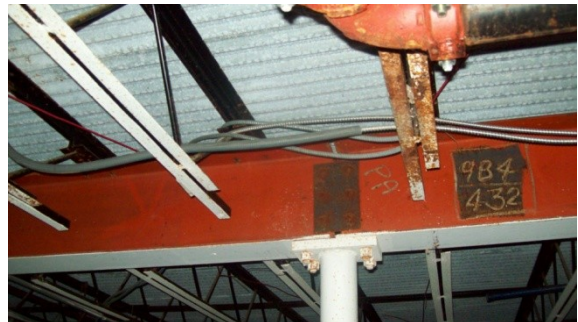
Photo #6:	4670 Plenum LBP on Beams and Support Posts
-----------	---

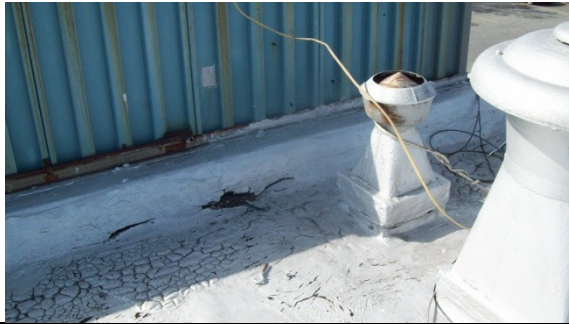
Photo #7:	4670 Roof LBP on Vent Pipes and Parapet Wall
-----------	---

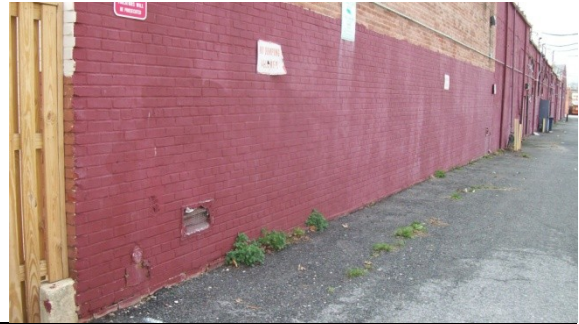
Photo #8:	4670 Exterior Rear LBP on Vent
-----------	-----------------------------------

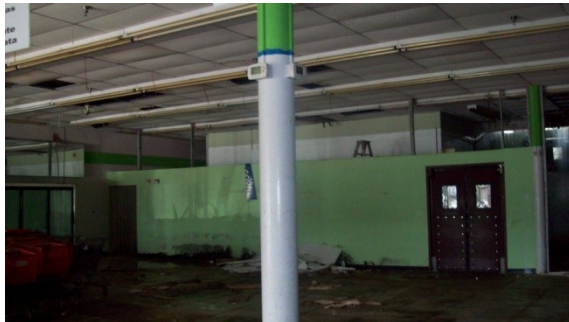
Photo #9:	4670 Showroom LBP on Support Posts
-----------	---------------------------------------
