Asbestos Inspection

Suitland Shopping Center
4646 and 4670 Suitland Road
Suitland, MD 20746

ON SITE DATES: FEBRUARY 28TH, TO MARCH 2ND, 2017

REPORT DATE: MARCH 9TH, 2017

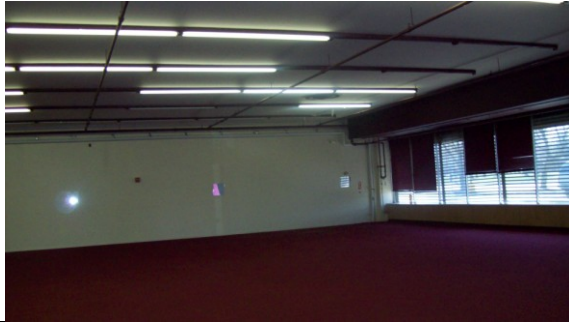
Photo #1:	4646 Perimeter Walls Plaster Sample Set 1 Non-ACM
-----------	---

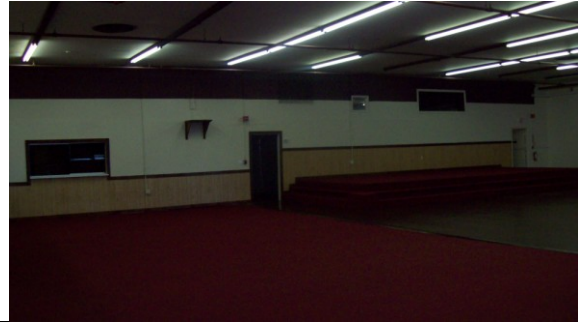
Photo #2:	4646 Interior Walls Drywall/Joint Compound/Tape Sample Sets 3, 4, 5 Non-ACM
-----------	---

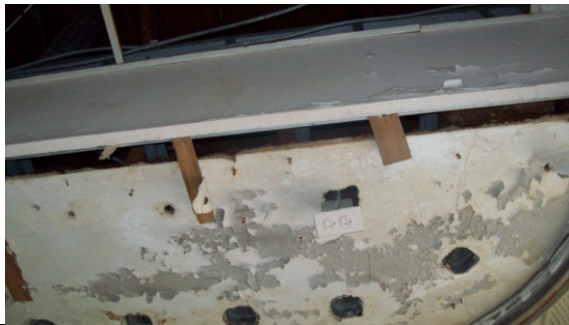
Photo #3:	4670 Soffit Plaster Sample Set 1 Non-ACM
-----------	--

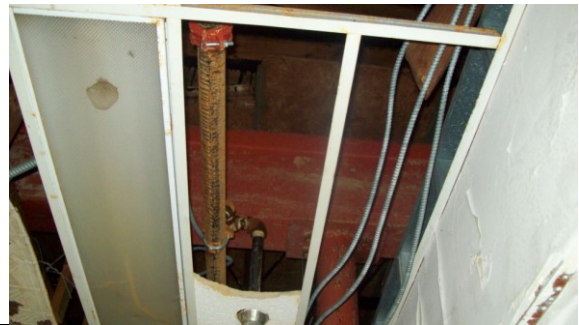
Photo #4:	4670 Wall System – Joint Compound 2% Chrysotile Asbestos in 4670
-----------	--

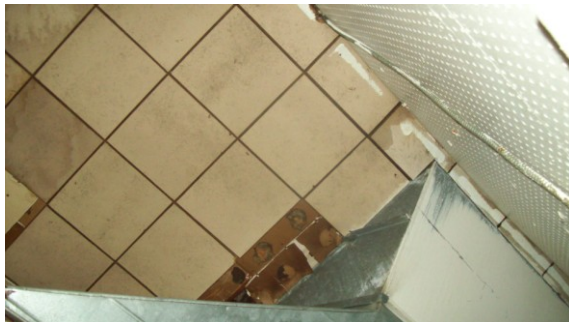
Photo #5:	4646 Hallway/Backstage Area 1'x1' Ceiling Tile and Glue Dots Sample Sets 5 and 6 Non-ACM
-----------	--

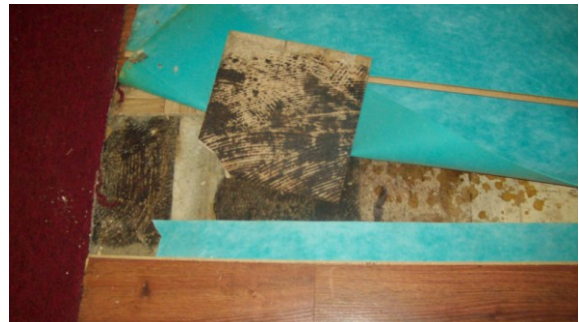
Photo #6:	4646 Under Wood Floor 9'x9' Floor Tile & Mastic Sample Set 8 Tile & Mastic ACM
-----------	--

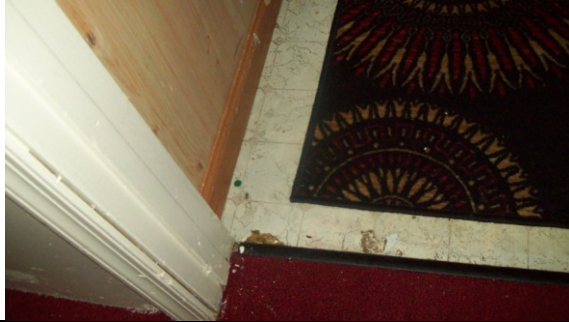
Photo #7:	4646 Bathroom-1 Top Layer Vinyl Flooring Sample 9A Non-ACM
-----------	---

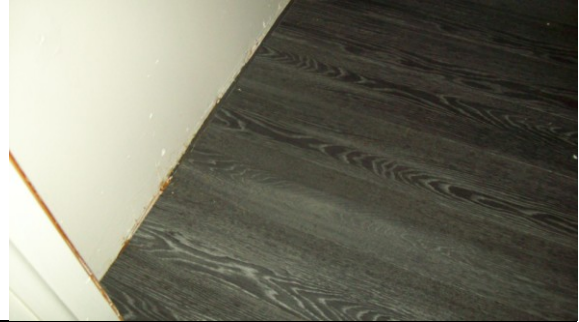
Photo #8:	4646 Mezzanine Bathroom Gray Vinyl Flooring Sample 10A Non-ACM
-----------	---

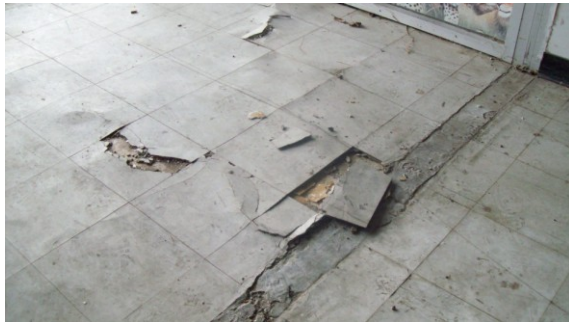
Photo #9:	4670 Foyer/Showroom Multiple Layers Tile and Flash Patch Sample Sets 11,12,13 Non-ACM
-----------	--

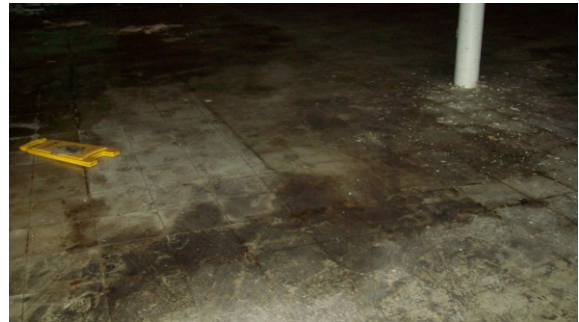
Photo #10:	4670 Showroom 12"x12" Floor Tile and Mastic Sample Sets 11,12 Non-ACM
------------	--

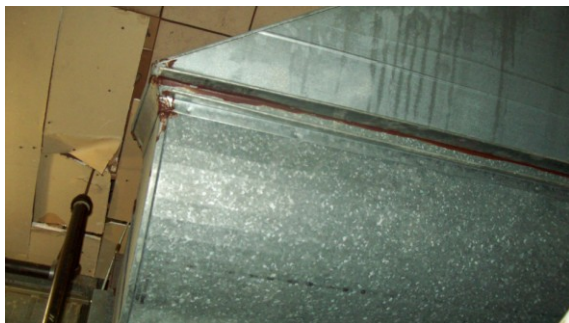
Photo #11:	4646 Hallway-1 Red Duct Seam Sealant Sample 17A Non-ACM
------------	--

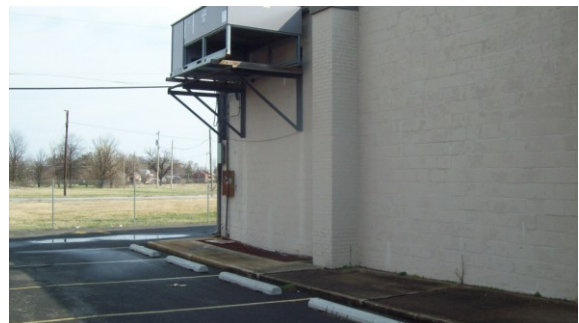
Textured Wall Paint located on the exterior of the spaces was found to contain trace (<1%) amounts of asbestos. While not classified as an ACM, OSHA still regulates airborne employee exposure to asbestos fibers. Any activities that may turn this material to dust may be regulated by OSHA and require employee exposure monitoring and respiratory protection.

Photo #12:	4646 Exterior Wall Textured Paint Sample 19A Trace <1% Chrysotile Asbestos
------------	---

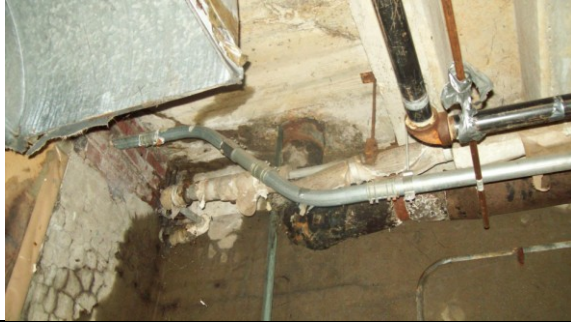
Photo #13: 4646 Basement – Samples 23, 24, 25 ACM
Pipe Insulation/Elbows and Seam Cement & Black Mastic on Fiberglass Insulation

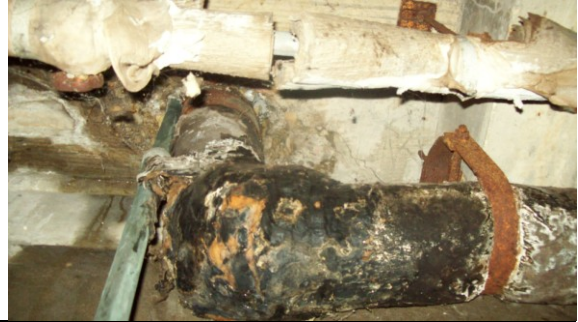
Photo #14: 4646 Basement – Samples 23, 24, 25 ACM
Pipe Insulation/Elbows and Seam Cement & Black Mastic on Fiberglass Insulation

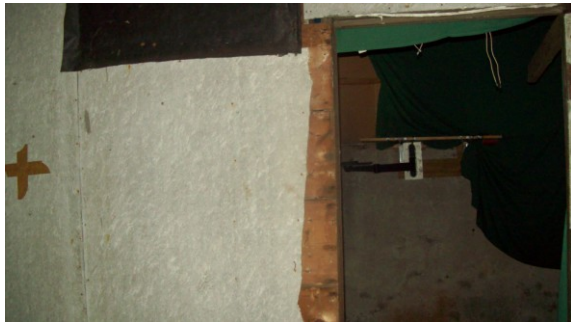
Photo #15: 4646 Basement
Cement Wallboard
Sample 26A 35% Chrysotile Asbestos

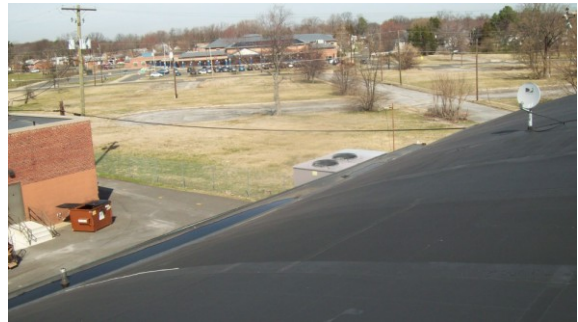
Photo #16: 4646 Roof Membrane and Insulation
Samples 27A, 28A Non-ACM

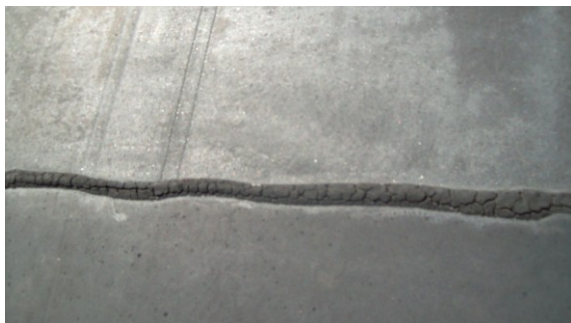
Photo #17: 4646 Roof Membrane Tar
Sample 29A Non-ACM

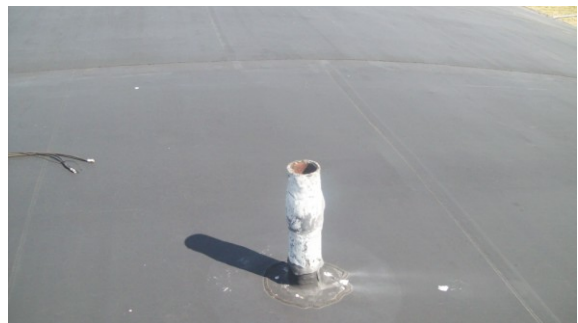
Photo #18: Roof Penetration Tar
Sample 30A 3% Chrysotile Asbestos

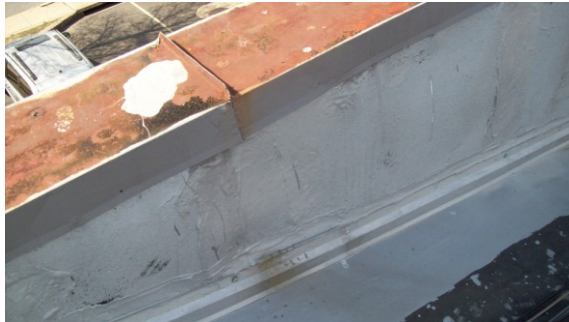
Photo #19: 4646 Roof Flashing Mastic
Sample 34A 3% Chrysotile Asbestos

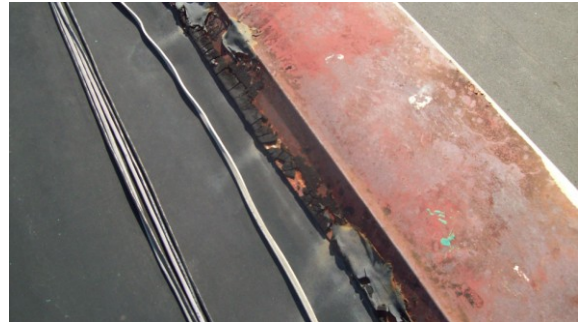
Photo #20: 4646 Roof Tar on Metal Flashing
Grey is #5 Chrysotile Asbestos

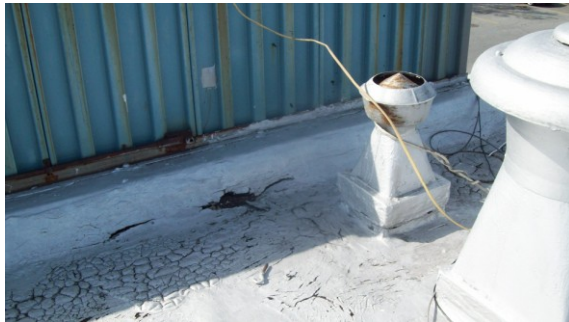
Photo #21: 4670 Roof
Flashing and Penetration Tar are ACM

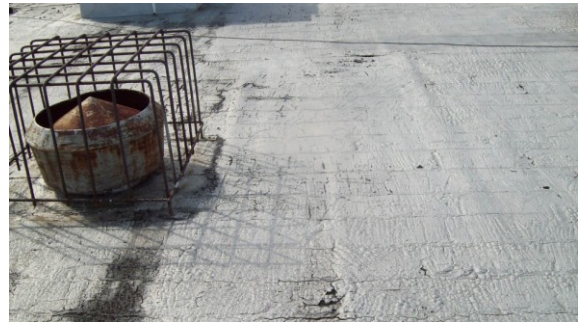
Photo #22: 4670 Roof Membrane East Side
Samples 38A, 39A Non-ACM

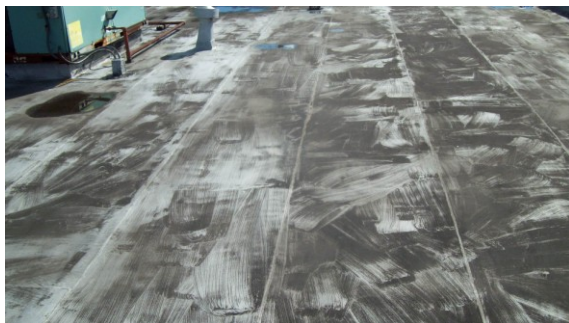
Photo #23: 4670 Roof Membrane/Tar West Side
Non-ACM

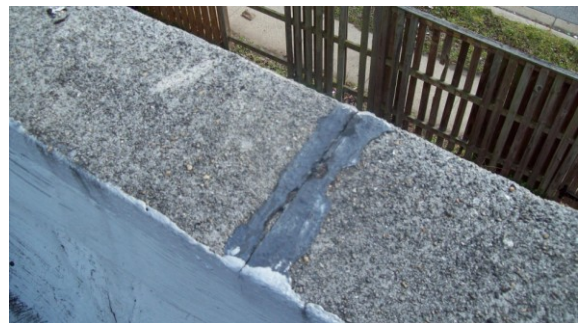
Photo #24: 4670 East Parapet Wall
Sealant
Sample 41A 5% Chrysotile Asbestos

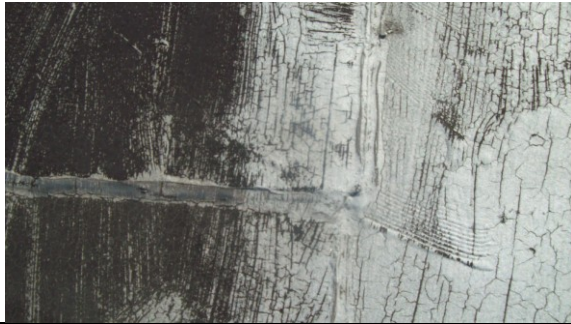
Photo #25:	4670 East Roof Membrane Sealant Sample 40A Non-ACM
------------	--

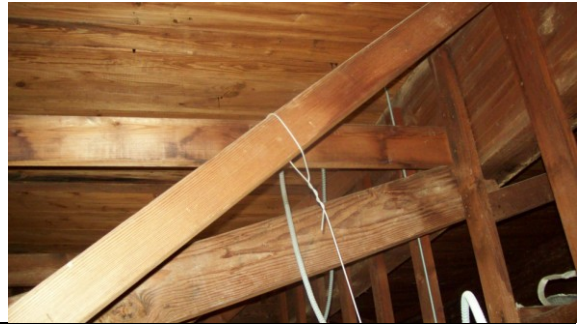
Photo #26:	4670 Plenum No Suspected ACM's
------------	-----------------------------------

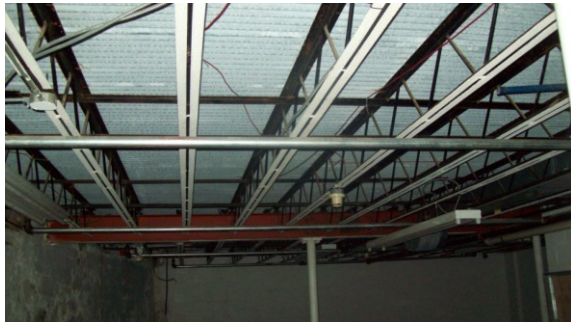
Photo #27:	4670 Plenum No Suspected ACM's
------------	-----------------------------------

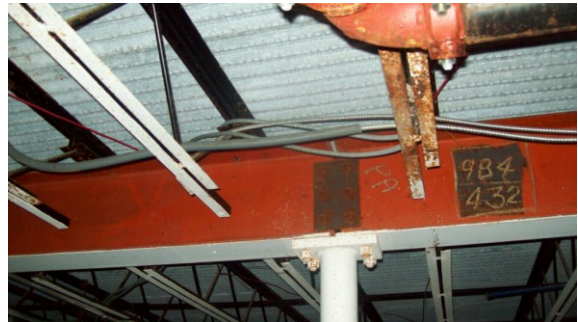
Photo #28:	4670 Plenum No Suspected ACM's
------------	-----------------------------------

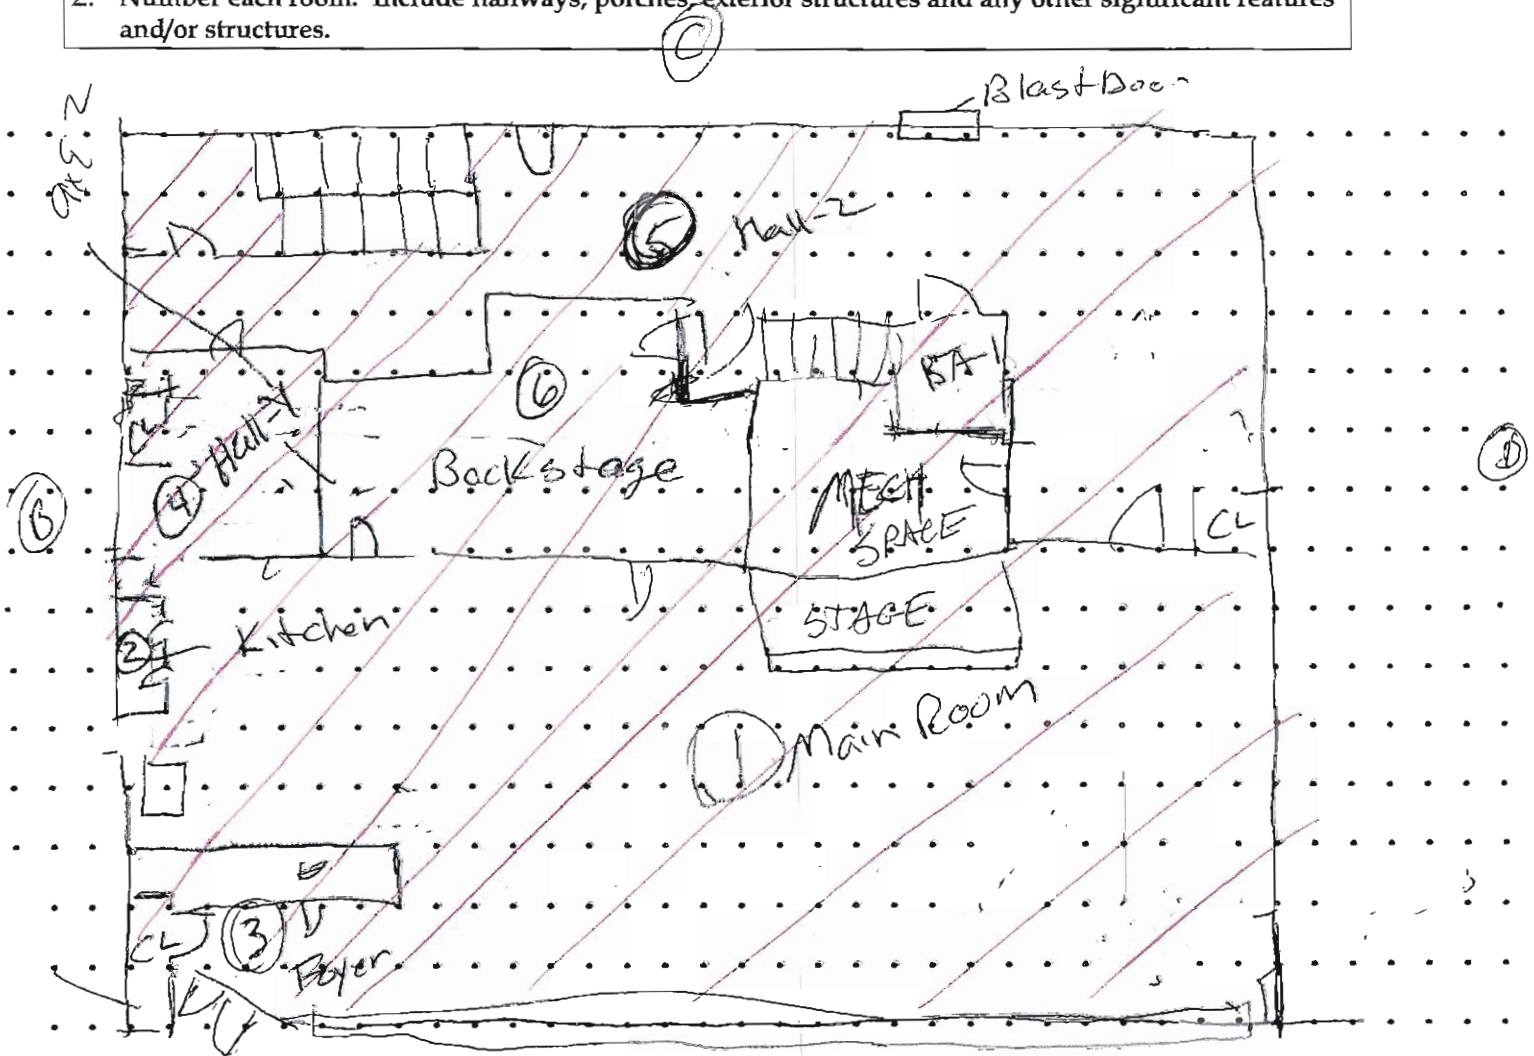
-Acem Floor Tile & Mastic
