Asbestos Inspection

Suitland Shopping Center
4622 and 4626 Suitland Road
Suitland, MD 20746

REPORT DATE: MARCH 10TH, 2017

OSE Project #134-004B ACM

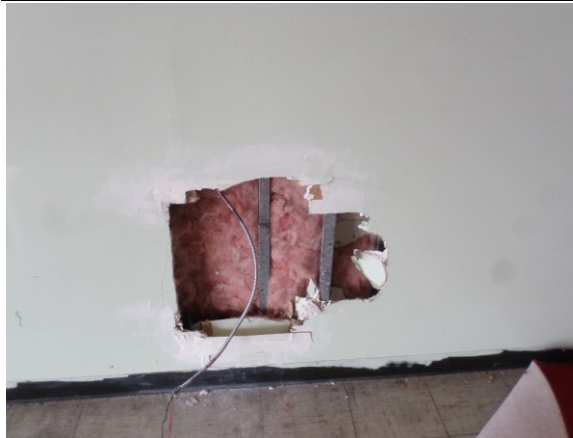
Photo #3:	Typical Drywall/Joint Compound Drywall #3 Joint Compound #4 Non-ACM
-----------	---

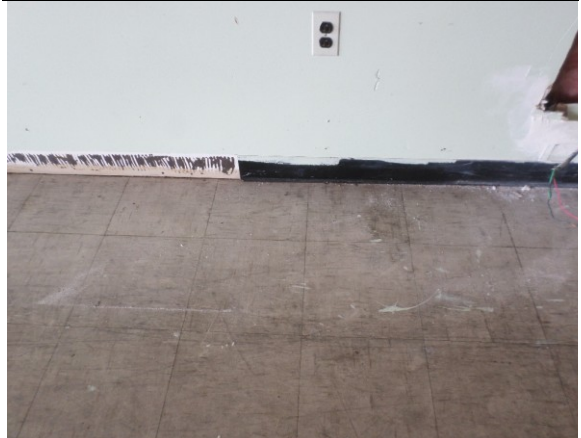
Photo #4:	4" Black Cove Base #24 and Glue #25 Non-ACM
-----------	--

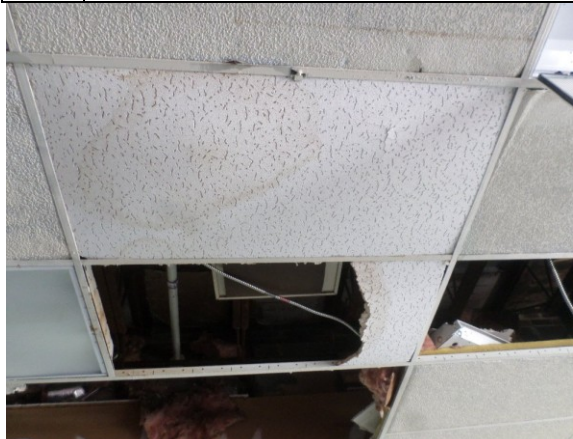
Photo #5:	4622 2x4 Pinhole Fissure Ceiling Tile Sample Set #18 Non-ACM
-----------	--

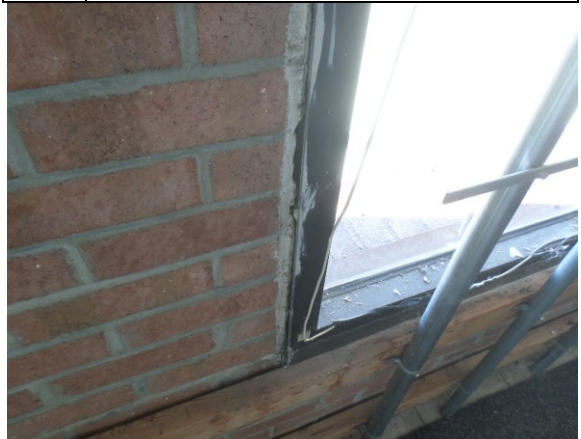
Photo #6:	4622 Interior Window Caulk Sample Set #17 Non-ACM
-----------	--

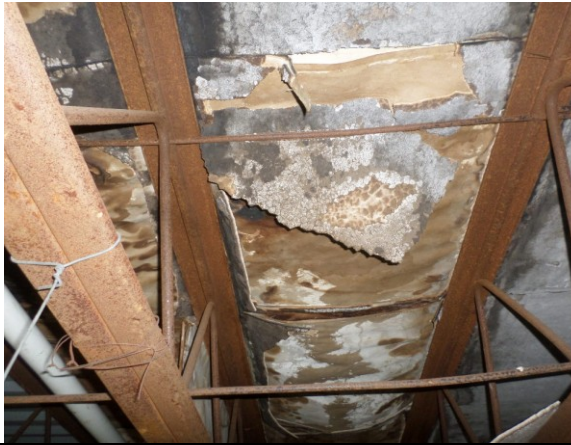
Photo #7:	Typical Plaster Ceiling Sample Set #1 Non-ACM
-----------	--

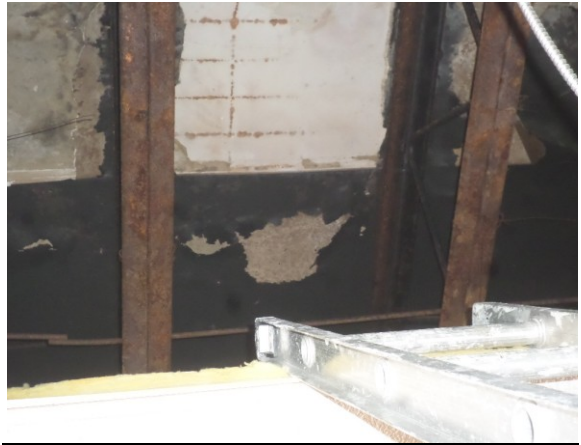
Photo #8:	4622 Roof Paper Interior Sample Set #16 Non-ACM
-----------	---

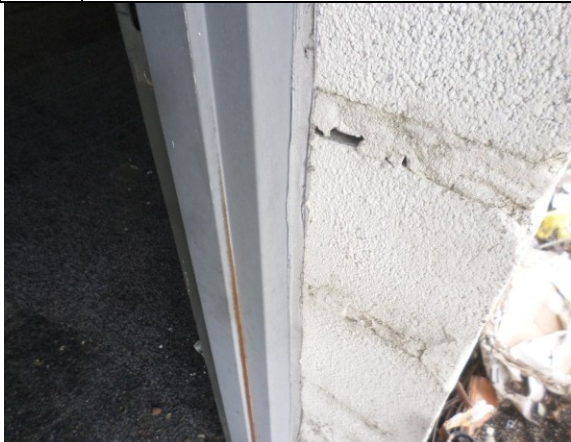
Photo #9:	4622 Rear Gray Door Caulk Sample Set #15 Non-ACM
-----------	--

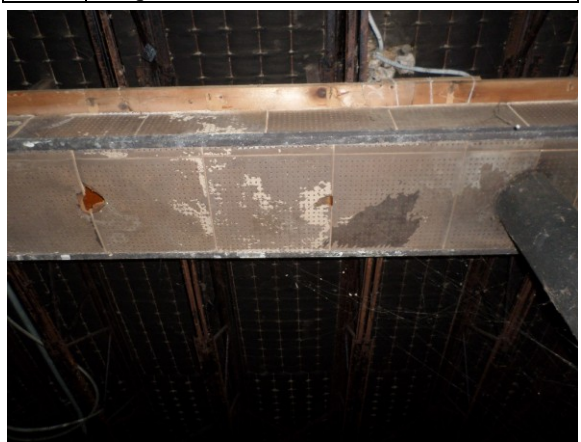
Photo #10:	Basement Area 1x1 Gypsum Ceiling Tile Sample Set #21 Non-ACM
------------	--

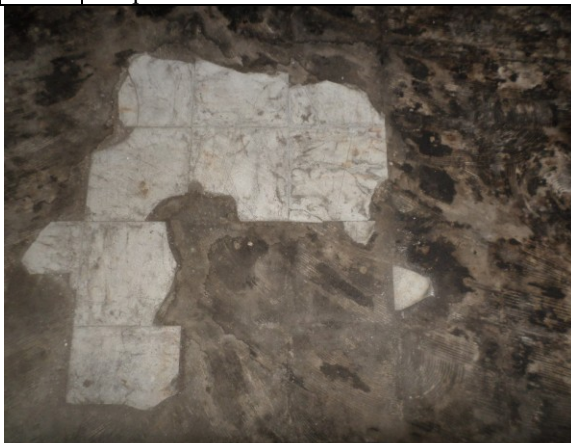
Sample Number(s)	Mat. Type	Material Description	Location	Friable	Approx. Quantity	% Asbestos	Condition
5A	M	9"x9" White Floor Tile	Basement Area	NF	10 SF	5% Chrysotile	D
6A	M	Floor Tile Associated Mastic	Basement Area	NF	300 SF	2% Chrysotile	G
7A, 8A	M	12"x12" White Floor Tile and Associated Mastic	4622 Main Area	NF	1,200 SF	2-5% Chrysotile	G
26A, 29A	M	Window Caulk	Exterior Front	NF	180 LF	3-4% Chrysotile	G
27A	M	Door Caulk	Exterior Front	NF	48 LF	3% Chrysotile	G

Photo #11:	Basement Area 9x9 White Floor Tile and Mastic #5 and #6 Tile and Mastic ACM
------------	---

- **There was no friable (can be reduced to powder by hand pressure when dry) Asbestos Containing Materials (ACMs) identified in the Spaces.**
- **Non-friable ACM was identified at the site in the form of 12”x12” Vinyl Flooring Tile and Associated Black Mastic throughout the first floor of 4622 and Exterior Front Window and Door Caulk.**
- Any ACM that may be rendered friable during demolition activities should be removed by an MDE accredited Asbestos Abatement Contractor using MDE accredited personnel prior to performing such activities. Any abatement work should be overseen by a reputable and qualified Asbestos Project Monitor. Work Plans/Specifications for the work to be performed should be prepared by an AHERA and MDE certified Asbestos Project Designer.

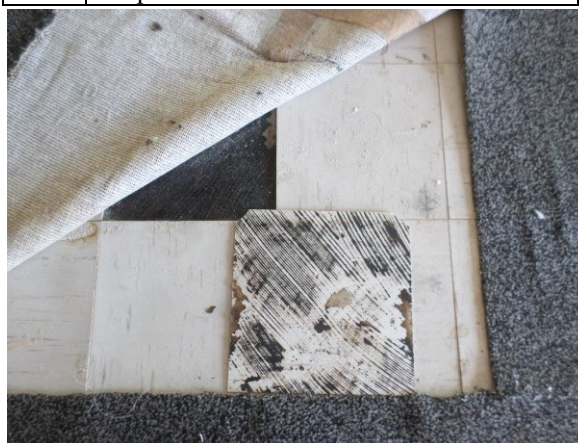
Photo #12:	4622 12x12 White Tile and Mastic #7 and #8 Tile and Mastic ACM
------------	--

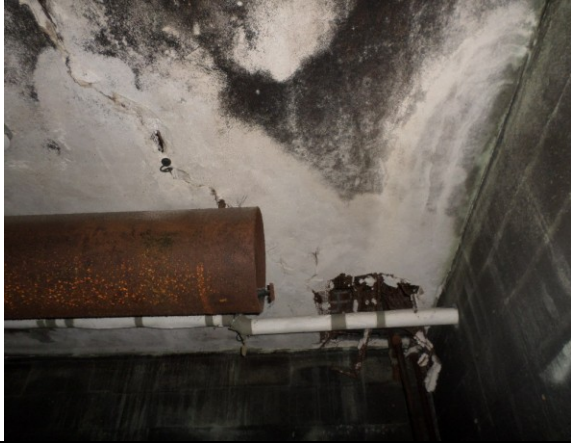
Photo #13:	Plaster Sample Set #2 Non-ACM
------------	----------------------------------

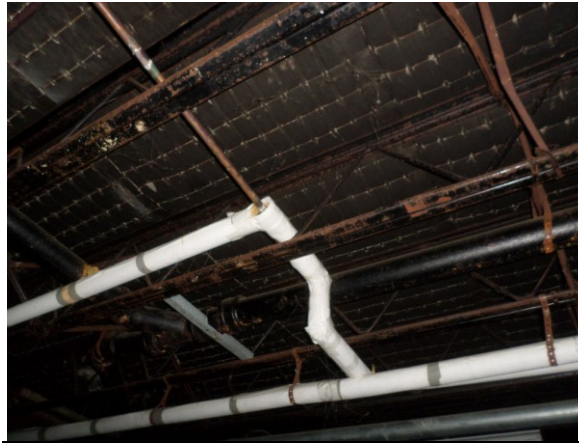
Photo #14:	Basement Area Fiberglass Pipes in Basement
------------	---

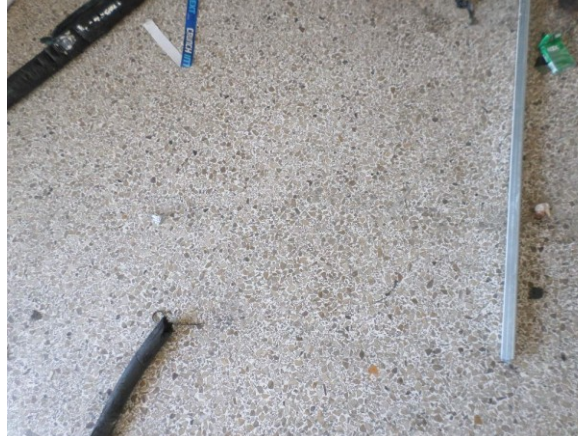
Photo #16:	4626 Main Area 12x12 Stone Pattern Tile & Mastic Sample Sets #9, #10 Non-ACM
------------	--

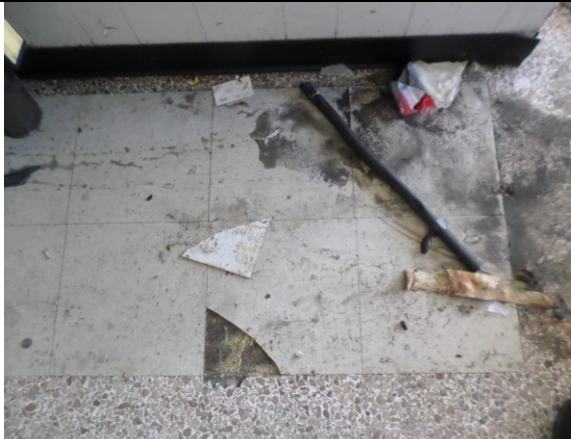
Photo #17:	4626 Main Area 12x12 White Tile w/Gray Mottle Sample Sets #11, #12 Non-ACM
------------	--

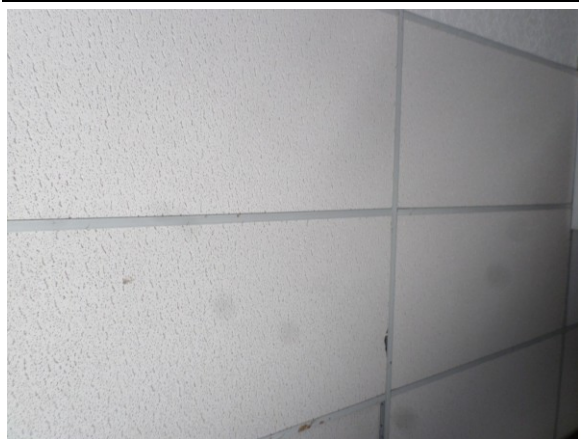
Photo #18:	4626 2x4 Pinhole Fissure Ceiling Tile Sample Set #19 Non-ACM
------------	--

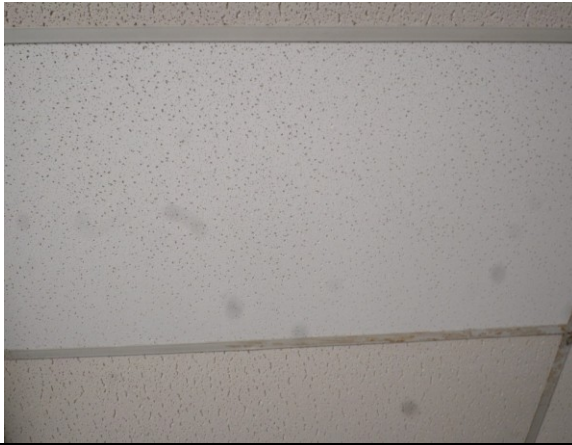
Photo #19:	4626 2x4 Pinhole Ceiling Tile Sample Set #20 Non-ACM
------------	--

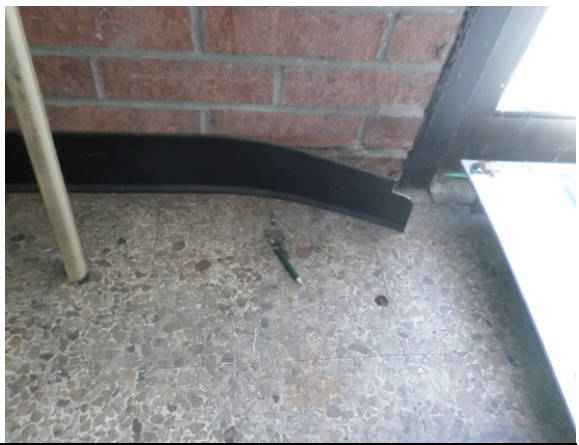
Photo #20:	4626 Main Area 4" Brown Cove Base and Glue Sample Sets #22, #23 Non-ACM
------------	---

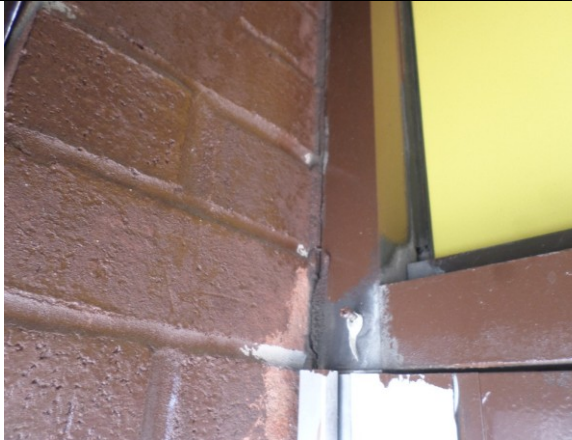
- Window and Door Caulking

Photo #21:	Exterior Window Caulk Sample Set #26 3% Chrysotile
------------	--

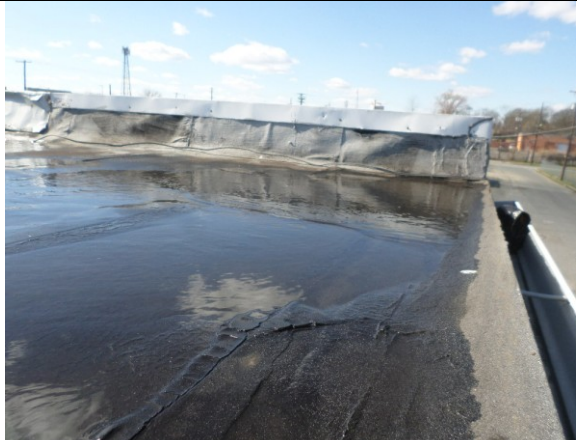
Photo #22:	Rolled Roof, Roof Tar Sample Sets #13, #14 Nn-ACM
------------	--

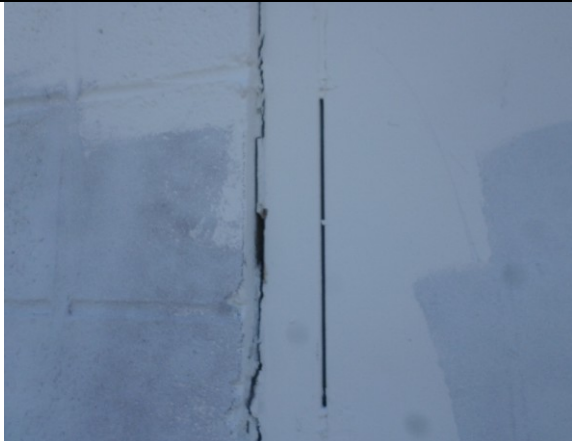
Photo #23:	4626 Rear Door Caulk Sample Set #28 Non-ACM
------------	---

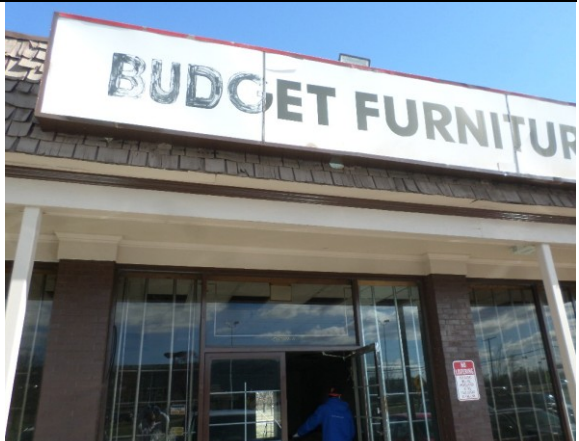
Photo #24:	Exterior Window Caulk Sample Set #29 4% Chrysotile
------------	--
