Asbestos Bulk Sampling Report

4701 Silver Hill Road

KEM Project No. 23167

November 8, 2018

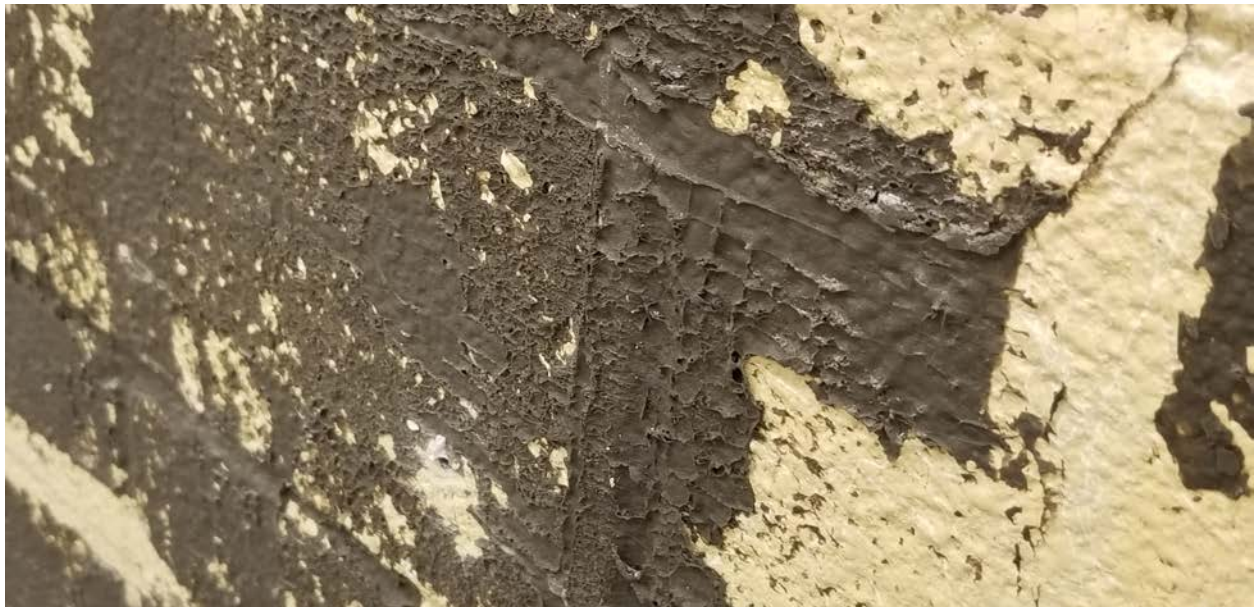
- Wall mastic material; Color: Black; Location: 1st Floor (see photographs below)
- Drywall joint compound material; Color: White; Location: 1st Floor and Basement/Basement Stairwell

Figure 5.1. Asbestos-containing black wall mastic, close-up.

The ACM wall mastic may be left in-place and does not require abatement. However, the wall mastic is required to be abated prior to any renovation activities that may render the wall mastic friable.

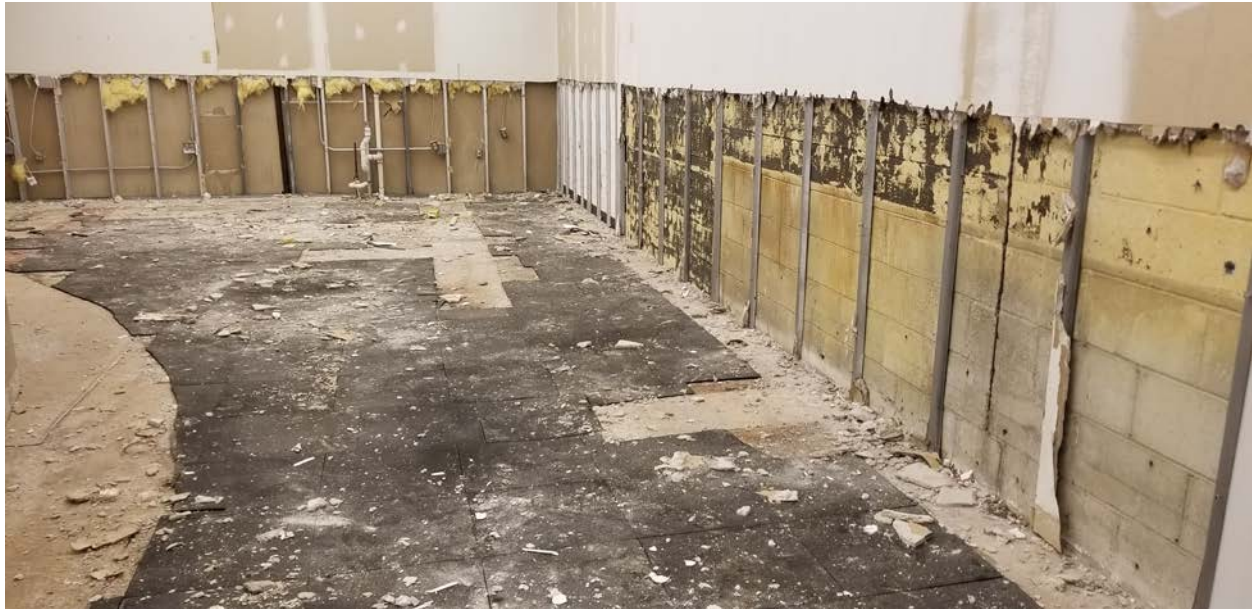
Figure 5.2. Asbestos-containing black wall mastic from a distance.
