Mold Inspection Report

Kingdom Power Plaza

4701 Silver Hill Road,
Suitland, Maryland 20746
KEM Project No. 23167
November 8, 2018

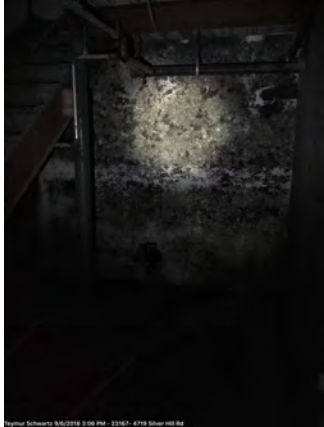
<p>Issue Info</p> <p>ID: 2 Area: Bldg 4701 Description: 9/6/18. Bldg 4701. Basement. The water from the sprinklers ended up in the basement that currently has standing water at about a quarter inch. The mold growth is much worse in the basement. There only a few drywall walls in the basement and they are completely covered in heavy mold growth. The mold growth is also seen on inorganic materials such as the steel beams and concrete. There was also a leaking copper pipe in the basement that was leaking pretty heavily. Category: Issue Status: Open Responsible party: Kynoch Environmental Calendar Age: 1</p>
Issue #2

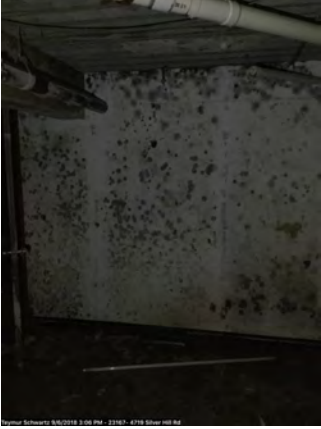
Issue #2

<p style="text-align: right;">Issue Info</p> <p>ID: 2 Area: Bldg 4701 Description: 9/6/18. Bldg 4701. Basement. The water from the sprinklers ended up in the basement that currently has standing water at about a quarter inch. The mold growth is much worse in the basement. There only a few drywall walls in the basement and they are completely covered in heavy mold growth. The mold growth is also seen on inorganic materials such as the steel beams and concrete. There was also a leaking copper pipe in the basement that was leaking pretty heavily. Category: Issue Status: Open Responsible party: Kynoch Environmental Calendar Age: 1</p>
---	--

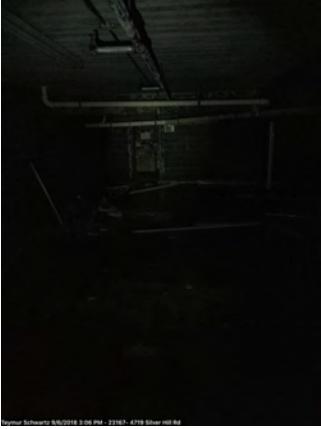
Issue #2

<p style="text-align: right;">Issue Info</p> <p>ID: 2 Area: Bldg 4701 Description: 9/6/18. Bldg 4701. Basement. The water from the sprinklers ended up in the basement that currently has standing water at about a quarter inch. The mold growth is much worse in the basement. There only a few drywall walls in the basement and they are completely covered in heavy mold growth. The mold growth is also seen on inorganic materials such as the steel beams and concrete. There was also a leaking copper pipe in the basement that was leaking pretty heavily. Category: Issue Status: Open Responsible party: Kynoch Environmental Calendar Age: 1</p>
---	--

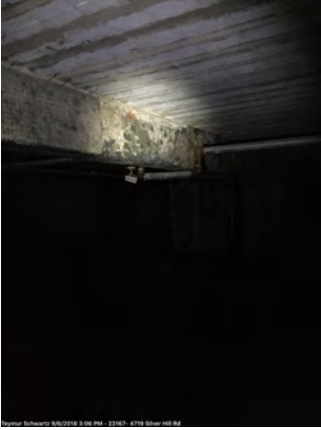
Issue #2

<p style="text-align: right;">Issue Info</p> <p>ID: 2 Area: Bldg 4701 Description: 9/6/18. Bldg 4701. Basement. The water from the sprinklers ended up in the basement that currently has standing water at about a quarter inch. The mold growth is much worse in the basement. There only a few drywall walls in the basement and they are completely covered in heavy mold growth. The mold growth is also seen on inorganic materials such as the steel beams and concrete. There was also a leaking copper pipe in the basement that was leaking pretty heavily. Category: Issue Status: Open Responsible party: Kynoch Environmental Calendar Age: 1</p>
--	--

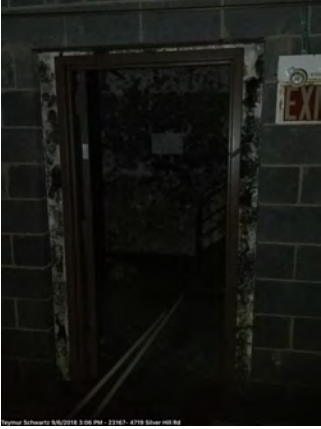
Issue #2

<p>Issue Info</p> <p>ID: 2 Area: Bldg 4701 Description: 9/6/18. Bldg 4701. Basement. The water from the sprinklers ended up in the basement that currently has standing water at about a quarter inch. The mold growth is much worse in the basement. There only a few drywall walls in the basement and they are completely covered in heavy mold growth. The mold growth is also seen on inorganic materials such as the steel beams and concrete. There was also a leaking copper pipe in the basement that was leaking pretty heavily. Category: Issue Status: Open Responsible party: Kynoch Environmental Calendar Age: 1</p>
---	---

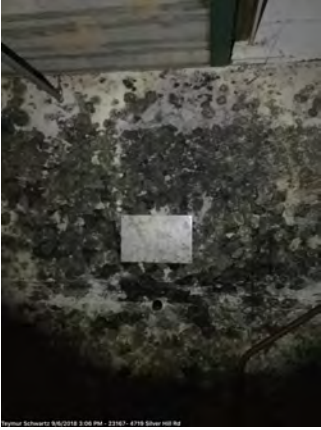
<p>Issue Info</p> <p>ID: 2 Area: Bldg 4701 Description: 9/6/18. Bldg 4701. Basement. The water from the sprinklers ended up in the basement that currently has standing water at about a quarter inch. The mold growth is much worse in the basement. There only a few drywall walls in the basement and they are completely covered in heavy mold growth. The mold growth is also seen on inorganic materials such as the steel beams and concrete. There was also a leaking copper pipe in the basement that was leaking pretty heavily. Category: Issue Status: Open Responsible party: Kynoch Environmental Calendar Age: 1</p>
--	---

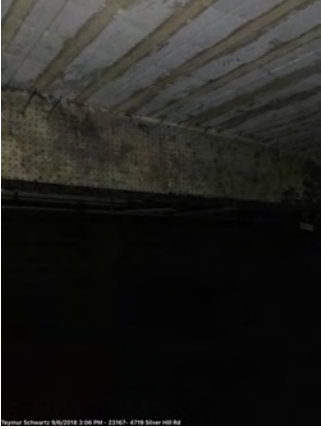
<p style="text-align: right;">Issue Info</p> <p>ID: 2 Area: Bldg 4701 Description: 9/6/18. Bldg 4701. Basement. The water from the sprinklers ended up in the basement that currently has standing water at about a quarter inch. The mold growth is much worse in the basement. There only a few drywall walls in the basement and they are completely covered in heavy mold growth. The mold growth is also seen on inorganic materials such as the steel beams and concrete. There was also a leaking copper pipe in the basement that was leaking pretty heavily. Category: Issue Status: Open Responsible party: Kynoch Environmental Calendar Age: 1</p>
---	--

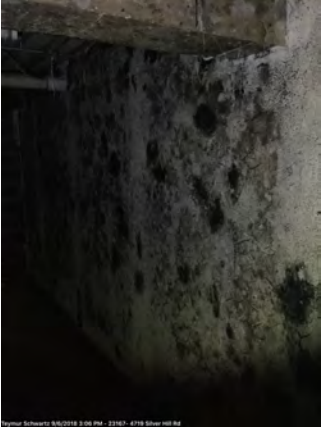
<p style="text-align: right;">Issue Info</p> <p>ID: 2 Area: Bldg 4701 Description: 9/6/18. Bldg 4701. Basement. The water from the sprinklers ended up in the basement that currently has standing water at about a quarter inch. The mold growth is much worse in the basement. There only a few drywall walls in the basement and they are completely covered in heavy mold growth. The mold growth is also seen on inorganic materials such as the steel beams and concrete. There was also a leaking copper pipe in the basement that was leaking pretty heavily. Category: Issue Status: Open Responsible party: Kynoch Environmental Calendar Age: 1</p>
--	--

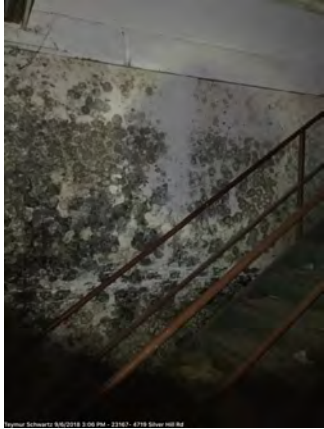
<p>Issue Info</p> <p>ID: 2 Area: Bldg 4701 Description: 9/6/18. Bldg 4701. Basement. The water from the sprinklers ended up in the basement that currently has standing water at about a quarter inch. The mold growth is much worse in the basement. There only a few drywall walls in the basement and they are completely covered in heavy mold growth. The mold growth is also seen on inorganic materials such as the steel beams and concrete. There was also a leaking copper pipe in the basement that was leaking pretty heavily. Category: Issue Status: Open Responsible party: Kynoch Environmental Calendar Age: 1</p>
---	---

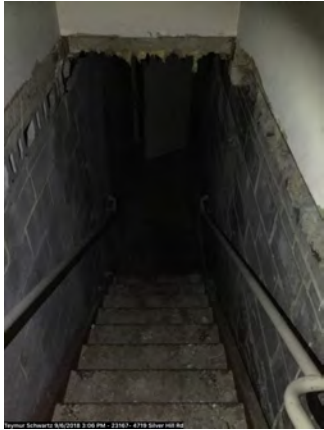
<p>Issue Info</p> <p>ID: 2 Area: Bldg 4701 Description: 9/6/18. Bldg 4701. Basement. The water from the sprinklers ended up in the basement that currently has standing water at about a quarter inch. The mold growth is much worse in the basement. There only a few drywall walls in the basement and they are completely covered in heavy mold growth. The mold growth is also seen on inorganic materials such as the steel beams and concrete. There was also a leaking copper pipe in the basement that was leaking pretty heavily. Category: Issue Status: Open Responsible party: Kynoch Environmental Calendar Age: 1</p>
--	---

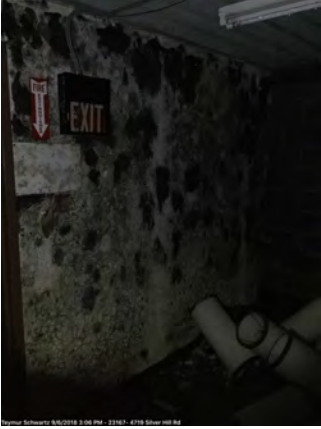
<p>Issue Info</p> <p>ID: 2 Area: Bldg 4701 Description: 9/6/18. Bldg 4701. Basement. The water from the sprinklers ended up in the basement that currently has standing water at about a quarter inch. The mold growth is much worse in the basement. There only a few drywall walls in the basement and they are completely covered in heavy mold growth. The mold growth is also seen on inorganic materials such as the steel beams and concrete. There was also a leaking copper pipe in the basement that was leaking pretty heavily. Category: Issue Status: Open Responsible party: Kynoch Environmental Calendar Age: 1</p>
---	---

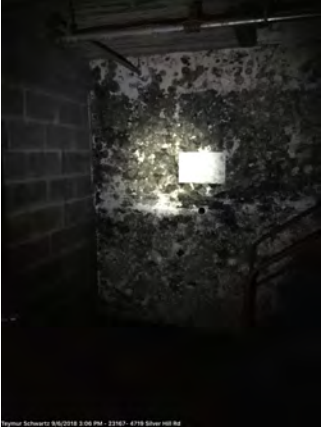
<p>Issue Info</p> <p>ID: 2 Area: Bldg 4701 Description: 9/6/18. Bldg 4701. Basement. The water from the sprinklers ended up in the basement that currently has standing water at about a quarter inch. The mold growth is much worse in the basement. There only a few drywall walls in the basement and they are completely covered in heavy mold growth. The mold growth is also seen on inorganic materials such as the steel beams and concrete. There was also a leaking copper pipe in the basement that was leaking pretty heavily. Category: Issue Status: Open Responsible party: Kynoch Environmental Calendar Age: 1</p>
--	---

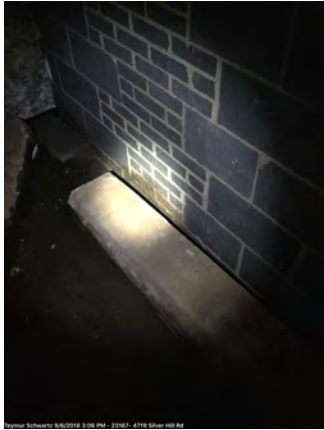
<p>Issue Info</p> <p>ID: 2 Area: Bldg 4701 Description: 9/6/18. Bldg 4701. Basement. The water from the sprinklers ended up in the basement that currently has standing water at about a quarter inch. The mold growth is much worse in the basement. There only a few drywall walls in the basement and they are completely covered in heavy mold growth. The mold growth is also seen on inorganic materials such as the steel beams and concrete. There was also a leaking copper pipe in the basement that was leaking pretty heavily. Category: Issue Status: Open Responsible party: Kynoch Environmental Calendar Age: 1</p>
--	---

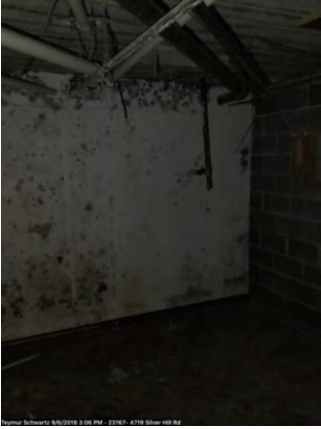
<p style="text-align: right;">Issue Info</p> <p>ID: 2 Area: Bldg 4701 Description: 9/6/18. Bldg 4701. Basement. The water from the sprinklers ended up in the basement that currently has standing water at about a quarter inch. The mold growth is much worse in the basement. There only a few drywall walls in the basement and they are completely covered in heavy mold growth. The mold growth is also seen on inorganic materials such as the steel beams and concrete. There was also a leaking copper pipe in the basement that was leaking pretty heavily. Category: Issue Status: Open Responsible party: Kynoch Environmental Calendar Age: 1</p>
---	--

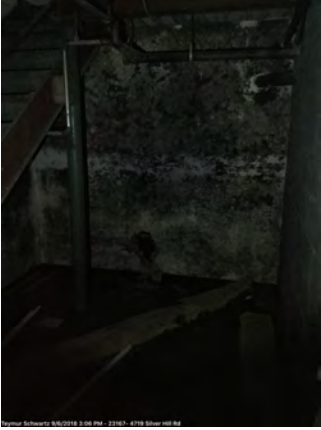
<p style="text-align: right;">Issue Info</p> <p>ID: 2 Area: Bldg 4701 Description: 9/6/18. Bldg 4701. Basement. The water from the sprinklers ended up in the basement that currently has standing water at about a quarter inch. The mold growth is much worse in the basement. There only a few drywall walls in the basement and they are completely covered in heavy mold growth. The mold growth is also seen on inorganic materials such as the steel beams and concrete. There was also a leaking copper pipe in the basement that was leaking pretty heavily. Category: Issue Status: Open Responsible party: Kynoch Environmental Calendar Age: 1</p>
--	--

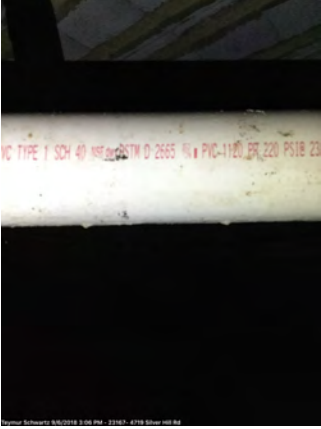
<p>Issue Info</p> <p>ID: 2 Area: Bldg 4701 Description: 9/6/18. Bldg 4701. Basement. The water from the sprinklers ended up in the basement that currently has standing water at about a quarter inch. The mold growth is much worse in the basement. There only a few drywall walls in the basement and they are completely covered in heavy mold growth. The mold growth is also seen on inorganic materials such as the steel beams and concrete. There was also a leaking copper pipe in the basement that was leaking pretty heavily. Category: Issue Status: Open Responsible party: Kynoch Environmental Calendar Age: 1</p>
---	---

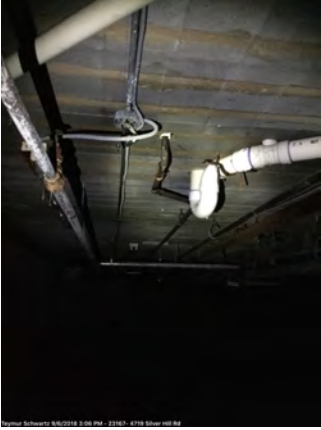
<p>Issue Info</p> <p>ID: 2 Area: Bldg 4701 Description: 9/6/18. Bldg 4701. Basement. The water from the sprinklers ended up in the basement that currently has standing water at about a quarter inch. The mold growth is much worse in the basement. There only a few drywall walls in the basement and they are completely covered in heavy mold growth. The mold growth is also seen on inorganic materials such as the steel beams and concrete. There was also a leaking copper pipe in the basement that was leaking pretty heavily. Category: Issue Status: Open Responsible party: Kynoch Environmental Calendar Age: 1</p>
--	---

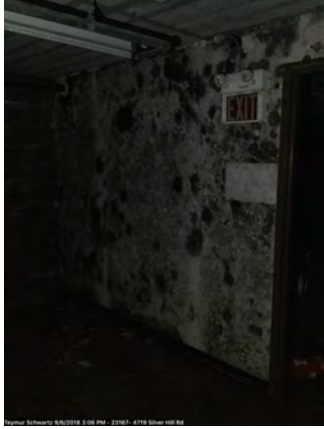
<p>Issue Info</p> <p>ID: 2 Area: Bldg 4701 Description: 9/6/18. Bldg 4701. Basement. The water from the sprinklers ended up in the basement that currently has standing water at about a quarter inch. The mold growth is much worse in the basement. There only a few drywall walls in the basement and they are completely covered in heavy mold growth. The mold growth is also seen on inorganic materials such as the steel beams and concrete. There was also a leaking copper pipe in the basement that was leaking pretty heavily. Category: Issue Status: Open Responsible party: Kynoch Environmental Calendar Age: 1</p>
---	---

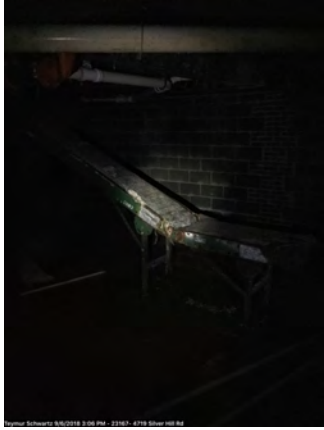
<p>Issue Info</p> <p>ID: 2 Area: Bldg 4701 Description: 9/6/18. Bldg 4701. Basement. The water from the sprinklers ended up in the basement that currently has standing water at about a quarter inch. The mold growth is much worse in the basement. There only a few drywall walls in the basement and they are completely covered in heavy mold growth. The mold growth is also seen on inorganic materials such as the steel beams and concrete. There was also a leaking copper pipe in the basement that was leaking pretty heavily. Category: Issue Status: Open Responsible party: Kynoch Environmental Calendar Age: 1</p>
--	---

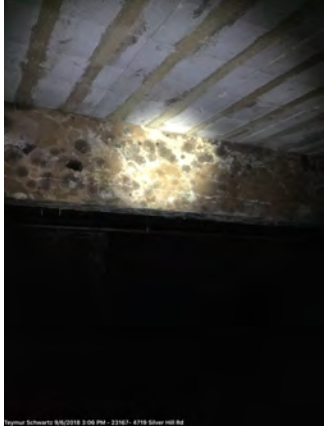
<p>Issue Info</p> <p>ID: 2 Area: Bldg 4701 Description: 9/6/18. Bldg 4701. Basement. The water from the sprinklers ended up in the basement that currently has standing water at about a quarter inch. The mold growth is much worse in the basement. There only a few drywall walls in the basement and they are completely covered in heavy mold growth. The mold growth is also seen on inorganic materials such as the steel beams and concrete. There was also a leaking copper pipe in the basement that was leaking pretty heavily. Category: Issue Status: Open Responsible party: Kynoch Environmental Calendar Age: 1</p>
---	---

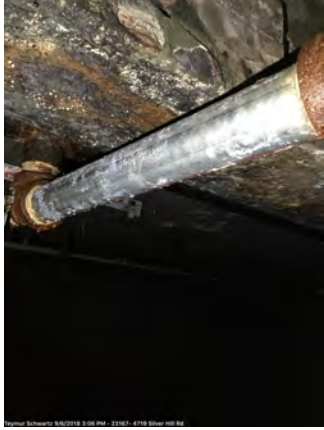
<p>Issue Info</p> <p>ID: 2 Area: Bldg 4701 Description: 9/6/18. Bldg 4701. Basement. The water from the sprinklers ended up in the basement that currently has standing water at about a quarter inch. The mold growth is much worse in the basement. There only a few drywall walls in the basement and they are completely covered in heavy mold growth. The mold growth is also seen on inorganic materials such as the steel beams and concrete. There was also a leaking copper pipe in the basement that was leaking pretty heavily. Category: Issue Status: Open Responsible party: Kynoch Environmental Calendar Age: 1</p>
--	---

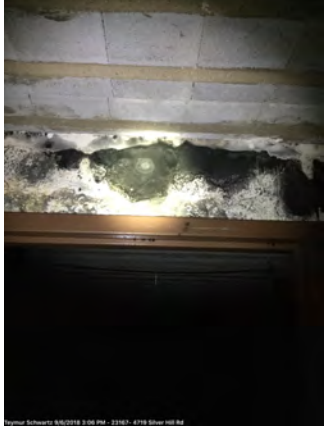
<p>Issue Info</p> <p>ID: 2 Area: Bldg 4701 Description: 9/6/18. Bldg 4701. Basement. The water from the sprinklers ended up in the basement that currently has standing water at about a quarter inch. The mold growth is much worse in the basement. There only a few drywall walls in the basement and they are completely covered in heavy mold growth. The mold growth is also seen on inorganic materials such as the steel beams and concrete. There was also a leaking copper pipe in the basement that was leaking pretty heavily. Category: Issue Status: Open Responsible party: Kynoch Environmental Calendar Age: 1</p>
---	---

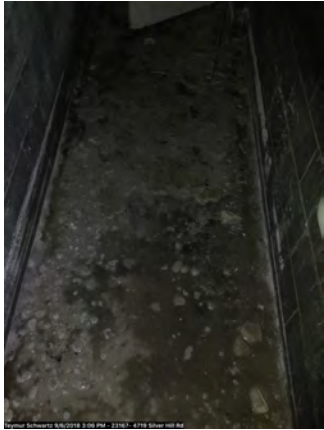
<p>Issue Info</p> <p>ID: 2 Area: Bldg 4701 Description: 9/6/18. Bldg 4701. Basement. The water from the sprinklers ended up in the basement that currently has standing water at about a quarter inch. The mold growth is much worse in the basement. There only a few drywall walls in the basement and they are completely covered in heavy mold growth. The mold growth is also seen on inorganic materials such as the steel beams and concrete. There was also a leaking copper pipe in the basement that was leaking pretty heavily. Category: Issue Status: Open Responsible party: Kynoch Environmental Calendar Age: 1</p>
--	---

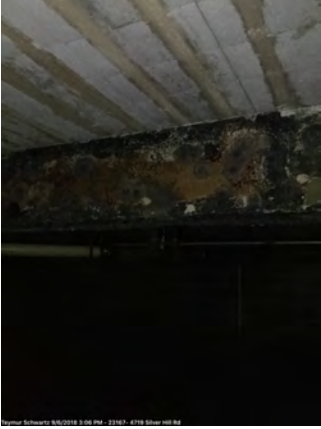
<p style="text-align: right;">Issue Info</p> <p>ID: 2 Area: Bldg 4701 Description: 9/6/18. Bldg 4701. Basement. The water from the sprinklers ended up in the basement that currently has standing water at about a quarter inch. The mold growth is much worse in the basement. There only a few drywall walls in the basement and they are completely covered in heavy mold growth. The mold growth is also seen on inorganic materials such as the steel beams and concrete. There was also a leaking copper pipe in the basement that was leaking pretty heavily. Category: Issue Status: Open Responsible party: Kynoch Environmental Calendar Age: 1</p>
---	--

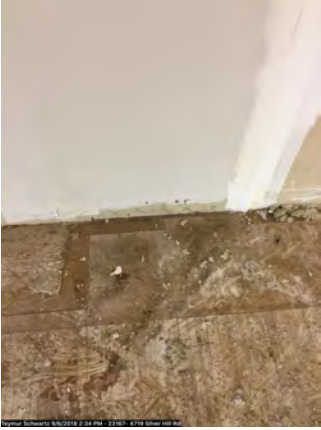
<p style="text-align: right;">Issue Info</p> <p>ID: 1 Area: Bldg 4701 Description: 9/6/18. Bldg 4701. 1st Floor. KEM was asked to inspect this bldg after it was reported that the sprinklers went off and flooded the bldg. The main floor and basement were flooded and as a result there was an extensive amount of mold growth. Most of the materials on the main floor are now dry as this flood happened some time ago. KEM found one area of wet drywall in the back of the bldg on a wall that is adjacent to a sink at the floor (janitor's sink). Some drywall has already been removed. Ceiling tiles show signs of water intrusion as some have sagged and or fallen to the ground. KEM found one sprinkler by the entrance to the bldg that was dripping but has now stopped. Mold is found all throughout the 1st Floor mostly on the drywall by the floor. In some areas the mold is higher up at about 6-10 feet from the ground. Other than the small dripping from sprinkler there are no ongoing water intrusion that was seen by KEM. Category: Issue Status: Open Responsible party: Kynoch Environmental Calendar Age: 1</p>

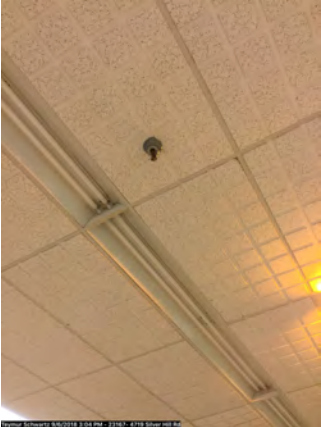
<p>Issue Info</p> <p>ID: 1 Area: Bldg 4701 Description: 9/6/18. Bldg 4701. 1st Floor. KEM was asked to inspect this bldg after it was reported that the sprinklers went off and flooded the bldg. The main floor and basement were flooded and as a result there was an extensive amount of mold growth. Most of the materials on the main floor are now dry as this flood happened some time ago. KEM found one area of wet drywall in the back of the bldg on a wall that is adjacent to a sink at the floor (janitor's sink). Some drywall has already been removed. Ceiling tiles show signs of water intrusion as some have sagged and or fallen to the ground. KEM found one sprinkler by the entrance to the bldg that was dripping but has now stopped. Mold is found all throughout the 1st Floor mostly on the drywall by the floor. In some areas the mold is higher up at about 6-10 feet from the ground. Other than the small dripping from sprinkler there are no ongoing water intrusion that was seen by KEM. Category: Issue Status: Open Responsible party: Kynoch Environmental Calendar Age: 1</p>

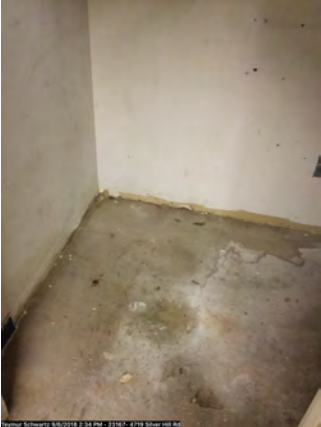
<p>Issue Info</p> <p>ID: 1 Area: Bldg 4701 Description: 9/6/18. Bldg 4701. 1st Floor. KEM was asked to inspect this bldg after it was reported that the sprinklers went off and flooded the bldg. The main floor and basement were flooded and as a result there was an extensive amount of mold growth. Most of the materials on the main floor are now dry as this flood happened some time ago. KEM found one area of wet drywall in the back of the bldg on a wall that is adjacent to a sink at the floor (janitor's sink). Some drywall has already been removed. Ceiling tiles show signs of water intrusion as some have sagged and or fallen to the ground. KEM found one sprinkler by the entrance to the bldg that was dripping but has now stopped. Mold is found all throughout the 1st Floor mostly on the drywall by the floor. In some areas the mold is higher up at about 6-10 feet from the ground. Other than the small dripping from sprinkler there are no ongoing water intrusion that was seen by KEM. Category: Issue Status: Open Responsible party: Kynoch Environmental Calendar Age: 1</p>

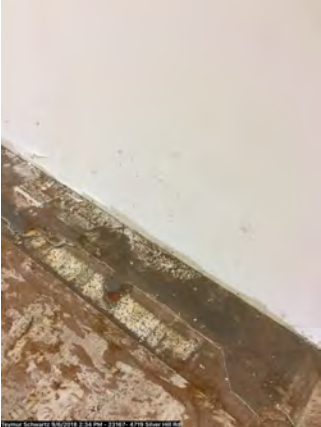
<p>Issue Info</p> <p>ID: 1 Area: Bldg 4701 Description: 9/6/18. Bldg 4701. 1st Floor. KEM was asked to inspect this bldg after it was reported that the sprinklers went off and flooded the bldg. The main floor and basement were flooded and as a result there was an extensive amount of mold growth. Most of the materials on the main floor are now dry as this flood happened some time ago. KEM found one area of wet drywall in the back of the bldg on a wall that is adjacent to a sink at the floor (janitor's sink). Some drywall has already been removed. Ceiling tiles show signs of water intrusion as some have sagged and or fallen to the ground. KEM found one sprinkler by the entrance to the bldg that was dripping but has now stopped. Mold is found all throughout the 1st Floor mostly on the drywall by the floor. In some areas the mold is higher up at about 6-10 feet from the ground. Other than the small dripping from sprinkler there are no ongoing water intrusion that was seen by KEM. Category: Issue Status: Open Responsible party: Kynoch Environmental Calendar Age: 1</p>

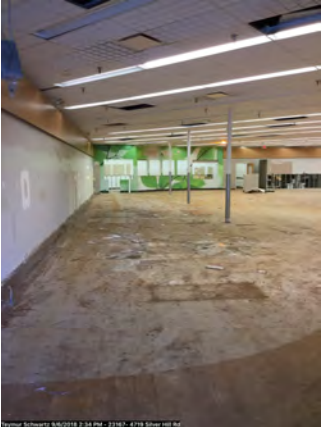
<p>Issue Info</p> <p>ID: 1 Area: Bldg 4701 Description: 9/6/18. Bldg 4701. 1st Floor. KEM was asked to inspect this bldg after it was reported that the sprinklers went off and flooded the bldg. The main floor and basement were flooded and as a result there was an extensive amount of mold growth. Most of the materials on the main floor are now dry as this flood happened some time ago. KEM found one area of wet drywall in the back of the bldg on a wall that is adjacent to a sink at the floor (janitor's sink). Some drywall has already been removed. Ceiling tiles show signs of water intrusion as some have sagged and or fallen to the ground. KEM found one sprinkler by the entrance to the bldg that was dripping but has now stopped. Mold is found all throughout the 1st Floor mostly on the drywall by the floor. In some areas the mold is higher up at about 6-10 feet from the ground. Other than the small dripping from sprinkler there are no ongoing water intrusion that was seen by KEM. Category: Issue Status: Open Responsible party: Kynoch Environmental Calendar Age: 1</p>

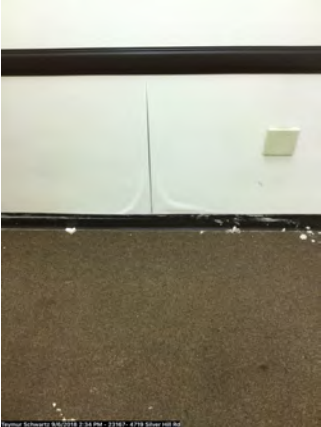
<p>Issue Info</p> <p>ID: 1 Area: Bldg 4701 Description: 9/6/18. Bldg 4701. 1st Floor. KEM was asked to inspect this bldg after it was reported that the sprinklers went off and flooded the bldg. The main floor and basement were flooded and as a result there was an extensive amount of mold growth. Most of the materials on the main floor are now dry as this flood happened some time ago. KEM found one area of wet drywall in the back of the bldg on a wall that is adjacent to a sink at the floor (janitor's sink). Some drywall has already been removed. Ceiling tiles show signs of water intrusion as some have sagged and or fallen to the ground. KEM found one sprinkler by the entrance to the bldg that was dripping but has now stopped. Mold is found all throughout the 1st Floor mostly on the drywall by the floor. In some areas the mold is higher up at about 6-10 feet from the ground. Other than the small dripping from sprinkler there are no ongoing water intrusion that was seen by KEM. Category: Issue Status: Open Responsible party: Kynoch Environmental Calendar Age: 1</p>

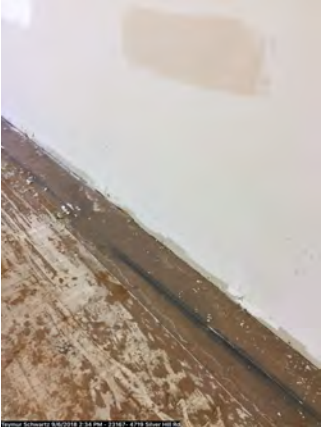
<p>Issue Info</p> <p>ID: 1 Area: Bldg 4701 Description: 9/6/18. Bldg 4701. 1st Floor. KEM was asked to inspect this bldg after it was reported that the sprinklers went off and flooded the bldg. The main floor and basement were flooded and as a result there was an extensive amount of mold growth. Most of the materials on the main floor are now dry as this flood happened some time ago. KEM found one area of wet drywall in the back of the bldg on a wall that is adjacent to a sink at the floor (janitor's sink). Some drywall has already been removed. Ceiling tiles show signs of water intrusion as some have sagged and or fallen to the ground. KEM found one sprinkler by the entrance to the bldg that was dripping but has now stopped. Mold is found all throughout the 1st Floor mostly on the drywall by the floor. In some areas the mold is higher up at about 6-10 feet from the ground. Other than the small dripping from sprinkler there are no ongoing water intrusion that was seen by KEM. Category: Issue Status: Open Responsible party: Kynoch Environmental Calendar Age: 1</p>

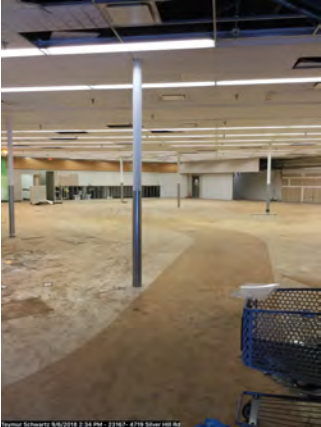
<p>Issue Info</p> <p>ID: 1 Area: Bldg 4701 Description: 9/6/18. Bldg 4701. 1st Floor. KEM was asked to inspect this bldg after it was reported that the sprinklers went off and flooded the bldg. The main floor and basement were flooded and as a result there was an extensive amount of mold growth. Most of the materials on the main floor are now dry as this flood happened some time ago. KEM found one area of wet drywall in the back of the bldg on a wall that is adjacent to a sink at the floor (janitor's sink). Some drywall has already been removed. Ceiling tiles show signs of water intrusion as some have sagged and or fallen to the ground. KEM found one sprinkler by the entrance to the bldg that was dripping but has now stopped. Mold is found all throughout the 1st Floor mostly on the drywall by the floor. In some areas the mold is higher up at about 6-10 feet from the ground. Other than the small dripping from sprinkler there are no ongoing water intrusion that was seen by KEM. Category: Issue Status: Open Responsible party: Kynoch Environmental Calendar Age: 1</p>

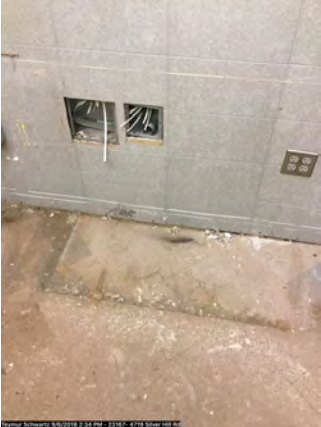
<p>Issue Info</p> <p>ID: 1 Area: Bldg 4701 Description: 9/6/18. Bldg 4701. 1st Floor. KEM was asked to inspect this bldg after it was reported that the sprinklers went off and flooded the bldg. The main floor and basement were flooded and as a result there was an extensive amount of mold growth. Most of the materials on the main floor are now dry as this flood happened some time ago. KEM found one area of wet drywall in the back of the bldg on a wall that is adjacent to a sink at the floor (janitor's sink). Some drywall has already been removed. Ceiling tiles show signs of water intrusion as some have sagged and or fallen to the ground. KEM found one sprinkler by the entrance to the bldg that was dripping but has now stopped. Mold is found all throughout the 1st Floor mostly on the drywall by the floor. In some areas the mold is higher up at about 6-10 feet from the ground. Other than the small dripping from sprinkler there are no ongoing water intrusion that was seen by KEM. Category: Issue Status: Open Responsible party: Kynoch Environmental Calendar Age: 1</p>

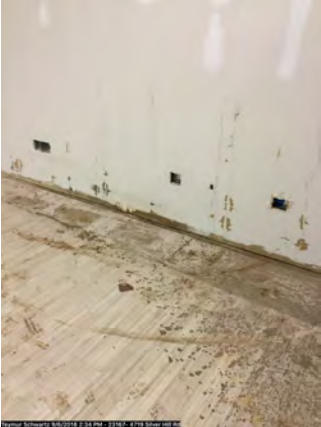
<p>Issue Info</p> <p>ID: 1 Area: Bldg 4701 Description: 9/6/18. Bldg 4701. 1st Floor. KEM was asked to inspect this bldg after it was reported that the sprinklers went off and flooded the bldg. The main floor and basement were flooded and as a result there was an extensive amount of mold growth. Most of the materials on the main floor are now dry as this flood happened some time ago. KEM found one area of wet drywall in the back of the bldg on a wall that is adjacent to a sink at the floor (janitor's sink). Some drywall has already been removed. Ceiling tiles show signs of water intrusion as some have sagged and or fallen to the ground. KEM found one sprinkler by the entrance to the bldg that was dripping but has now stopped. Mold is found all throughout the 1st Floor mostly on the drywall by the floor. In some areas the mold is higher up at about 6-10 feet from the ground. Other than the small dripping from sprinkler there are no ongoing water intrusion that was seen by KEM. Category: Issue Status: Open Responsible party: Kynoch Environmental Calendar Age: 1</p>

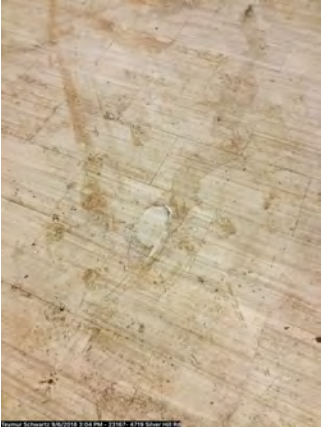
<p>Issue Info</p> <p>ID: 1 Area: Bldg 4701 Description: 9/6/18. Bldg 4701. 1st Floor. KEM was asked to inspect this bldg after it was reported that the sprinklers went off and flooded the bldg. The main floor and basement were flooded and as a result there was an extensive amount of mold growth. Most of the materials on the main floor are now dry as this flood happened some time ago. KEM found one area of wet drywall in the back of the bldg on a wall that is adjacent to a sink at the floor (janitor's sink). Some drywall has already been removed. Ceiling tiles show signs of water intrusion as some have sagged and or fallen to the ground. KEM found one sprinkler by the entrance to the bldg that was dripping but has now stopped. Mold is found all throughout the 1st Floor mostly on the drywall by the floor. In some areas the mold is higher up at about 6-10 feet from the ground. Other than the small dripping from sprinkler there are no ongoing water intrusion that was seen by KEM. Category: Issue Status: Open Responsible party: Kynoch Environmental Calendar Age: 1</p>

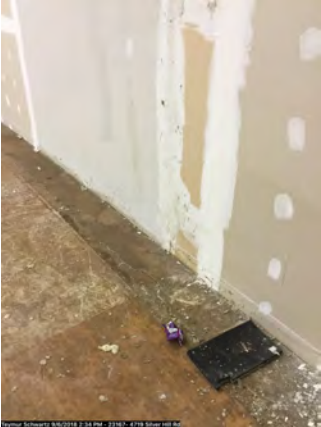
<p>Issue Info</p> <p>ID: 1 Area: Bldg 4701 Description: 9/6/18. Bldg 4701. 1st Floor. KEM was asked to inspect this bldg after it was reported that the sprinklers went off and flooded the bldg. The main floor and basement were flooded and as a result there was an extensive amount of mold growth. Most of the materials on the main floor are now dry as this flood happened some time ago. KEM found one area of wet drywall in the back of the bldg on a wall that is adjacent to a sink at the floor (janitor's sink). Some drywall has already been removed. Ceiling tiles show signs of water intrusion as some have sagged and or fallen to the ground. KEM found one sprinkler by the entrance to the bldg that was dripping but has now stopped. Mold is found all throughout the 1st Floor mostly on the drywall by the floor. In some areas the mold is higher up at about 6-10 feet from the ground. Other than the small dripping from sprinkler there are no ongoing water intrusion that was seen by KEM. Category: Issue Status: Open Responsible party: Kynoch Environmental Calendar Age: 1</p>

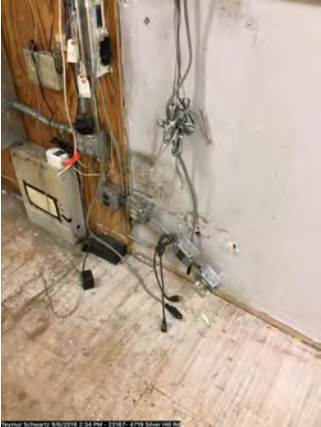
<p>Issue Info</p> <p>ID: 1 Area: Bldg 4701 Description: 9/6/18. Bldg 4701. 1st Floor. KEM was asked to inspect this bldg after it was reported that the sprinklers went off and flooded the bldg. The main floor and basement were flooded and as a result there was an extensive amount of mold growth. Most of the materials on the main floor are now dry as this flood happened some time ago. KEM found one area of wet drywall in the back of the bldg on a wall that is adjacent to a sink at the floor (janitor's sink). Some drywall has already been removed. Ceiling tiles show signs of water intrusion as some have sagged and or fallen to the ground. KEM found one sprinkler by the entrance to the bldg that was dripping but has now stopped. Mold is found all throughout the 1st Floor mostly on the drywall by the floor. In some areas the mold is higher up at about 6-10 feet from the ground. Other than the small dripping from sprinkler there are no ongoing water intrusion that was seen by KEM. Category: Issue Status: Open Responsible party: Kynoch Environmental Calendar Age: 1</p>

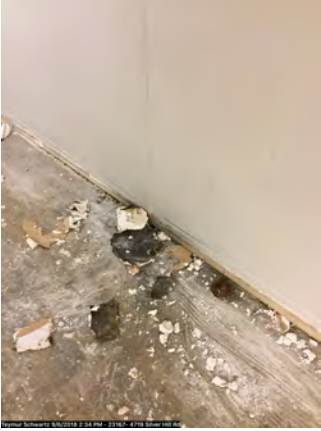
<p>Issue Info</p> <p>ID: 1 Area: Bldg 4701 Description: 9/6/18. Bldg 4701. 1st Floor. KEM was asked to inspect this bldg after it was reported that the sprinklers went off and flooded the bldg. The main floor and basement were flooded and as a result there was an extensive amount of mold growth. Most of the materials on the main floor are now dry as this flood happened some time ago. KEM found one area of wet drywall in the back of the bldg on a wall that is adjacent to a sink at the floor (janitor's sink). Some drywall has already been removed. Ceiling tiles show signs of water intrusion as some have sagged and or fallen to the ground. KEM found one sprinkler by the entrance to the bldg that was dripping but has now stopped. Mold is found all throughout the 1st Floor mostly on the drywall by the floor. In some areas the mold is higher up at about 6-10 feet from the ground. Other than the small dripping from sprinkler there are no ongoing water intrusion that was seen by KEM. Category: Issue Status: Open Responsible party: Kynoch Environmental Calendar Age: 1</p>

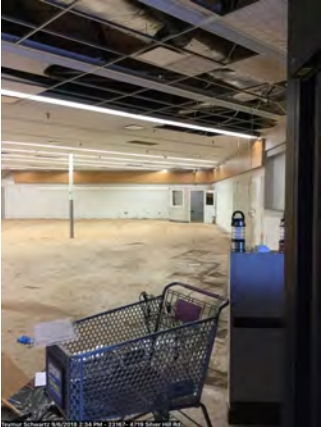
<p>Issue Info</p> <p>ID: 1 Area: Bldg 4701 Description: 9/6/18. Bldg 4701. 1st Floor. KEM was asked to inspect this bldg after it was reported that the sprinklers went off and flooded the bldg. The main floor and basement were flooded and as a result there was an extensive amount of mold growth. Most of the materials on the main floor are now dry as this flood happened some time ago. KEM found one area of wet drywall in the back of the bldg on a wall that is adjacent to a sink at the floor (janitor's sink). Some drywall has already been removed. Ceiling tiles show signs of water intrusion as some have sagged and or fallen to the ground. KEM found one sprinkler by the entrance to the bldg that was dripping but has now stopped. Mold is found all throughout the 1st Floor mostly on the drywall by the floor. In some areas the mold is higher up at about 6-10 feet from the ground. Other than the small dripping from sprinkler there are no ongoing water intrusion that was seen by KEM. Category: Issue Status: Open Responsible party: Kynoch Environmental Calendar Age: 1</p>

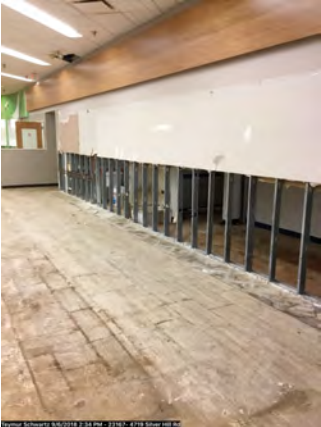
<p>Issue Info</p> <p>ID: 1 Area: Bldg 4701 Description: 9/6/18. Bldg 4701. 1st Floor. KEM was asked to inspect this bldg after it was reported that the sprinklers went off and flooded the bldg. The main floor and basement were flooded and as a result there was an extensive amount of mold growth. Most of the materials on the main floor are now dry as this flood happened some time ago. KEM found one area of wet drywall in the back of the bldg on a wall that is adjacent to a sink at the floor (janitor's sink). Some drywall has already been removed. Ceiling tiles show signs of water intrusion as some have sagged and or fallen to the ground. KEM found one sprinkler by the entrance to the bldg that was dripping but has now stopped. Mold is found all throughout the 1st Floor mostly on the drywall by the floor. In some areas the mold is higher up at about 6-10 feet from the ground. Other than the small dripping from sprinkler there are no ongoing water intrusion that was seen by KEM. Category: Issue Status: Open Responsible party: Kynoch Environmental Calendar Age: 1</p>

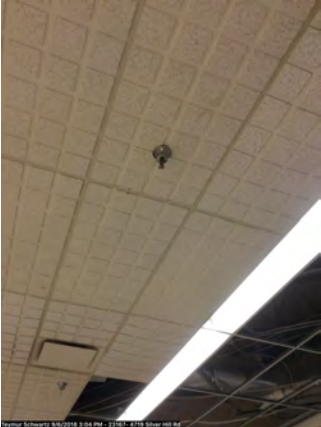
<p>Issue Info</p> <p>ID: 1 Area: Bldg 4701 Description: 9/6/18. Bldg 4701. 1st Floor. KEM was asked to inspect this bldg after it was reported that the sprinklers went off and flooded the bldg. The main floor and basement were flooded and as a result there was an extensive amount of mold growth. Most of the materials on the main floor are now dry as this flood happened some time ago. KEM found one area of wet drywall in the back of the bldg on a wall that is adjacent to a sink at the floor (janitor's sink). Some drywall has already been removed. Ceiling tiles show signs of water intrusion as some have sagged and or fallen to the ground. KEM found one sprinkler by the entrance to the bldg that was dripping but has now stopped. Mold is found all throughout the 1st Floor mostly on the drywall by the floor. In some areas the mold is higher up at about 6-10 feet from the ground. Other than the small dripping from sprinkler there are no ongoing water intrusion that was seen by KEM. Category: Issue Status: Open Responsible party: Kynoch Environmental Calendar Age: 1</p>

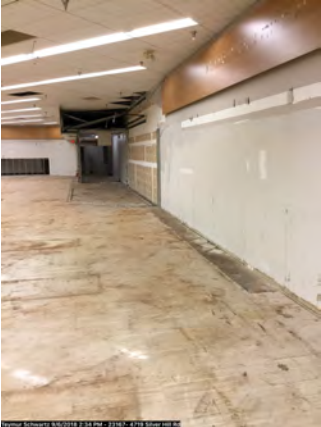
<p>Issue Info</p> <p>ID: 1 Area: Bldg 4701 Description: 9/6/18. Bldg 4701. 1st Floor. KEM was asked to inspect this bldg after it was reported that the sprinklers went off and flooded the bldg. The main floor and basement were flooded and as a result there was an extensive amount of mold growth. Most of the materials on the main floor are now dry as this flood happened some time ago. KEM found one area of wet drywall in the back of the bldg on a wall that is adjacent to a sink at the floor (janitor's sink). Some drywall has already been removed. Ceiling tiles show signs of water intrusion as some have sagged and or fallen to the ground. KEM found one sprinkler by the entrance to the bldg that was dripping but has now stopped. Mold is found all throughout the 1st Floor mostly on the drywall by the floor. In some areas the mold is higher up at about 6-10 feet from the ground. Other than the small dripping from sprinkler there are no ongoing water intrusion that was seen by KEM. Category: Issue Status: Open Responsible party: Kynoch Environmental Calendar Age: 1</p>

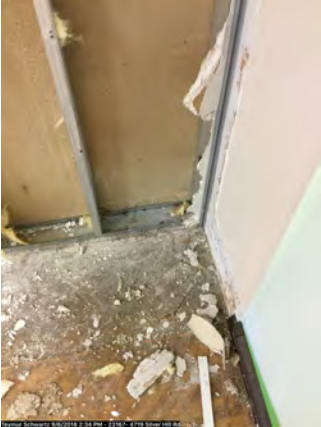
<p>Issue Info ID: 1 Area: Bldg 4701 Description: 9/6/18. Bldg 4701. 1st Floor. KEM was asked to inspect this bldg after it was reported that the sprinklers went off and flooded the bldg. The main floor and basement were flooded and as a result there was an extensive amount of mold growth. Most of the materials on the main floor are now dry as this flood happened some time ago. KEM found one area of wet drywall in the back of the bldg on a wall that is adjacent to a sink at the floor (janitor's sink). Some drywall has already been removed. Ceiling tiles show signs of water intrusion as some have sagged and or fallen to the ground. KEM found one sprinkler by the entrance to the bldg that was dripping but has now stopped. Mold is found all throughout the 1st Floor mostly on the drywall by the floor. In some areas the mold is higher up at about 6-10 feet from the ground. Other than the small dripping from sprinkler there are no ongoing water intrusion that was seen by KEM. Category: Issue Status: Open Responsible party: Kynoch Environmental Calendar Age: 1</p>

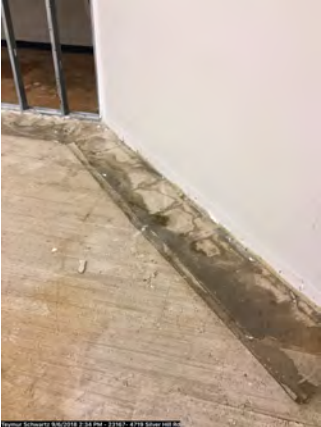
<p>Issue Info</p> <p>ID: 1 Area: Bldg 4701 Description: 9/6/18. Bldg 4701. 1st Floor. KEM was asked to inspect this bldg after it was reported that the sprinklers went off and flooded the bldg. The main floor and basement were flooded and as a result there was an extensive amount of mold growth. Most of the materials on the main floor are now dry as this flood happened some time ago. KEM found one area of wet drywall in the back of the bldg on a wall that is adjacent to a sink at the floor (janitor's sink). Some drywall has already been removed. Ceiling tiles show signs of water intrusion as some have sagged and or fallen to the ground. KEM found one sprinkler by the entrance to the bldg that was dripping but has now stopped. Mold is found all throughout the 1st Floor mostly on the drywall by the floor. In some areas the mold is higher up at about 6-10 feet from the ground. Other than the small dripping from sprinkler there are no ongoing water intrusion that was seen by KEM. Category: Issue Status: Open Responsible party: Kynoch Environmental Calendar Age: 1</p>

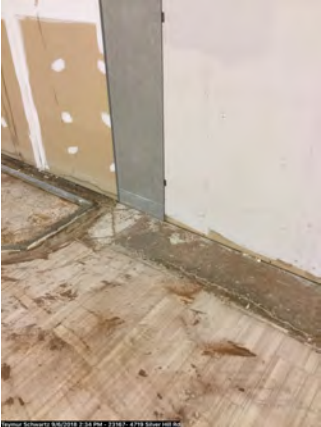
<p>Issue Info</p> <p>ID: 1 Area: Bldg 4701 Description: 9/6/18. Bldg 4701. 1st Floor. KEM was asked to inspect this bldg after it was reported that the sprinklers went off and flooded the bldg. The main floor and basement were flooded and as a result there was an extensive amount of mold growth. Most of the materials on the main floor are now dry as this flood happened some time ago. KEM found one area of wet drywall in the back of the bldg on a wall that is adjacent to a sink at the floor (janitor's sink). Some drywall has already been removed. Ceiling tiles show signs of water intrusion as some have sagged and or fallen to the ground. KEM found one sprinkler by the entrance to the bldg that was dripping but has now stopped. Mold is found all throughout the 1st Floor mostly on the drywall by the floor. In some areas the mold is higher up at about 6-10 feet from the ground. Other than the small dripping from sprinkler there are no ongoing water intrusion that was seen by KEM. Category: Issue Status: Open Responsible party: Kynoch Environmental Calendar Age: 1</p>

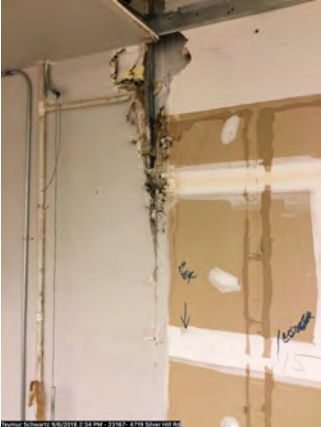
<p>Issue Info ID: 1 Area: Bldg 4701 Description: 9/6/18. Bldg 4701. 1st Floor. KEM was asked to inspect this bldg after it was reported that the sprinklers went off and flooded the bldg. The main floor and basement were flooded and as a result there was an extensive amount of mold growth. Most of the materials on the main floor are now dry as this flood happened some time ago. KEM found one area of wet drywall in the back of the bldg on a wall that is adjacent to a sink at the floor (janitor's sink). Some drywall has already been removed. Ceiling tiles show signs of water intrusion as some have sagged and or fallen to the ground. KEM found one sprinkler by the entrance to the bldg that was dripping but has now stopped. Mold is found all throughout the 1st Floor mostly on the drywall by the floor. In some areas the mold is higher up at about 6-10 feet from the ground. Other than the small dripping from sprinkler there are no ongoing water intrusion that was seen by KEM. Category: Issue Status: Open Responsible party: Kynoch Environmental Calendar Age: 1</p>

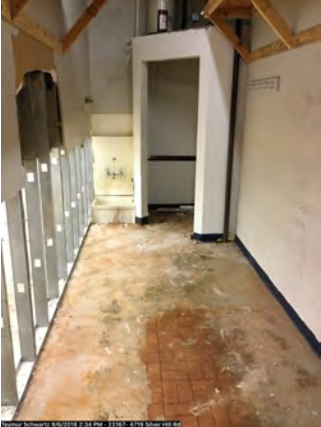
<p>Issue Info</p> <p>ID: 1 Area: Bldg 4701 Description: 9/6/18. Bldg 4701. 1st Floor. KEM was asked to inspect this bldg after it was reported that the sprinklers went off and flooded the bldg. The main floor and basement were flooded and as a result there was an extensive amount of mold growth. Most of the materials on the main floor are now dry as this flood happened some time ago. KEM found one area of wet drywall in the back of the bldg on a wall that is adjacent to a sink at the floor (janitor's sink). Some drywall has already been removed. Ceiling tiles show signs of water intrusion as some have sagged and or fallen to the ground. KEM found one sprinkler by the entrance to the bldg that was dripping but has now stopped. Mold is found all throughout the 1st Floor mostly on the drywall by the floor. In some areas the mold is higher up at about 6-10 feet from the ground. Other than the small dripping from sprinkler there are no ongoing water intrusion that was seen by KEM. Category: Issue Status: Open Responsible party: Kynoch Environmental Calendar Age: 1</p>

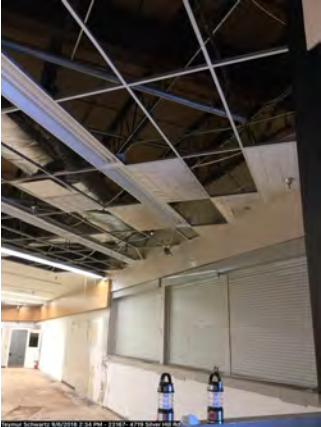
<p>Issue Info ID: 1 Area: Bldg 4701 Description: 9/6/18. Bldg 4701. 1st Floor. KEM was asked to inspect this bldg after it was reported that the sprinklers went off and flooded the bldg. The main floor and basement were flooded and as a result there was an extensive amount of mold growth. Most of the materials on the main floor are now dry as this flood happened some time ago. KEM found one area of wet drywall in the back of the bldg on a wall that is adjacent to a sink at the floor (janitor's sink). Some drywall has already been removed. Ceiling tiles show signs of water intrusion as some have sagged and or fallen to the ground. KEM found one sprinkler by the entrance to the bldg that was dripping but has now stopped. Mold is found all throughout the 1st Floor mostly on the drywall by the floor. In some areas the mold is higher up at about 6-10 feet from the ground. Other than the small dripping from sprinkler there are no ongoing water intrusion that was seen by KEM. Category: Issue Status: Open Responsible party: Kynoch Environmental Calendar Age: 1</p>

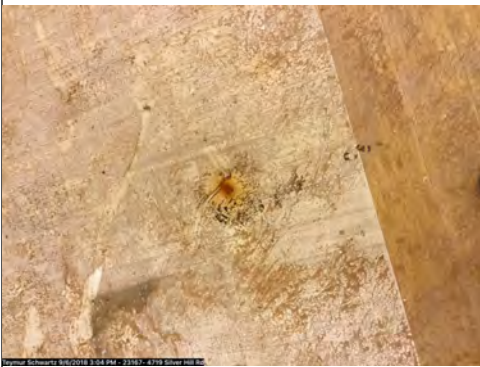
<p>Issue #1</p>

<p>Issue Info ID: 1 Area: Bldg 4701 Description: 9/6/18. Bldg 4701. 1st Floor. KEM was asked to inspect this bldg after it was reported that the sprinklers went off and flooded the bldg. The main floor and basement were flooded and as a result there was an extensive amount of mold growth. Most of the materials on the main floor are now dry as this flood happened some time ago. KEM found one area of wet drywall in the back of the bldg on a wall that is adjacent to a sink at the floor (janitor's sink). Some drywall has already been removed. Ceiling tiles show signs of water intrusion as some have sagged and or fallen to the ground. KEM found one sprinkler by the entrance to the bldg that was dripping but has now stopped. Mold is found all throughout the 1st Floor mostly on the drywall by the floor. In some areas the mold is higher up at about 6-10 feet from the ground. Other than the small dripping from sprinkler there are no ongoing water intrusion that was seen by KEM. Category: Issue Status: Open Responsible party: Kynoch Environmental Calendar Age: 1</p>

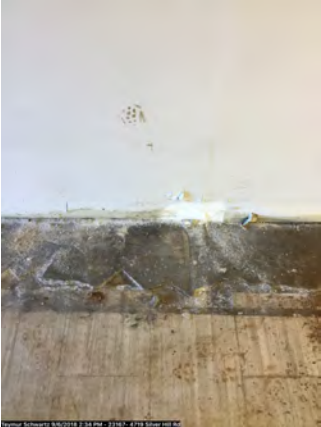
<p>Issue Info</p> <p>ID: 1 Area: Bldg 4701 Description: 9/6/18. Bldg 4701. 1st Floor. KEM was asked to inspect this bldg after it was reported that the sprinklers went off and flooded the bldg. The main floor and basement were flooded and as a result there was an extensive amount of mold growth. Most of the materials on the main floor are now dry as this flood happened some time ago. KEM found one area of wet drywall in the back of the bldg on a wall that is adjacent to a sink at the floor (janitor's sink). Some drywall has already been removed. Ceiling tiles show signs of water intrusion as some have sagged and or fallen to the ground. KEM found one sprinkler by the entrance to the bldg that was dripping but has now stopped. Mold is found all throughout the 1st Floor mostly on the drywall by the floor. In some areas the mold is higher up at about 6-10 feet from the ground. Other than the small dripping from sprinkler there are no ongoing water intrusion that was seen by KEM. Category: Issue Status: Open Responsible party: Kynoch Environmental Calendar Age: 1</p>

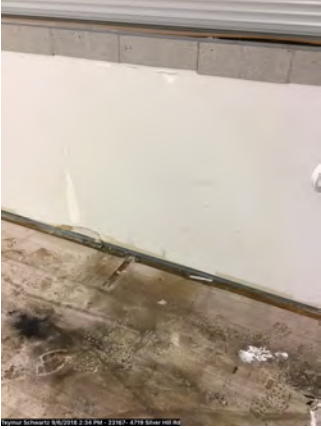
<p>Issue Info</p> <p>ID: 1 Area: Bldg 4701 Description: 9/6/18. Bldg 4701. 1st Floor. KEM was asked to inspect this bldg after it was reported that the sprinklers went off and flooded the bldg. The main floor and basement were flooded and as a result there was an extensive amount of mold growth. Most of the materials on the main floor are now dry as this flood happened some time ago. KEM found one area of wet drywall in the back of the bldg on a wall that is adjacent to a sink at the floor (janitor's sink). Some drywall has already been removed. Ceiling tiles show signs of water intrusion as some have sagged and or fallen to the ground. KEM found one sprinkler by the entrance to the bldg that was dripping but has now stopped. Mold is found all throughout the 1st Floor mostly on the drywall by the floor. In some areas the mold is higher up at about 6-10 feet from the ground. Other than the small dripping from sprinkler there are no ongoing water intrusion that was seen by KEM. Category: Issue Status: Open Responsible party: Kynoch Environmental Calendar Age: 1</p>
