# Mount Rainier Artist Lofts Capital Needs Assessment Phase I

MARCH 20, 2026

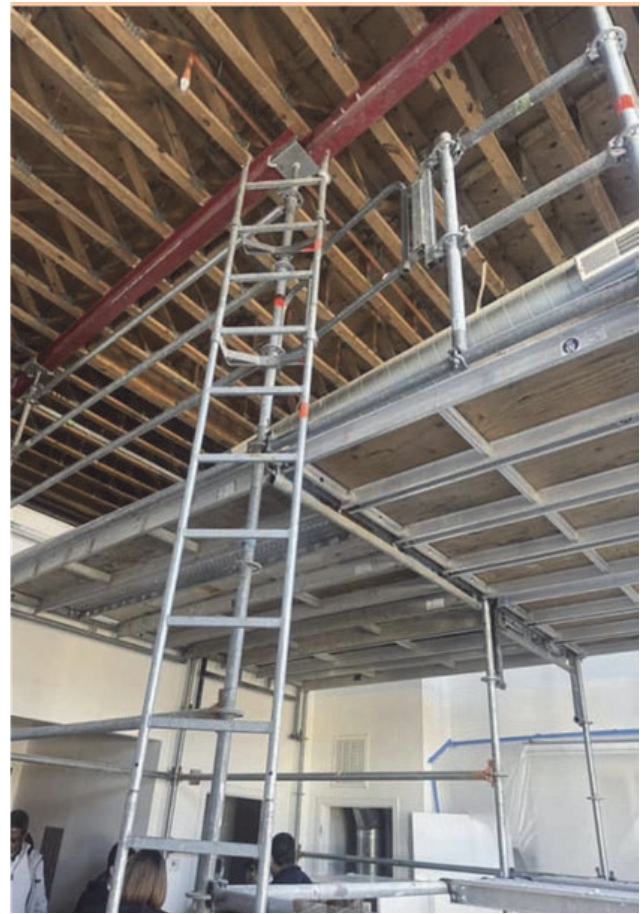
- Unit 312 contains compromised trusses that are presently supported by a temporary steel beam. The floor system above this unit has visibly buckled and poses a significant risk of structural failure or collapse. Based on these observations, it is reasonable to assume that additional trusses serving the third floor may also be defective and subject to similar structural risks.

Picture showing temporary support of failed ceiling trusses

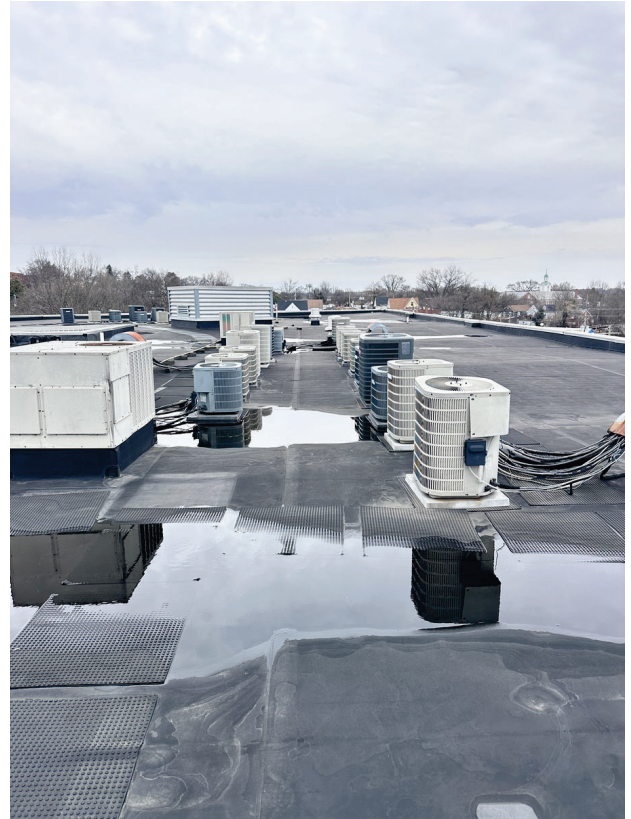
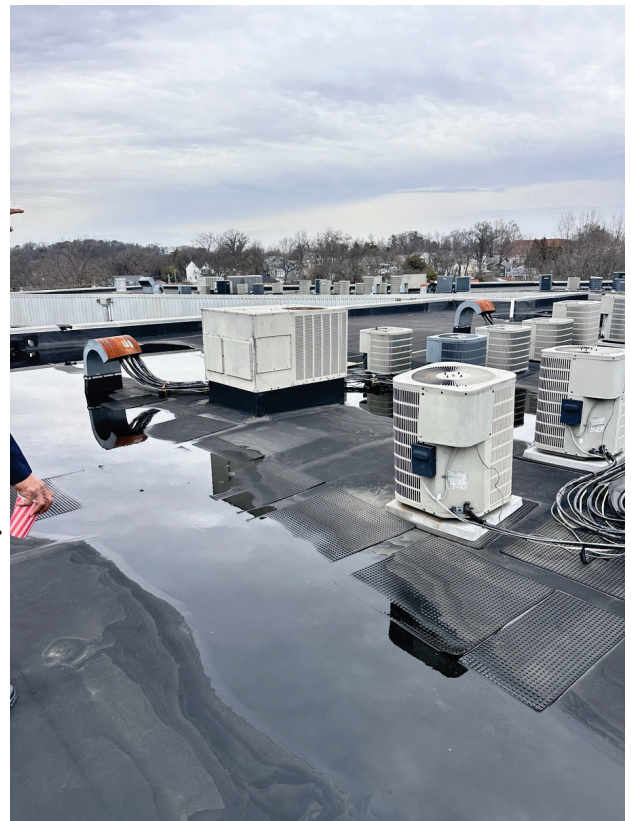
- General wear and deterioration of rooftop mechanical equipment
- Degraded refrigerant line insulation
- Deteriorated protective insulation due to prolonged weather exposure
- Inadequate equipment labeling for clear identification

Picture showing rooftop units with exposed wires

A licensed HVAC contractor should be engaged to establish a comprehensive maintenance program. This program should include inspection, repair, and servicing of all rooftop mechanical units to restore operational efficiency and ensure code compliance.

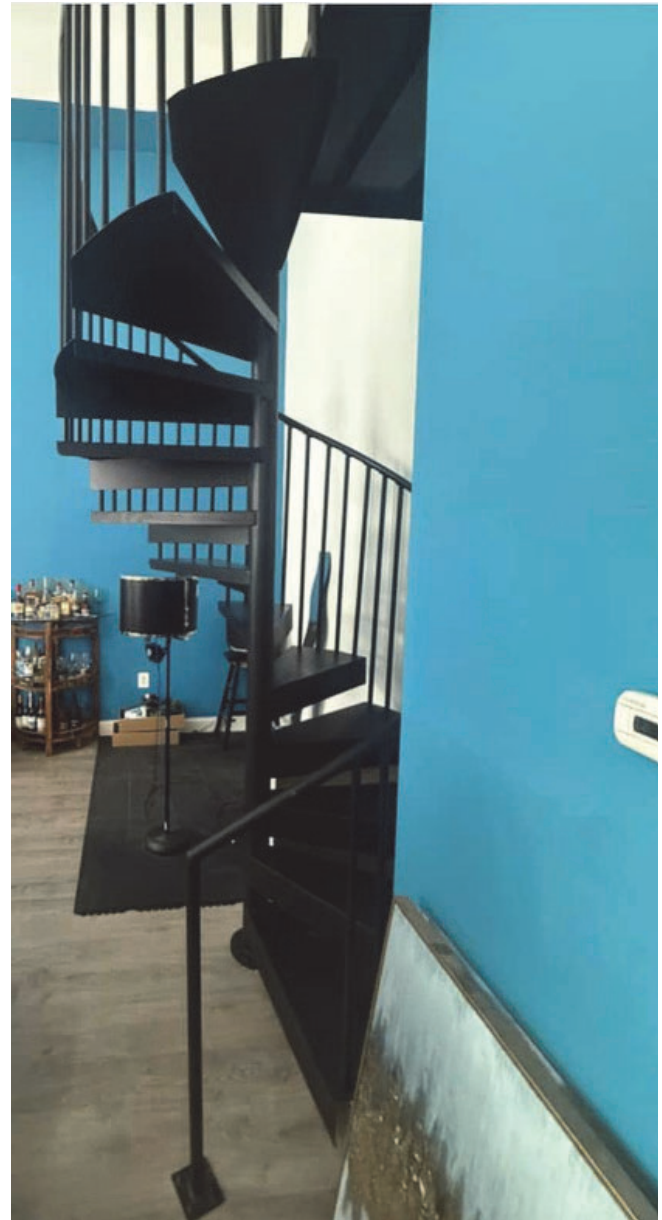
Illegal spiral staircase installed

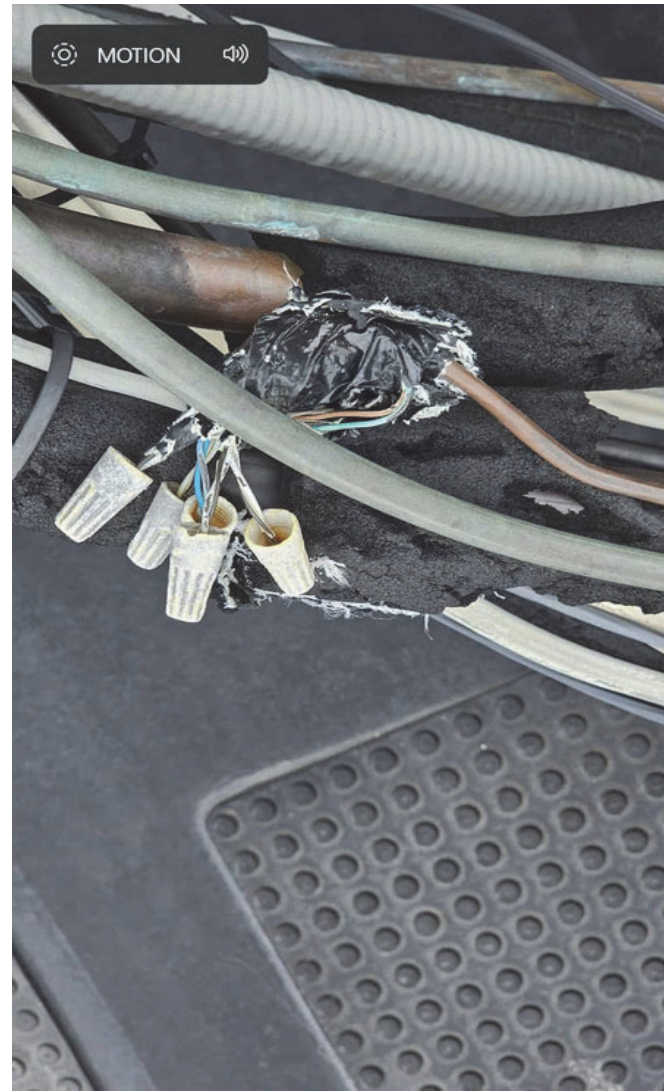
- Some lighting fixtures were non-operational or defective.
- Several ground fault circuit interrupter (GFCI) outlets were not functioning properly and are not compliant with electrical code requirements.
- Electrical panels were not opened or tested during the inspection.

Exposed electrical outlets and lines

1. Replace all defective lighting fixtures throughout the building.
2. Engage a licensed master electrician to inspect and service all GFCI outlets and confirm compliance with applicable electrical codes.

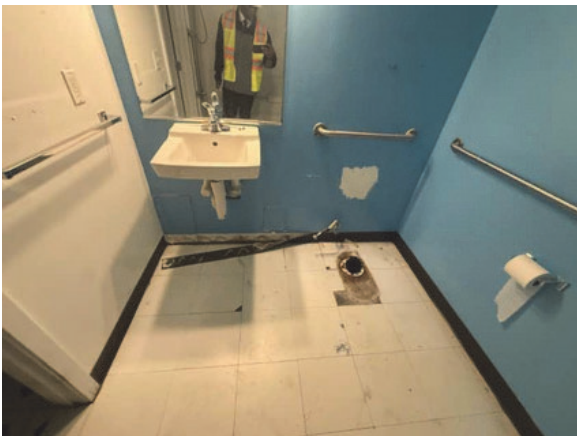
Missing plumbing fixtures

1. Engage a licensed master plumber to repair all leaking plumbing fixtures.
2. Conduct a full inspection of the water heating systems and implement routine plumbing maintenance.

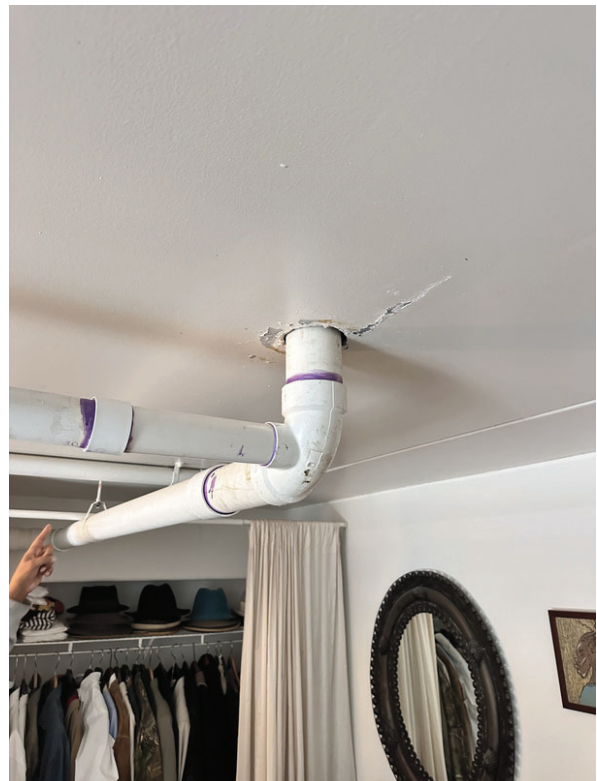
- Leaking toilets
- Leaking faucets
- Leaks throughout building pipes
- Minor fixture deficiencies
- The water heating systems were not tested during the inspection.

Leaks in residential units

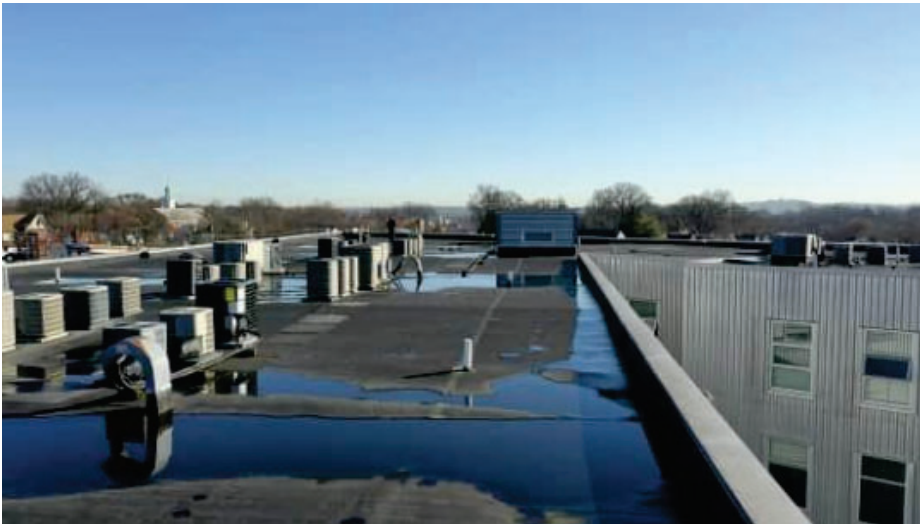
The roofing system was observed to have significant ponding issues in multiple areas. Standing water on the roof appears to result from inadequate roof slope, which may eventually lead to water infiltration into the units below.

Major ponding on entire roof

A qualified roofing contractor should conduct a comprehensive roof inspection and develop a corrective plan to improve roof drainage and eliminate ponding conditions.

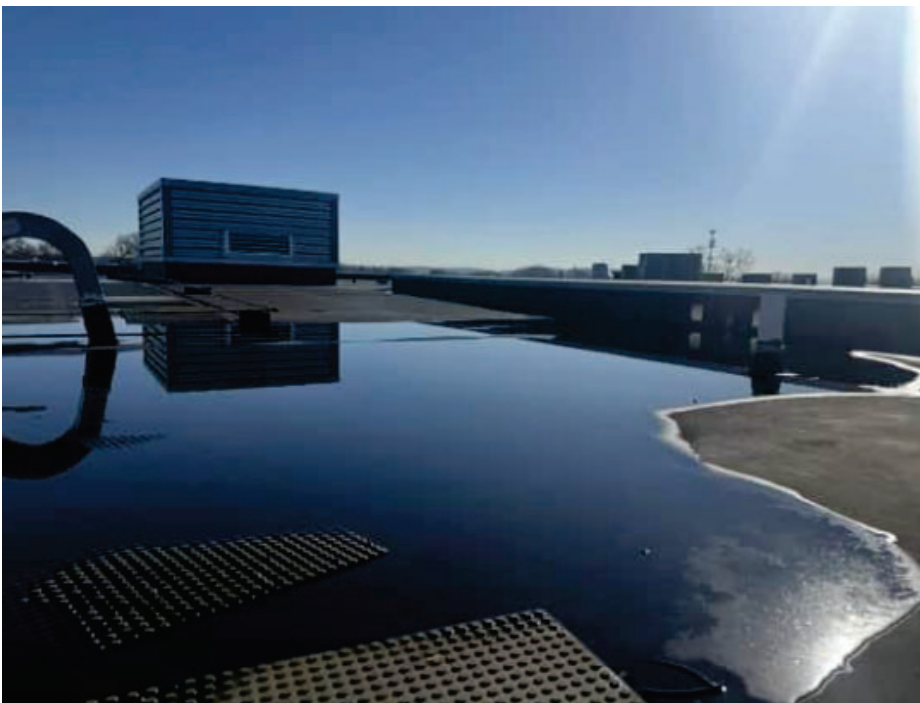
Inadequate slope for proper drainage

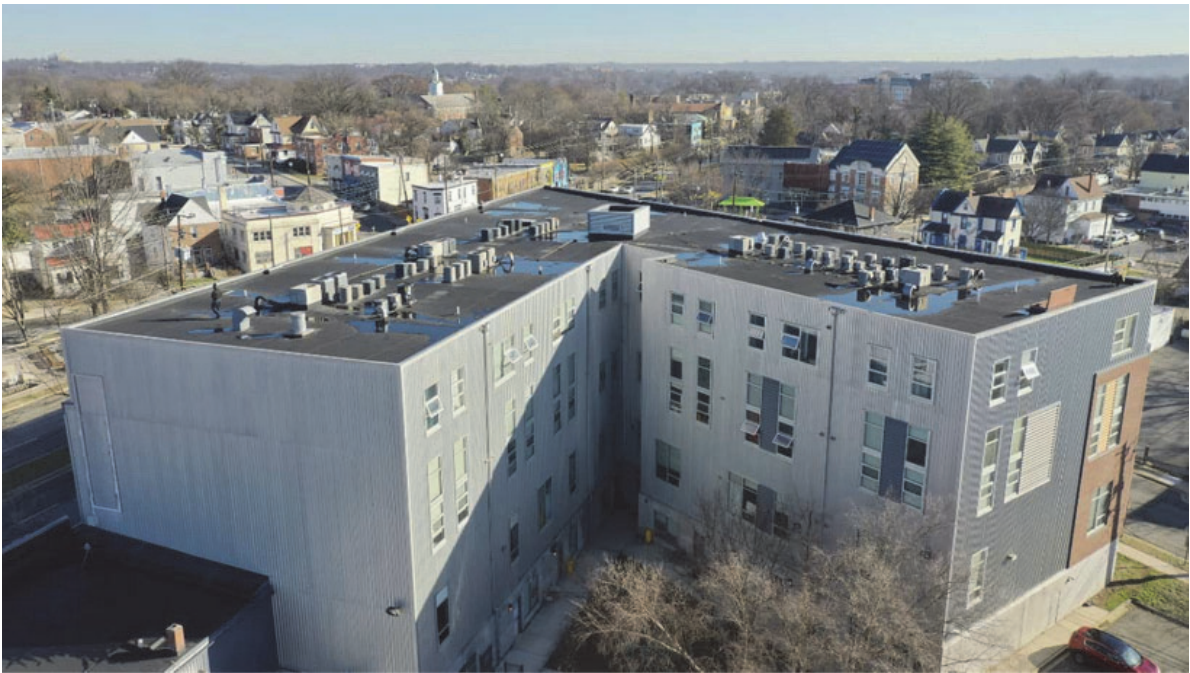
Localized areas of surface deterioration were observed, which are consistent with normal aging and weathering of building materials.

Building envelope in good condition

Property management should implement a routine exterior maintenance program, including annual caulking inspections and repairs to maintain the integrity of the building envelope.

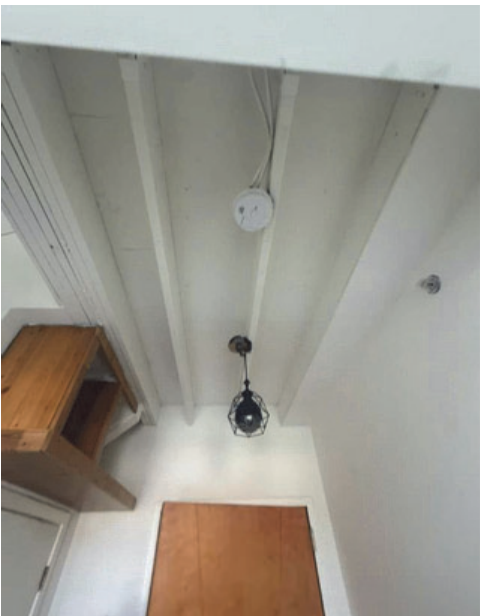
Defective smoke detectors throughout building

1. Annual testing and maintenance should be conducted by a licensed fire protection contractor to ensure proper operation of all life safety systems.
2. Inspect sprinkler heads to ensure they are not painted, obstructed, or leaking.
3. Correct any damaged or improperly installed fire protection components.
4. Property management should remove any stored materials that obstruct egress paths.

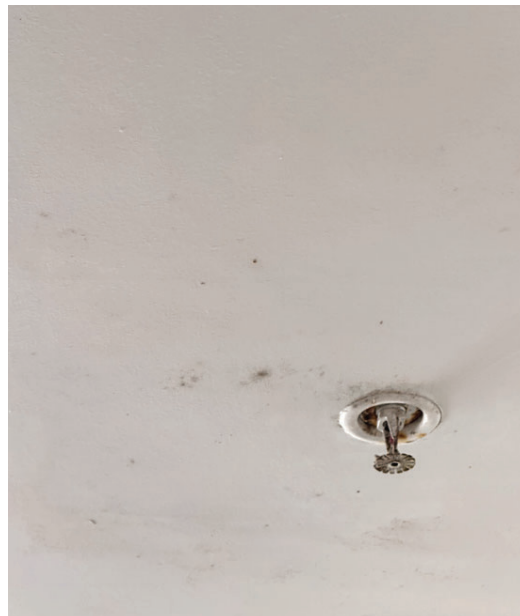
Defective and non-functional sprinkler systems

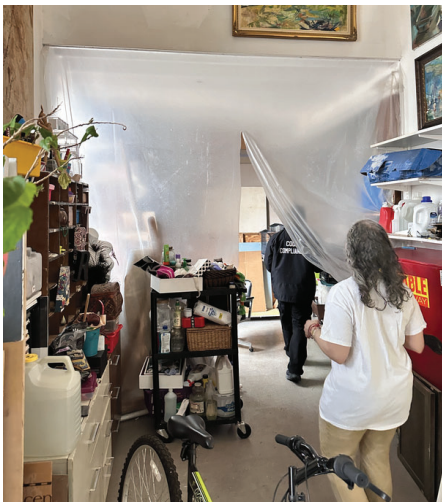
Obstructed walkways

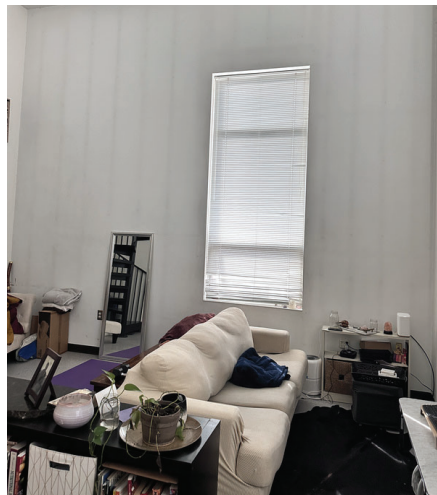
Ghosting repainting required

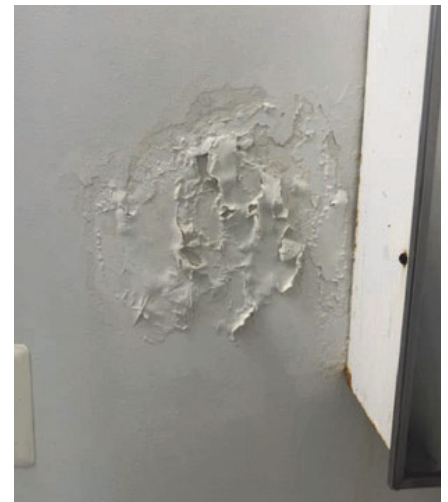
Drywall oxidation

1. Immediately engage a qualified general contractor to correct all violations noted by the City of Mount Rainier.
2. Engage a structural engineer to perform a comprehensive structural analysis once the affected units have been evacuated and structural elements exposed.
