## 3311 Rhode Island Ave. Structural Assessment

Report of Findings

**Subject:** **Structural Assessment**  
3311 Rhode Island Ave  
My. Ranier, MD 20712  
Project Number: P0100066584

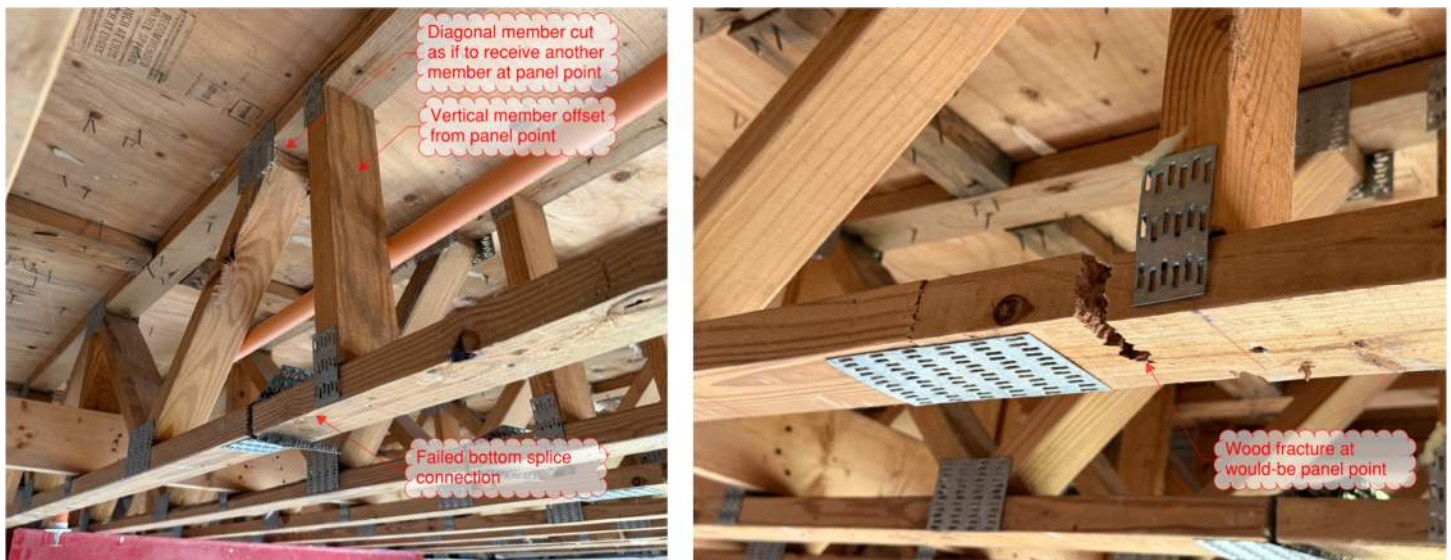
- Truss framing members are generally designed as 'two force' members to resist either tension or compression forces. The convergence of diagonal or vertical members along top and bottom chords is referred as a 'panel point'. Top and bottom chords can become overloaded if concentrated point loads are not located at panel points, inducing shear stresses not otherwise designed for.
- At the typical truss-joists which have failed, we observed the failed bottom chord splice connection is located where a panel point would be expected, making it difficult for the adjacent vertical member to properly align with this panel point. As a result, the vertical member at this location is offset from a panel point by approximately 4 to 6 inches. This offset may result

in a concentrated shear force that the truss was not designed for. The diagonal member also appears to be cut at an angle to receive this vertical member, indicating that this vertical member may have originally been designed to be located at panel points. At one of the truss-joists, a single wood fracture occurred immediately adjacent to the splice, further supporting this hypothesis. Figure 2 depicts the above narrative.

Figure 2 – Typical splice connection failure (left); wood fracture at would-be panel point if vertical member was not offset (right)

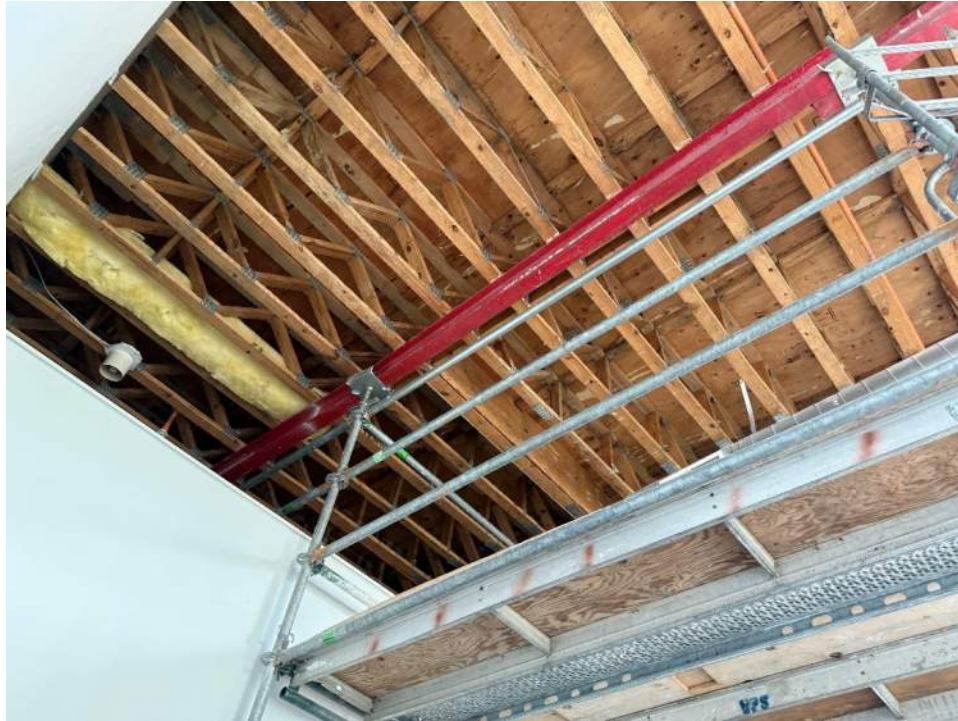
Unit 202 includes a rectangular floor plan with a loft space above. A shoring system was previously installed centrally located within the unit, and all ceiling finishes were removed to expose the open-web wood truss-joist floor framing above. These truss-joists are fabricated with 2x4 members, and metal plate connectors at each panel point. There are also intermediate metal plate connectors along the top and bottom chords to develop continuity of the member. The shoring tower includes two steel shoring beams supporting and perpendicular to the wood truss floor framing above (Photo 3). The truss-joist floor framing above spans the primary East-West direction (parallel to Rhode Island Avenue). The shoring system is branded by Scaffold Resources.

The top and bottom chord splice connections occur at approximately mid span. It is noted, however, that the shoring beams supporting the bottom chord trusses are located at approximate third points and not immediately below or adjacent to the referenced bottom splice failures. It is unclear, without performing a structural analysis, if the shoring locations are appropriate to resolve the failures observed.

Photo 3 – Overview of Unit 202 shoring

1. In the IMMEDIATE TERM (May 2027), either emergency structural repairs or temporary shoring adjustments under the direction of a licensed structural engineer shall be made at Unit 202's ceiling framing (Level 3 floor framing) to alleviate further structural concern. If repairs/shoring adjustments are anticipated to be cost prohibitive, or delays are likely, we recommend Unit 312 tenants be temporarily relocated until such structural modifications can be executed.

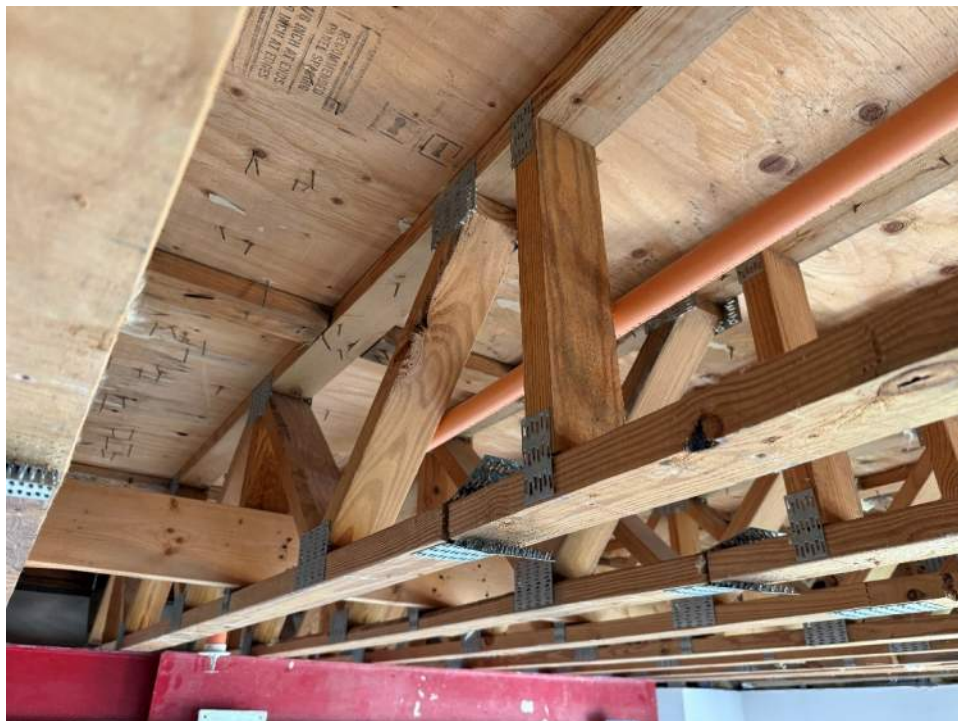
It is apparent that the majority of bottom chord metal-plate splice connections along the Level 3 wood truss framing has failed (Photos 4 and 5). Several top chord splice connection plates, to a lesser frequency than bottom chord splice plates, were also observed as failed (Photo 6). When interviewing the tenant of the space directly above (Unit 312), it was discussed that approximately two to three years ago, two successive and sudden loud 'pops' were felt by the resident. Approximately two months later, an additional audible pop was reported by the resident. Cracks in the floor finishes were also noted at Unit 312 (Photo 7). Shoring was installed after the tenant reported this distress. Based on this description and the observations within Unit 202, it is likely that these pops and floor cracks were due to the splice connection plates failing.

Photo 4 – Wood connection bottom splice plate failures

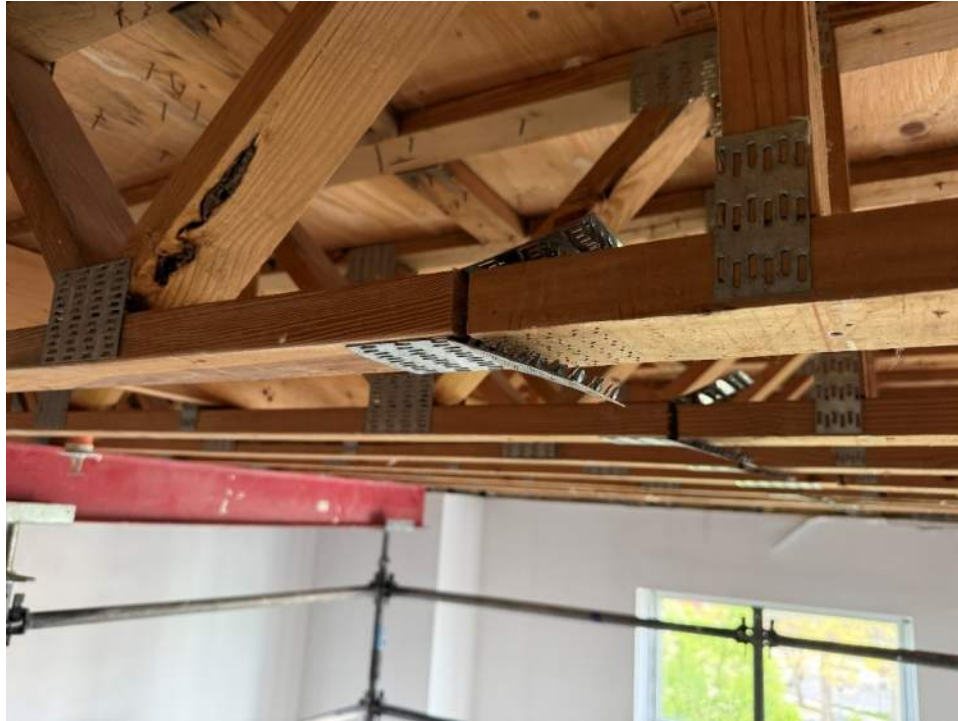
Photo 5 – Wood connection bottom splice plate failures

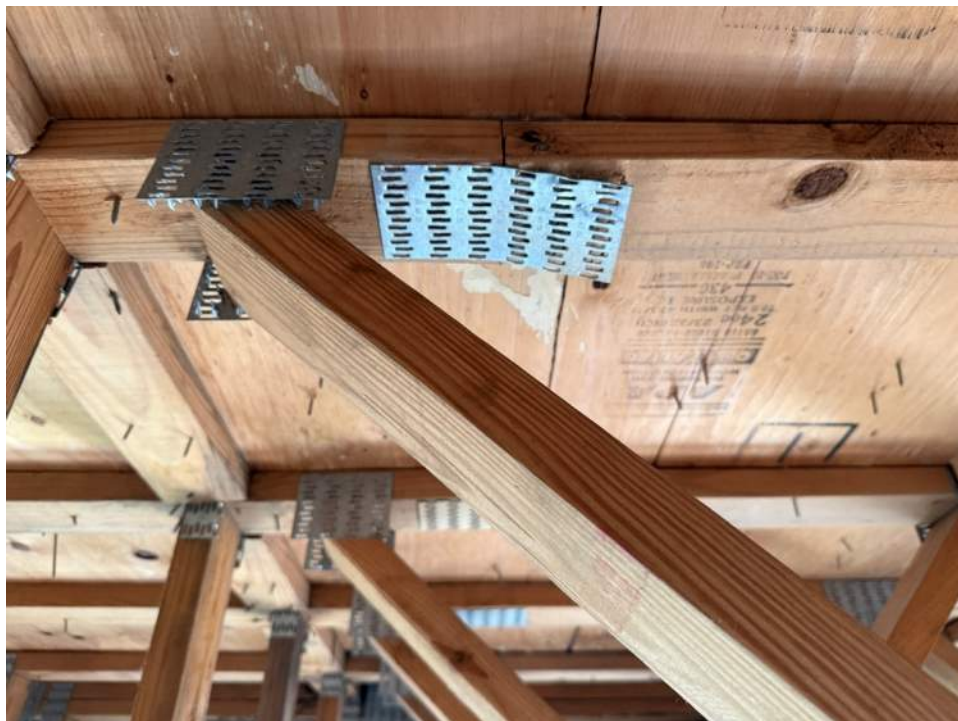
Photo 6 – Top splice and adjacent diagonal connection plate failures

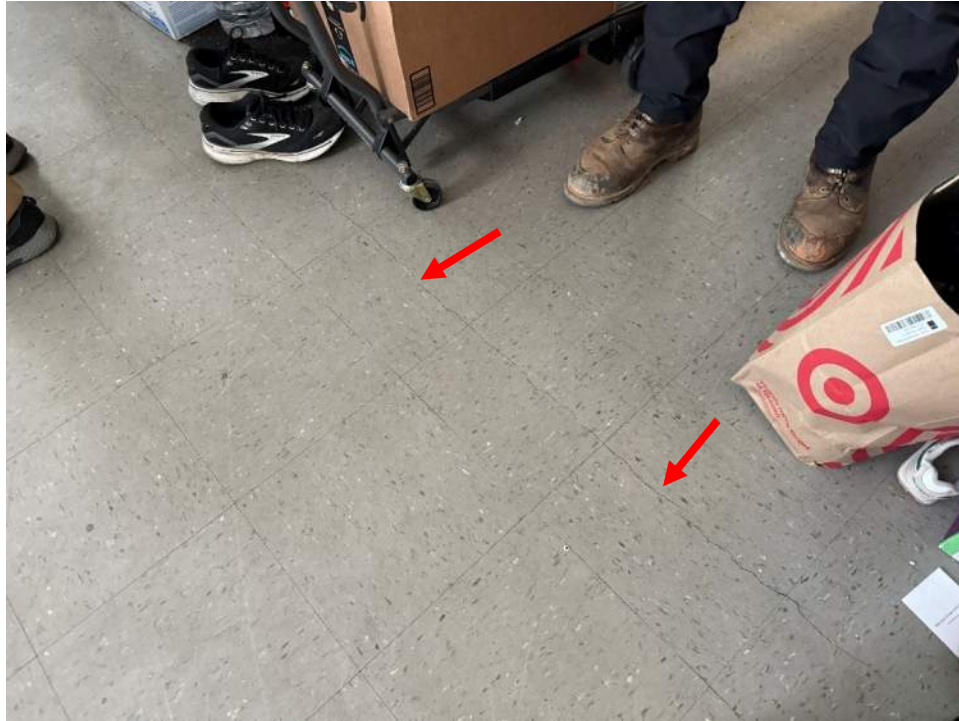
Photo 7 – Unit 312 floor finish cracks

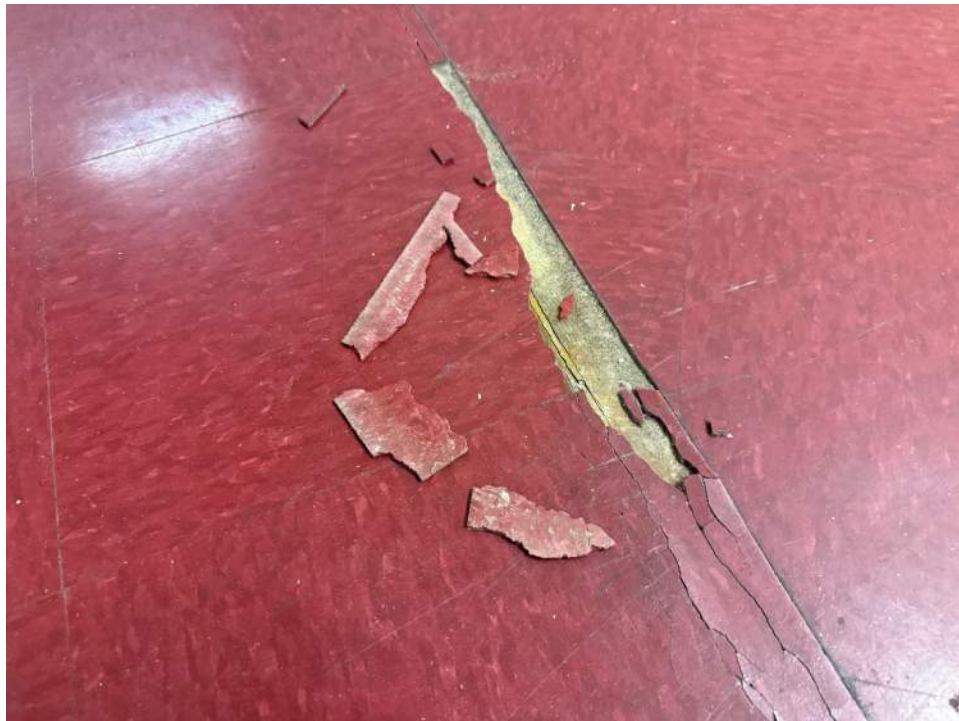
BECS entered approximately 5 units at Level 2 and Level 3. Of those units, several Level 3 units were identified with signs of structural movement, as evidenced by cracks in the floor, corners of door frames, and wall to ceiling transitions (Photos 8 through 10). Most tenants interviewed were not able to provide a clear history of when these signs of distress occurred. It is possible that previous repairs have addressed the cause of movement, and the symptoms (i.e. the referenced cracks in interior finishes) were not yet addressed. It is also possible that a systemic overloading issue persists at the referenced property.

Photo 8 – Failure in Level 3 floor finish

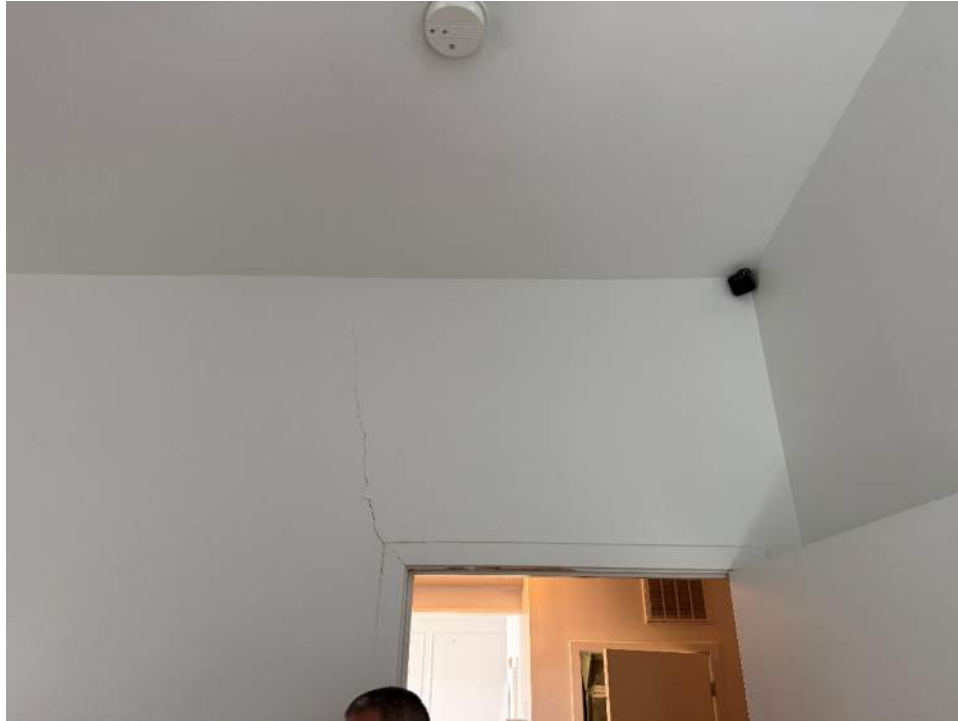
Photo 9 – Crack propagating from Unit 305 door header/jamb corner

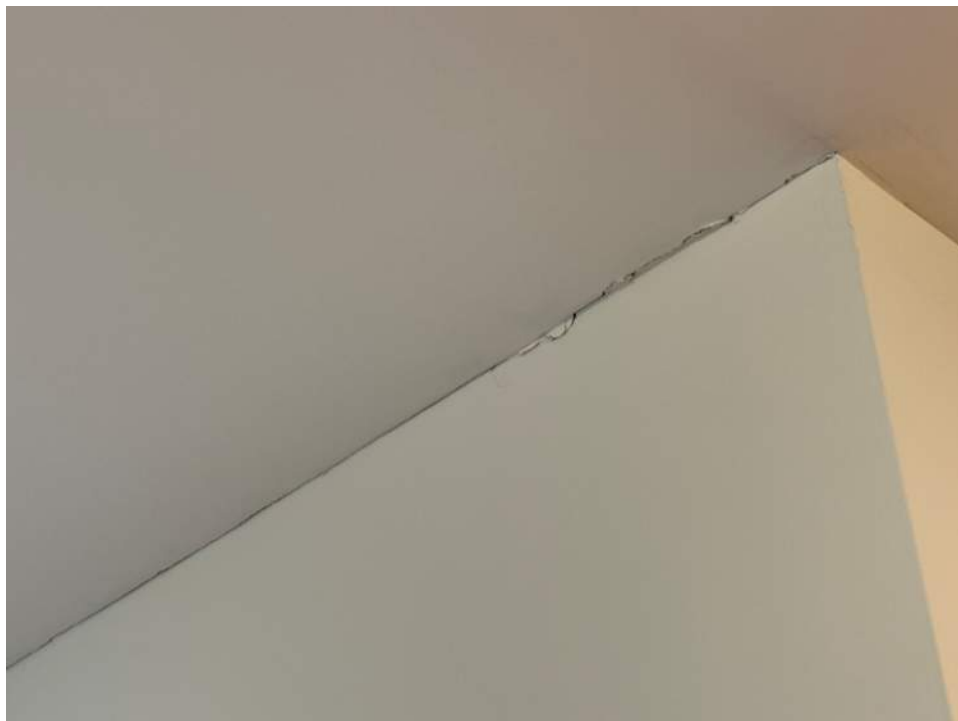
Photo 10 – Crack at Unit 305 wall/ceiling transition

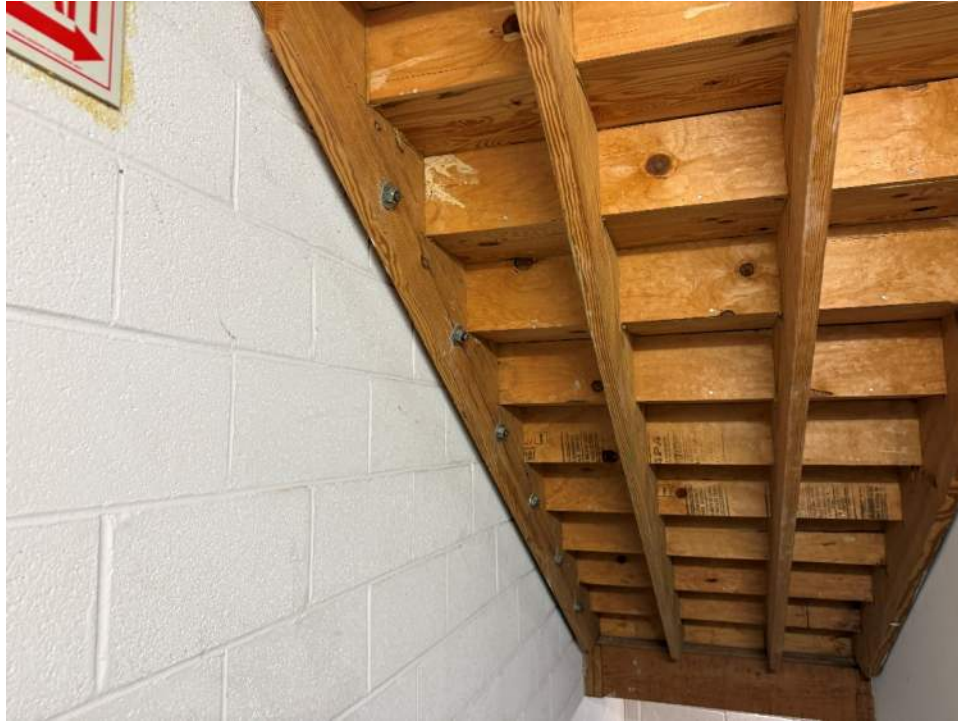
Two stairwells were also reviewed, located at the terminal ends of each 'wing' of the facility. These stairwells included signs of retrofits in which anchors were installed into the concrete masonry unit (CMU) block wall stair framing securing the wood framing to the stair walls. While it is expected to observe ledger board anchors supporting the stair landings to the walls, it is atypical to see stringers with direct attachment/connection to the adjacent walls, as seen at both stairwells. Furthermore, these anchors are skewed, suggesting that structural movement has occurred or that the post-installed anchors were installed to alleviate a potential concern with the stairwell (Photos 11 and 12). If the anchors were post-installed, the skewed angle of the anchors may be a direct result of existing constructability constraints such that the anchors were required to be installed at a skewed angle. Given the lack of cracks in the masonry, bowing or signs of sagging stair framing, and the note on the referenced permit addendum indicating stair repairs, it is likely that these anchors were installed in their current condition.

Photo 11 – Stair stringer with skewed anchors

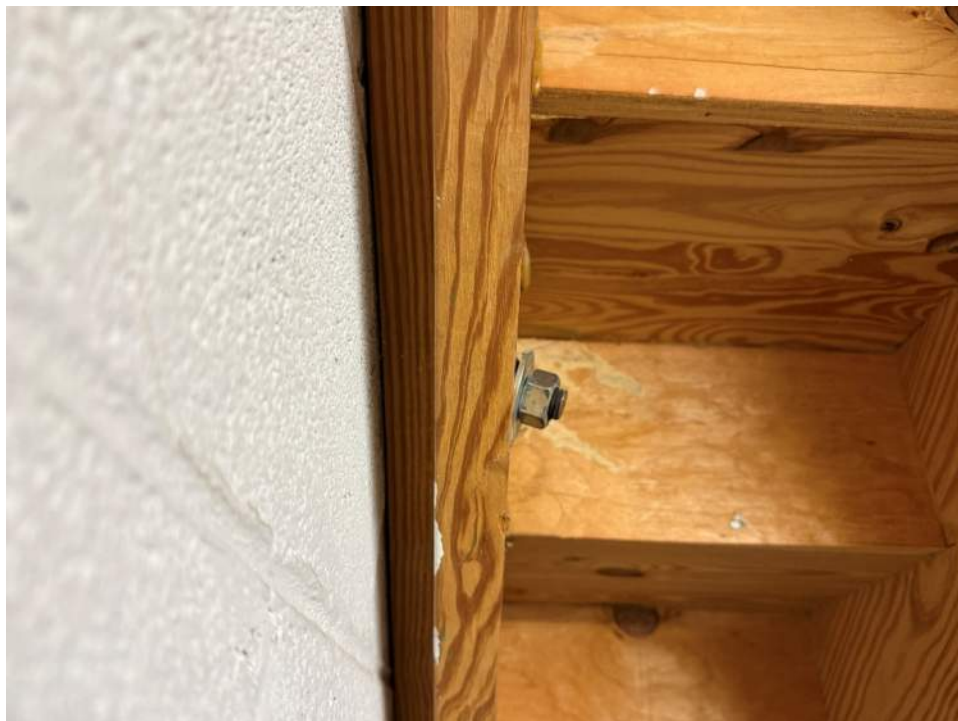
Photo 12 – Stair stringer with skewed anchors

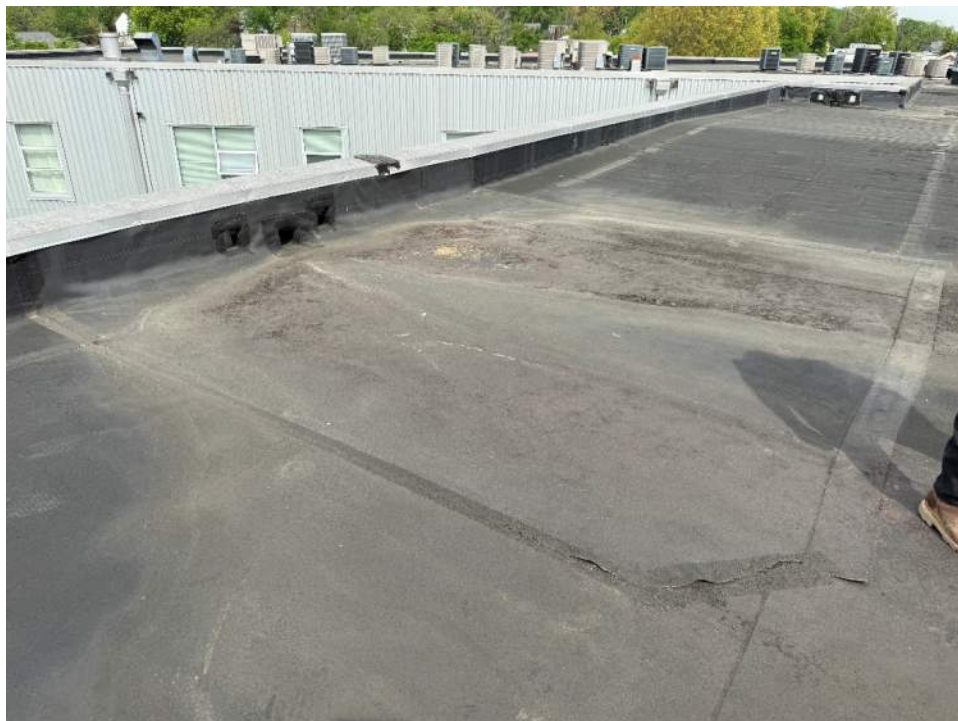
BECS also performed a limited visual assessment of exterior elements, including a brief walkthrough of rooftop areas and a ground level perimeter walkthrough to observe façade elements that may be exhibiting signs of structural movement. The roofing system was a Carlisle EPDM fully reinforced (membrane thickness of 60 mil) roofing system with tapered insulation that appears to have exceeded its service life, as evidenced by several reports of Level 3 leaks and multiple patch repairs throughout the roof (Photos 13 and 14). The roof drains towards exterior scuppers along the roof perimeter. The Level 3 hallway had several ceiling lights with water staining, and Unit 305 also had extensive damage from previous roof failures. While roofing observation failures do not directly correlate to observed structural distress items, it is noted that leaks can result in wood rot, and if left unaddressed, cause failures in the roofing system. Roof leaks should not be left to persist.

Photo 14 – Overview of roofing area with failed patch repairs
