HAZARDOUS MATERIALS SURVEY

PRINCE GEORGES COUNTY HOSPITAL

3001 HOSPITAL DRIVE
CHEVERLY, MARYLAND 20785

FEBRUARY 26, 2021

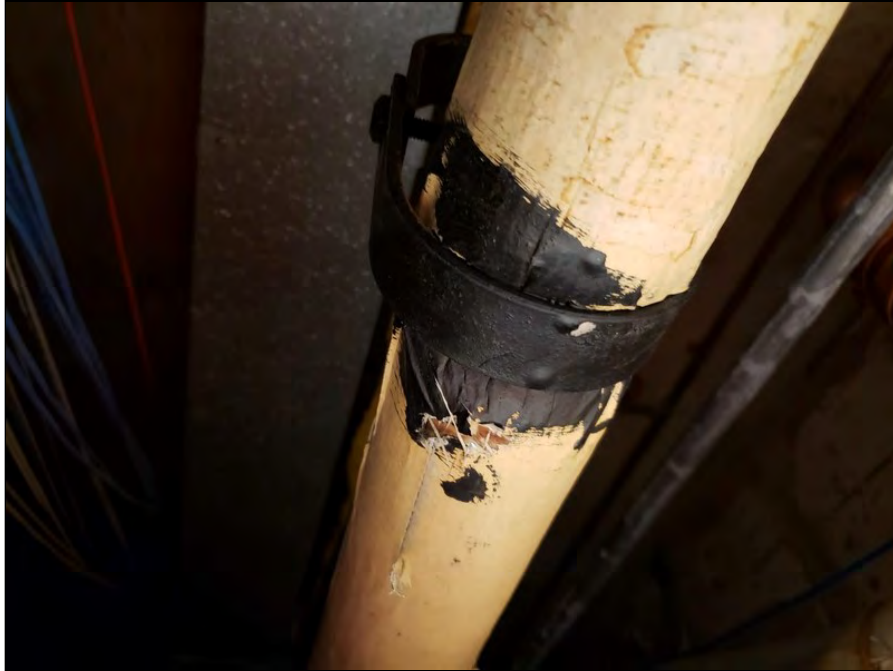
1 - Black Thermal System Insulation Hangar Mastic (ACM)

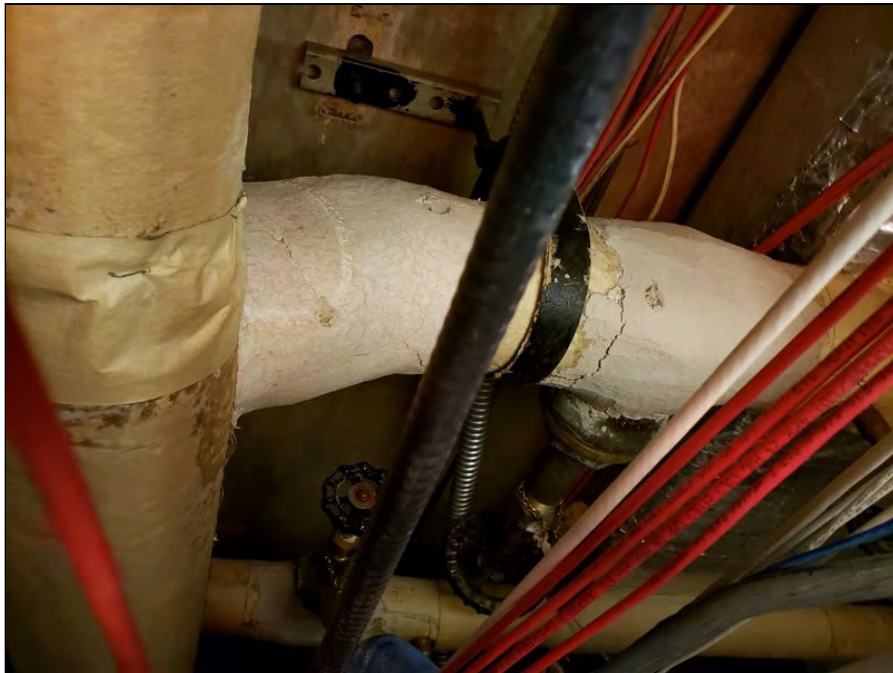
*One domestic water mudded elbow sample was analyzed with less than 1% amosite while another was analyzed with 3% amosite. ECS recommends to treat each of these domestic water mudded elbows as asbestos containing materials.

2 - Cemented Pipe Elbow (ACM)

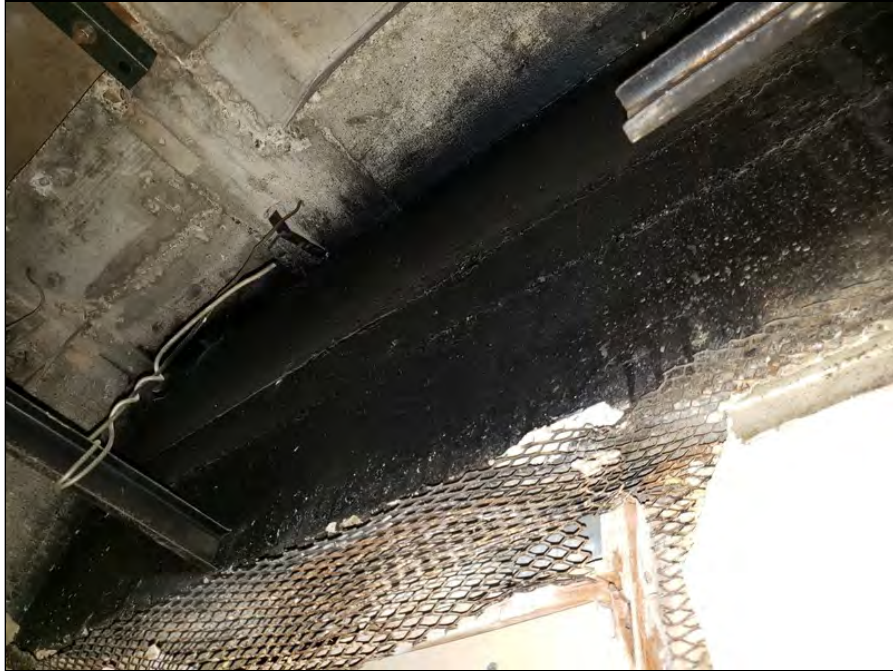
Due to the non-destructive nature of this survey, black waterproofing was only able to be observed on an exterior wall of the ACF Wing. ECS recommends that it be assumed that asbestos-containing black waterproofing is throughout the entire building until testing or observation indicates otherwise.

3 - Black Waterproofing (ACM)

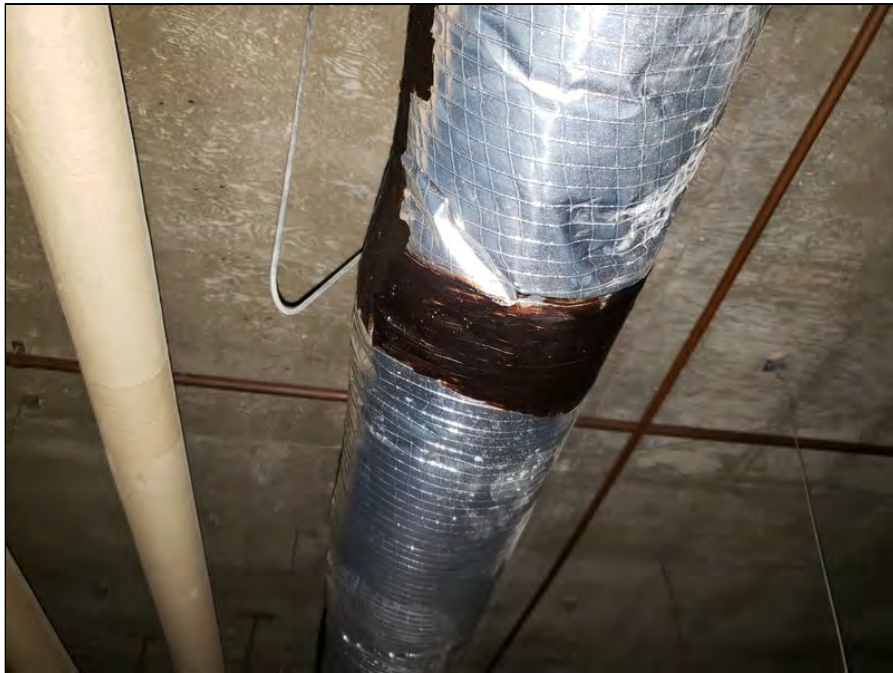
4 - Black Duct Mastic (ACM)

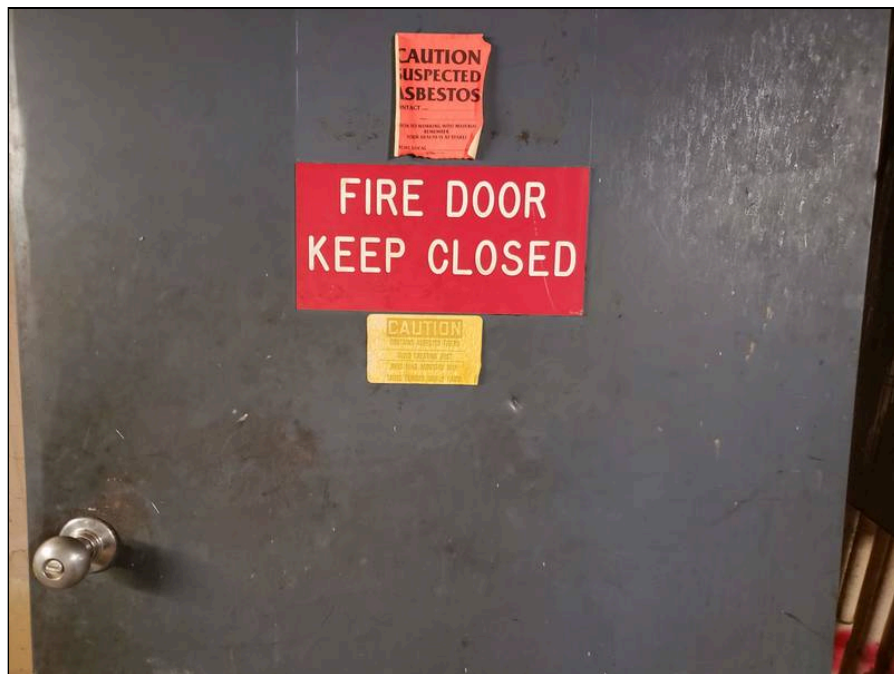
5 - Fire Door and Frame (Suspect ACM)

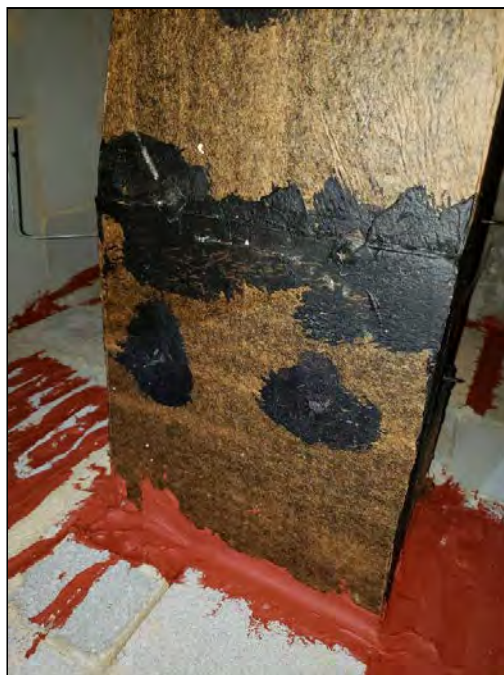
6 - Brown Fiber Duct Covering (ACM)

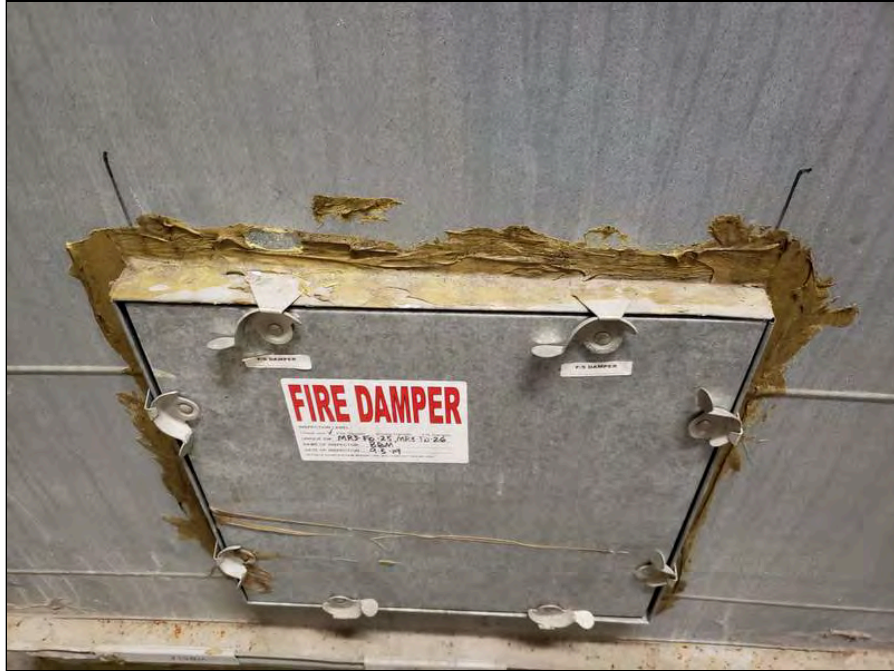
7 - Fire Damper (Suspect ACM)

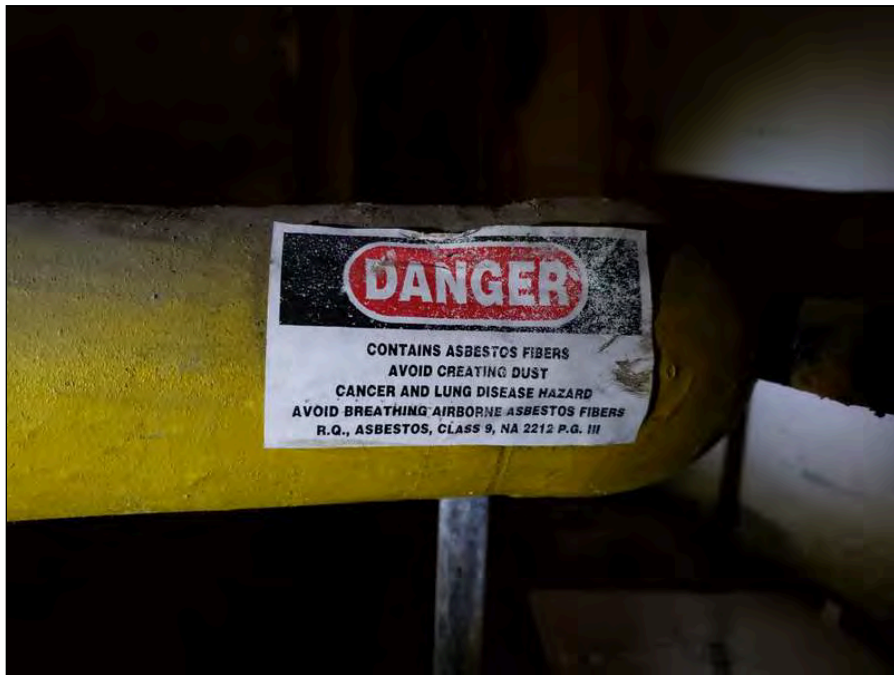
8 - Asbestos Labels Observed

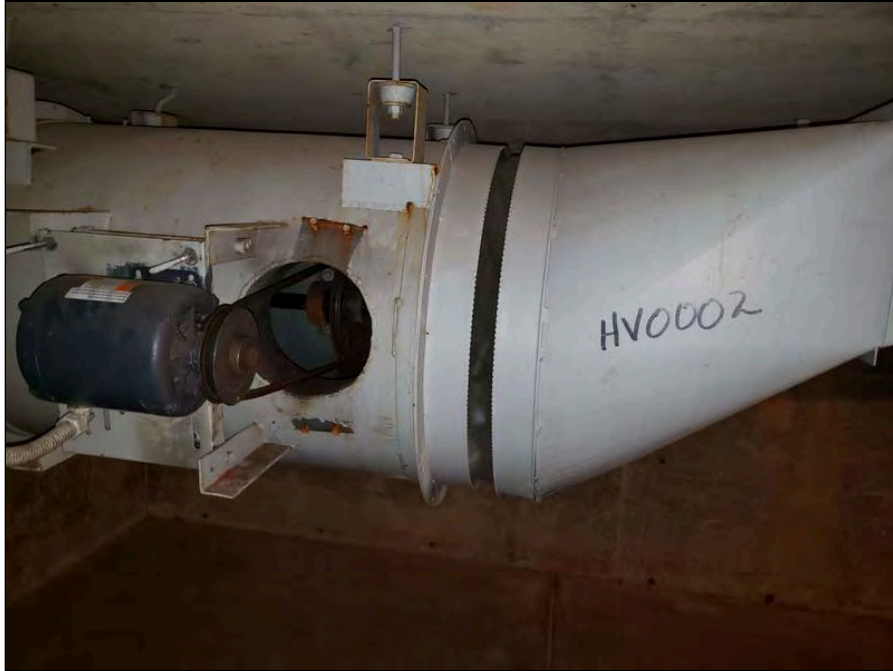
9 - Vibration Dampener (Suspect ACM)

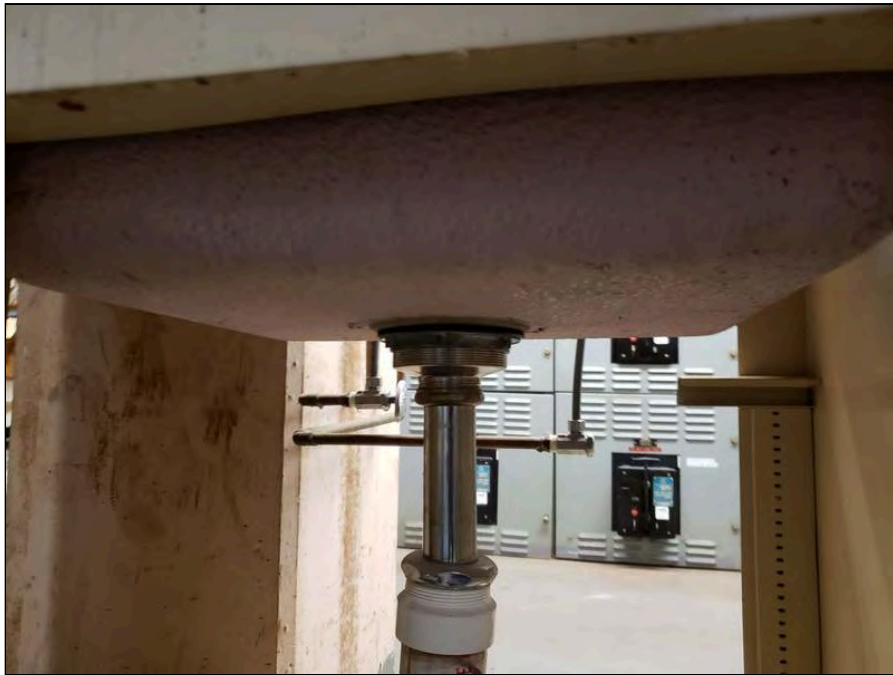
10 - Grey Sink Undercoat (ACM)

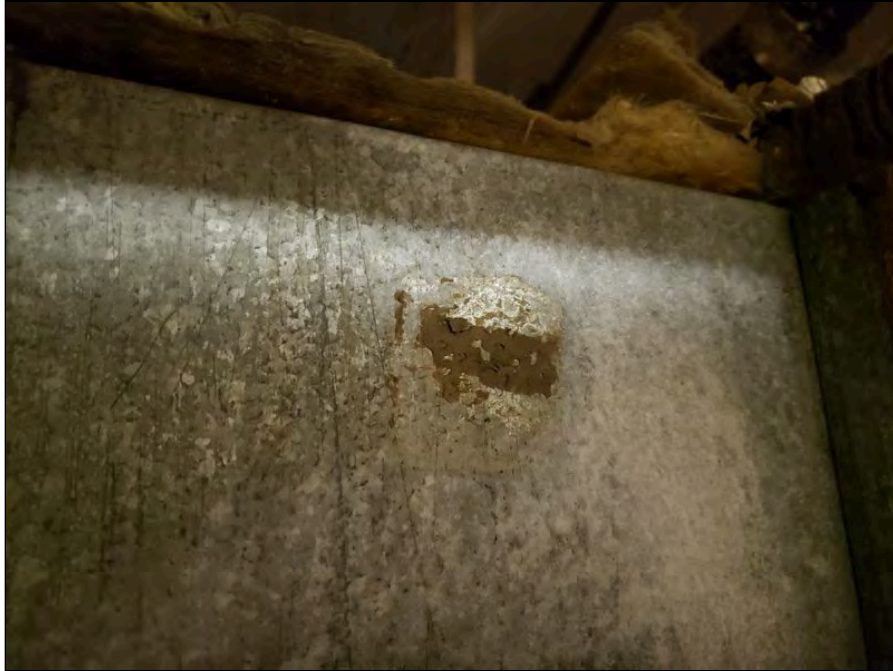
11 - Duct Pin Mastic (ACM)

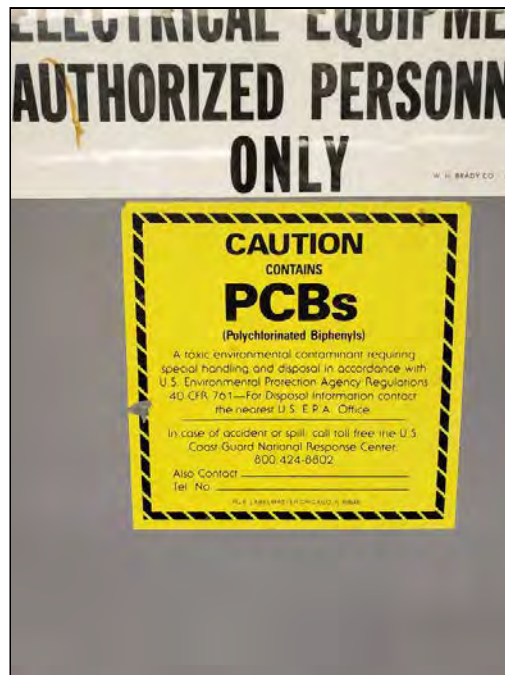
As part of our survey, ECS attempted to identify potential liquid PCB containing materials and equipment. At the time of the Hazardous Materials Survey, ECS visually observed several of the fluorescent light ballasts in accessible areas of the structure in an attempt to identify labeling indicating the presence/absence of PCB containing fluids. Labeling was not observed or accessible on the ballasts surveyed. At this time it is recommended that all ballasts be assumed to be suspect PCB containing. ECS observed signage on the electrical room door warning of PCB-containing equipment.

12 - PCB sign on electrical room

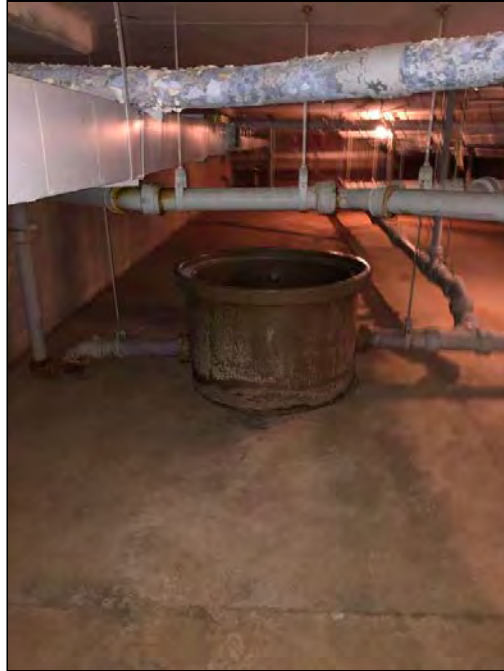
13 - Former chemical storage pool in the basement crawlspace

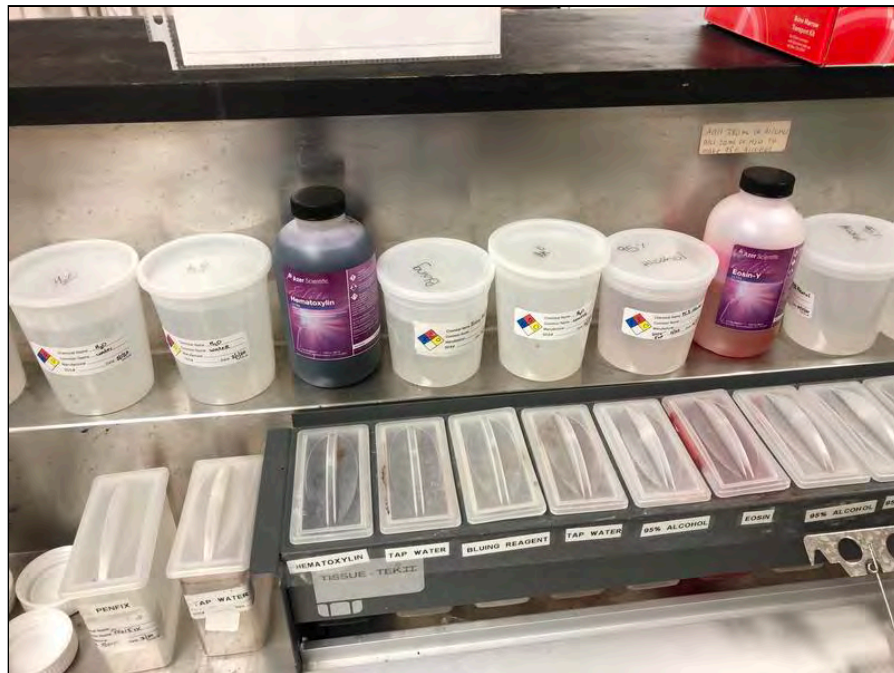
14 - Example of laboratory chemicals: stains in the histology lab

ECS recommends that departments properly remove and dispose of (or reuse) chemicals from the hospital as they abandon their work stations. Chemicals should be re-used, disposed of or recycled in accordance with State, Local, and Federal laws.

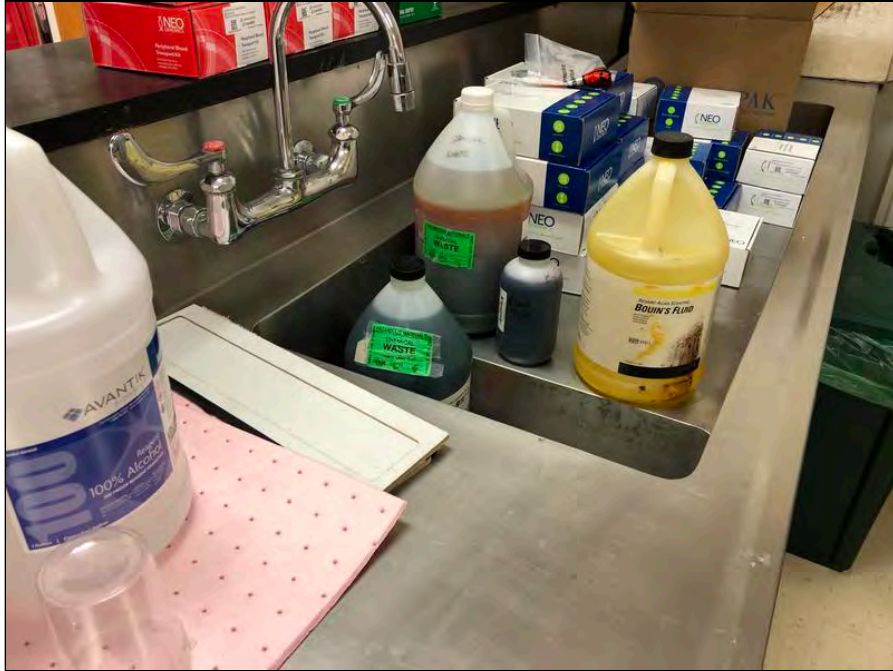
15 - Histology lab chemicals
