Annual NPDES MS4 Report

National Pollutant Discharge Elimination System Municipal Separate Storm Sewer Systems

2022 Annual Report

Prince George's County Government
Department of the Environment
Stormwater Management Division
1801 McCormick Drive, Suite 500
Largo, Maryland 20774

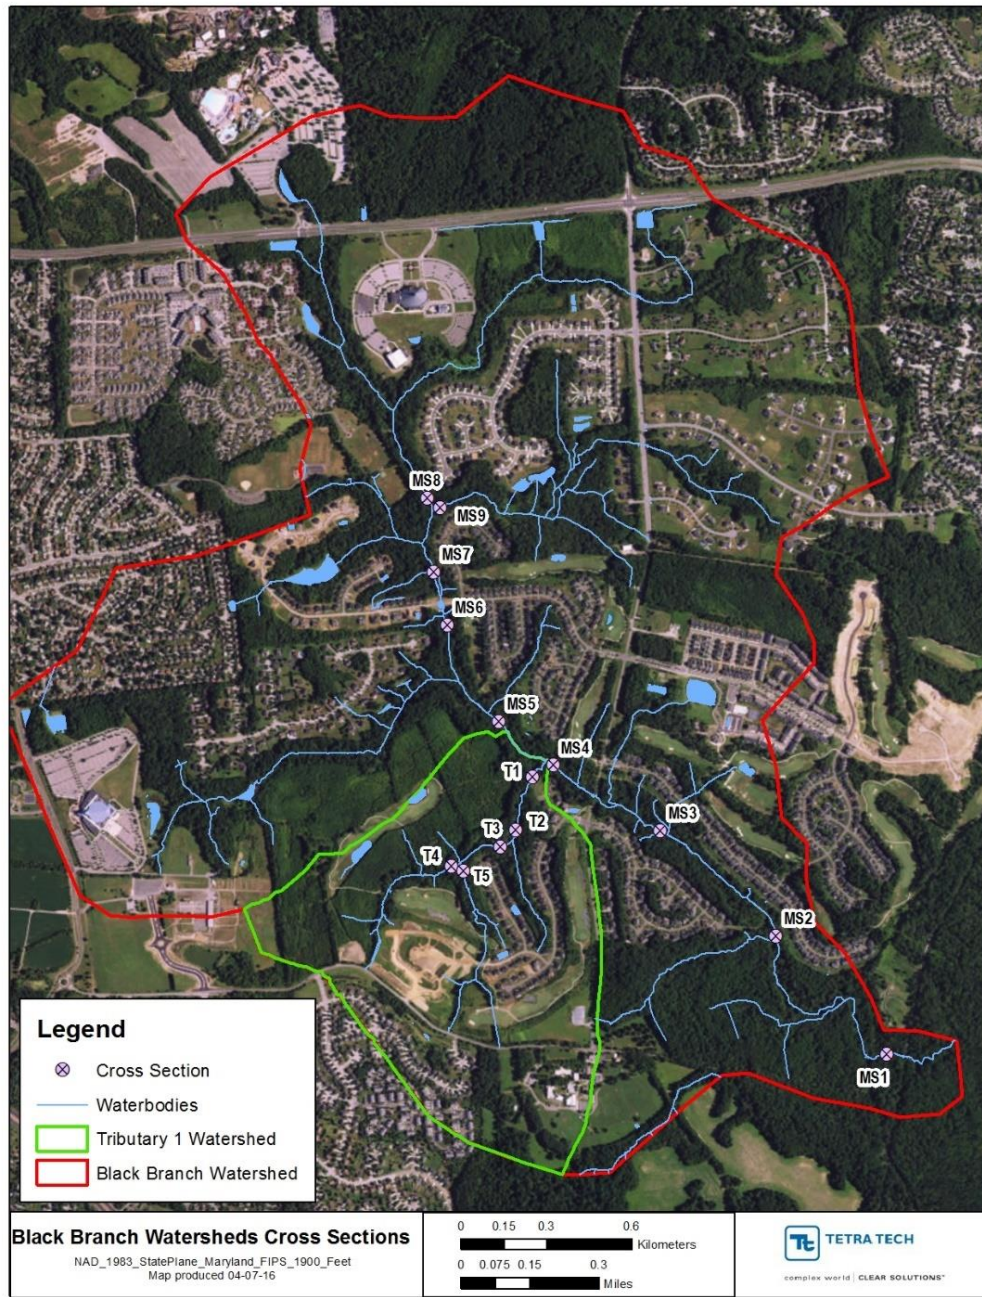
Figure F-2. Locations of Cross Sections in Black Branch and Tributary 1 Watersheds

Each year since 2001, the Black Branch watershed has been evaluated to determine whether there were any significant changes to the watershed's physical conditions since the baseline evaluation. For the FY 2022 report, the mainstem and Tributary 1 in the Black Branch watershed were evaluated in 2021 to determine whether any significant changes to the physical conditions of the BBW had occurred since they were last evaluated in 2019. The results are presented in the FY 2022 Black Branch Geomorphic Report with comparison to the base year of 2001. The report is provided on the DVD, under Assessment of Control\ Black Branch folder.

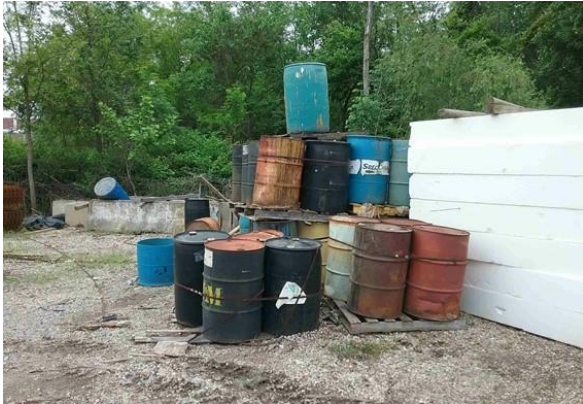
Improper storage of containers

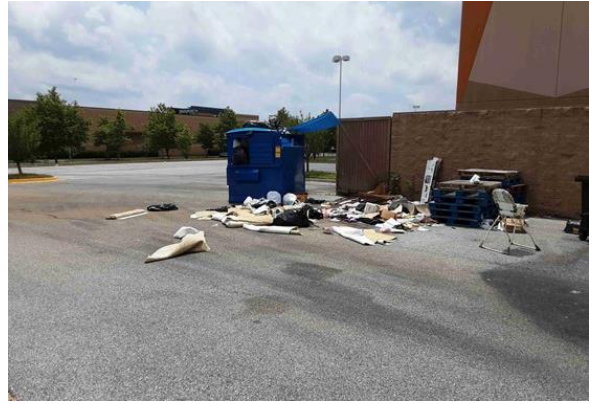
Trash and debris not disposed properly

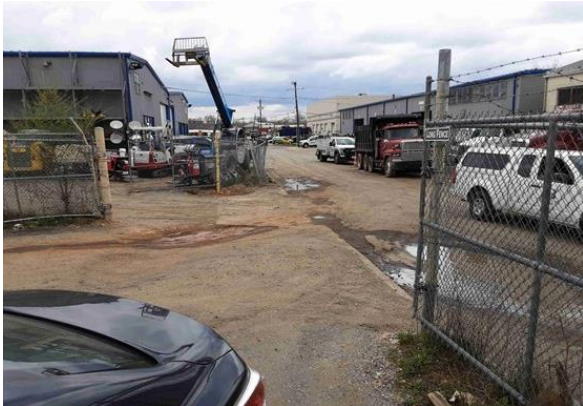
Sediment and sediment laden water entering storm drain system.

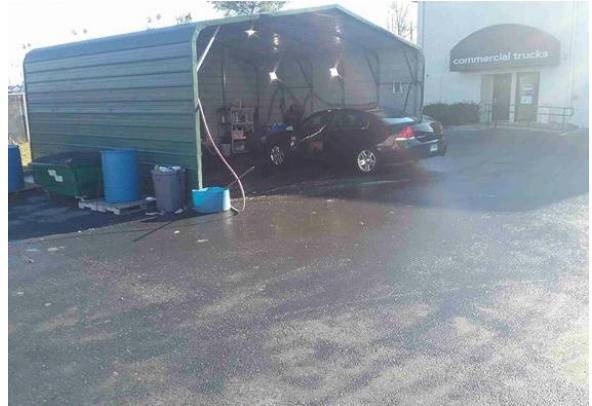
Vehicle washing with no water containment mat with a reclamation system

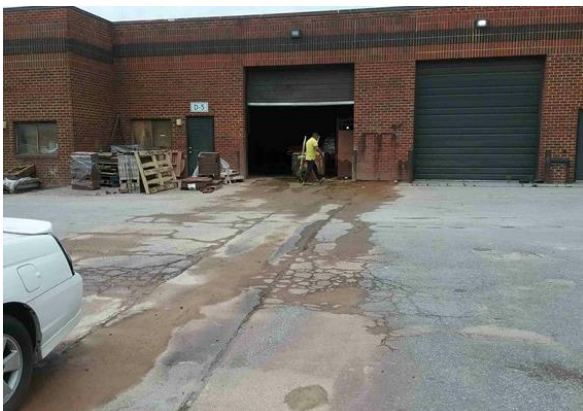
Runoff from commercial activity

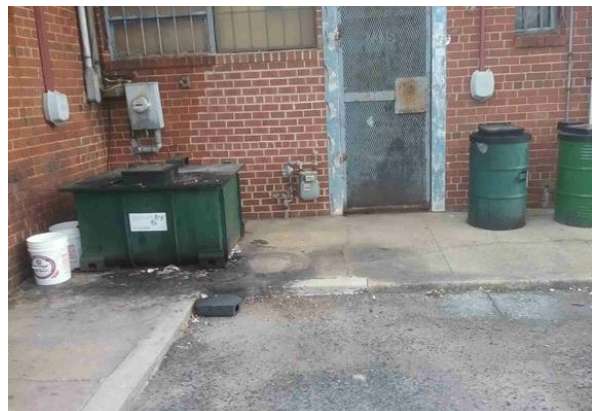
Grease container spillage

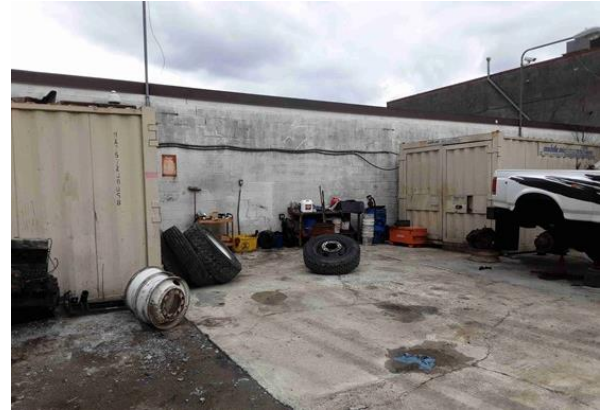
Vehicle repairs & spillage of automobile fluids
