# ACCESSIBILITY ASSESSMENT

145366.21R000-009.160

July 14, 2021

Housing Authority of Prince George's County - Administrative Office  
9200 Basil Court  
Largo, Maryland 20774

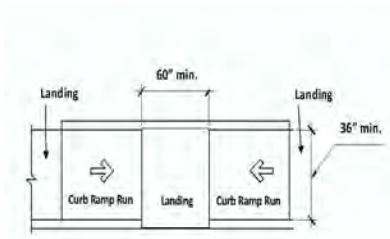
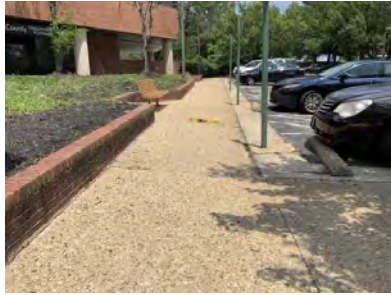
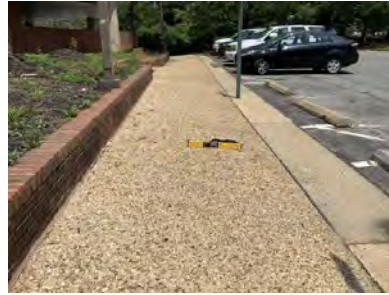
<b>Assembly</b>	Exterior Access Route
<b>Type</b>	Exterior Accessible Route
<b>ADA Standard</b>	403.3
<b>Barrier Detail</b>	The accessible route has cross slopes greater than 1:50 (2%).
<b>Location Description</b>	Curb Ramp CR1
<b>Observed</b>	Jun 14, 2021 by Ouraccessibleworld@gmail.com

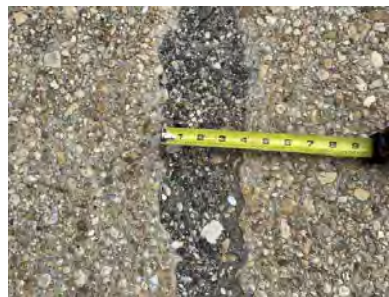
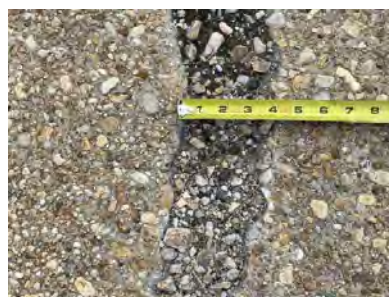
Photos for Barrier ID: AX240545

Assembly	Exterior Access Route
Type	Exterior Accessible Route
ADA Standard	302.3
Barrier Detail	The accessible route has gaps in the surface greater than 1/2" wide.
Location Description	From Accessible Parking Spaces P6 through 14 to Entrance
Observed	Jun 14, 2021 by Ouraccessibleworld@gmail.com
Site Conditions	There are gaps in the surface up to 4" wide.

Repair the accessible route to eliminate openings in the surface greater than 1/2" wide. This barrier must be removed in conjunction with barrier ID 240546. The cost of this barrier removal is covered under ID 240546 and therefore, the cost of this ID is shown as \$0. Openings in the ground surface of the accessible route shall not allow passage of a sphere more than 1/2" diameter. Elongated openings shall be placed so that the long dimension is perpendicular to the dominant direction of travel.

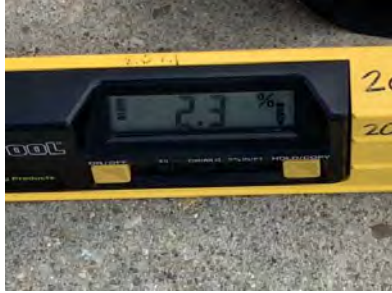
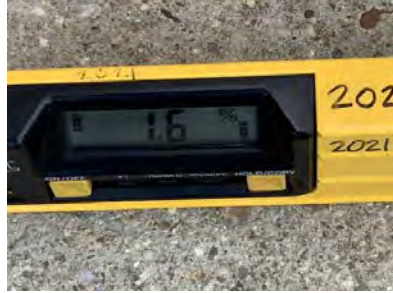
<b>Assembly</b>	Exterior Access Route
<b>Type</b>	Exterior Accessible Route
<b>ADA Standard</b>	403.3
<b>Barrier Detail</b>	The accessible route has cross slopes greater than 1:50 (2%).
<b>Location Description</b>	From Accessible Parking Spaces P6 through 14 to Entrance
<b>Observed</b>	Jun 14, 2021 by Ouraccessibleworld@gmail.com

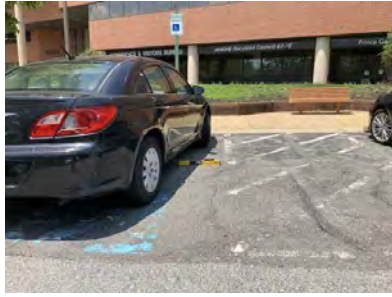
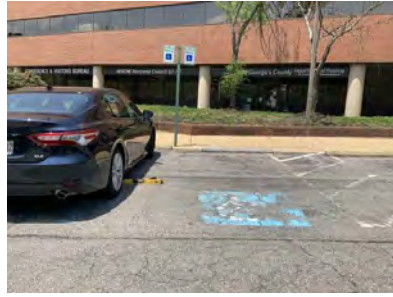
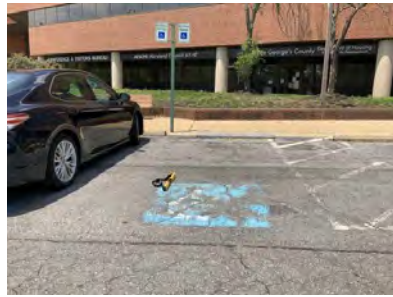
<b>Assembly</b>	Accessible Parking
<b>Type</b>	Parking Space-Car
<b>ADA Standard</b>	State of MD 05.07.D (2)(a)and (b),(3) & (6)
<b>Barrier Detail</b>	MARYLAND: Compliant signage is not provided at the space.
<b>Location Description</b>	Parking Lot 1 - Accessible Parking Spaces P1, P2, P3 and P4
<b>Observed</b>	Jun 14, 2021 by Ouraccessibleworld@gmail.com

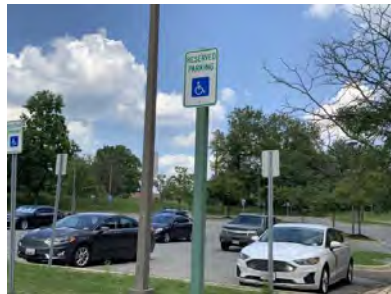
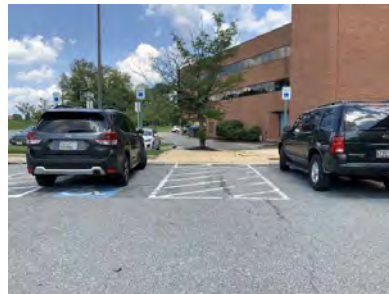
Photos for Barrier ID: AX240549

<b>Site Conditions</b>	"No Parking in Access Aisle" signage is not provided at the access aisle.
------------------------	---

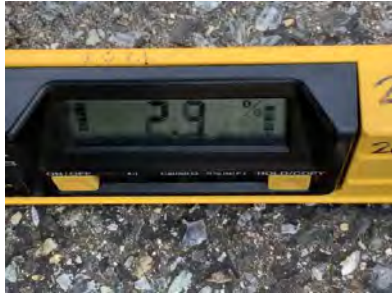
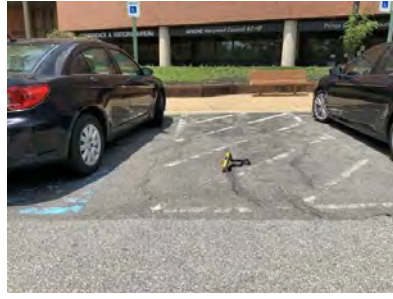
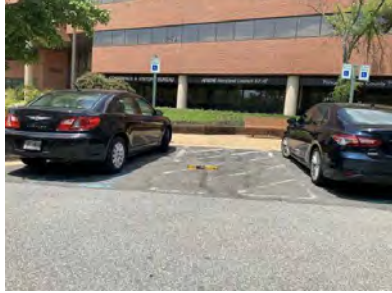
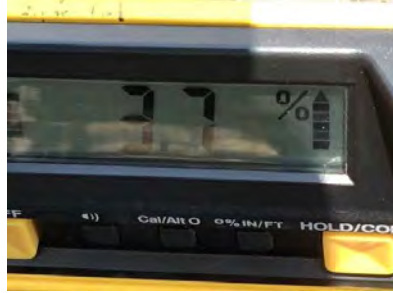
<b>Assembly</b>	Accessible Parking
<b>Type</b>	Parking Space-Van
<b>ADA Standard</b>	502.4
<b>Barrier Detail</b>	The access aisle slope is greater than 1:50 (2%).
<b>Location Description</b>	Parking Lot 1 Access Aisle at Accessible Parking Space P5
<b>Observed</b>	Jun 14, 2021 by Ouraccessibleworld@gmail.com
<b>Site Conditions</b>	The van access aisle has a running slope of up to 3.7%.

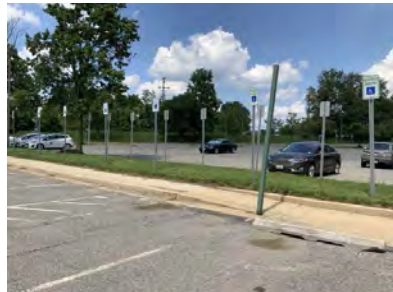
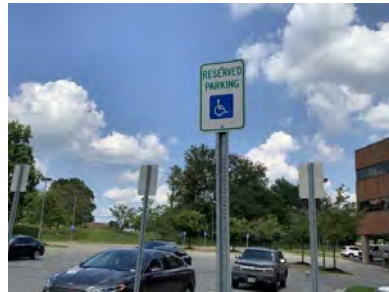
Photos for Barrier ID: AX240544

<b>Assembly</b>	Accessible Parking
<b>Type</b>	Parking Space-Car
<b>ADA Standard</b>	State of MD 05.07.D (2)(a)and (b),(3) & (6)
<b>Barrier Detail</b>	MARYLAND: Compliant signage is not provided at the space.
<b>Location Description</b>	Parking Lot 1 Accessible Parking Spaces P6, P7, P8, P9, P10, P11 and P12
<b>Observed</b>	Jun 14, 2021 by Ouraccessibleworld@gmail.com
<b>Site Conditions</b>	The signage does not contain the fine information.

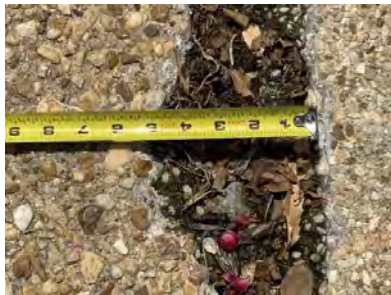
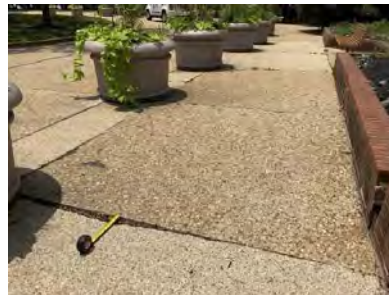
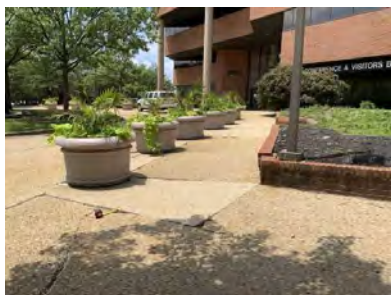
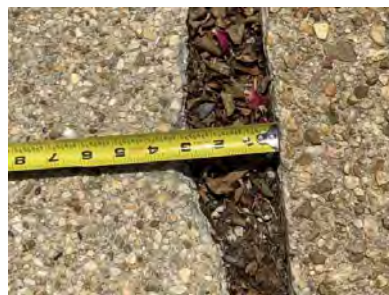
Photos for Barrier ID: AX240486

Assembly	Exterior Access Route
Type	Exterior Accessible Route
ADA Standard	302.3
Barrier Detail	The accessible route has gaps in the surface greater than 1/2" wide.
Location Description	Sidewalk from Curb Ramp CR1 to Main Entrance
Observed	Jun 14, 2021 by Ouraccessibleworld@gmail.com

Repair the accessible route to eliminate openings in the surface greater than 1/2" wide. Openings in the ground surface of the accessible route shall not allow passage of a sphere more than 1/2" diameter. Elongated openings shall be placed so that the long dimension is perpendicular to the dominant direction of travel.

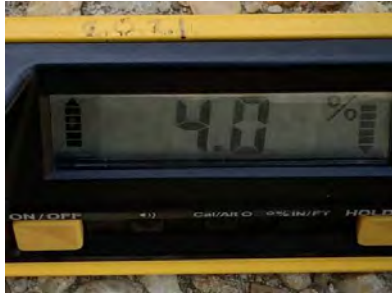
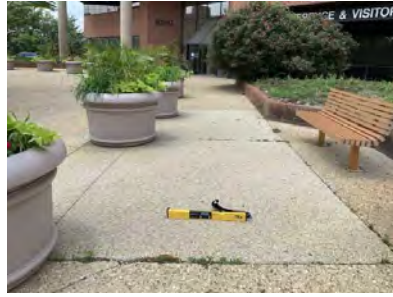
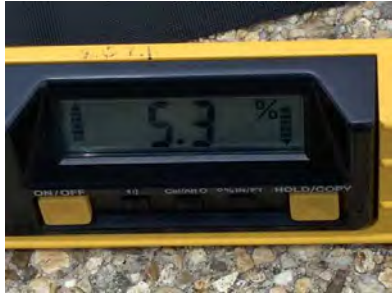
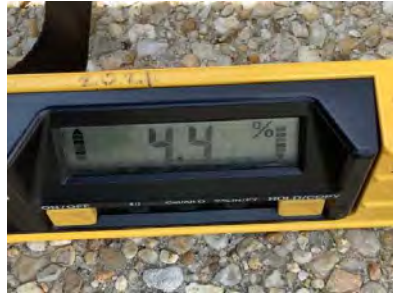
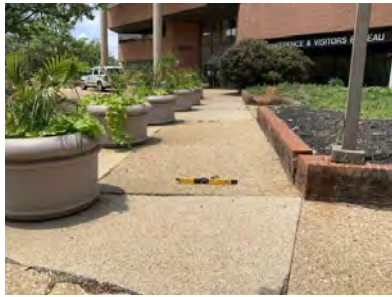
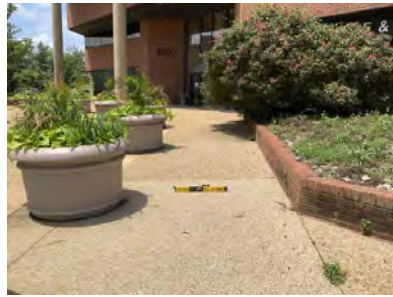
Assembly	Exterior Access Route
Type	Exterior Accessible Route
ADA Standard	403.3
Barrier Detail	The accessible route has cross slopes greater than 1:50 (2%).
Location Description	Sidewalk from Curb Ramp CR1 to Main Entrance
Observed	Jun 14, 2021 by Ouraccessibleworld@gmail.com

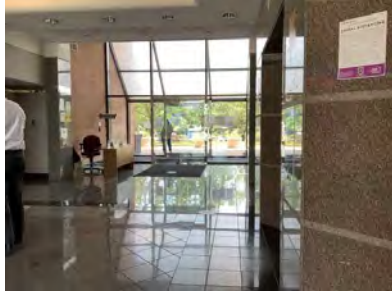
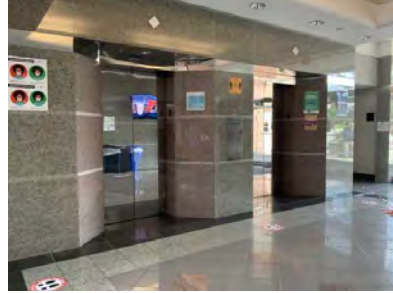
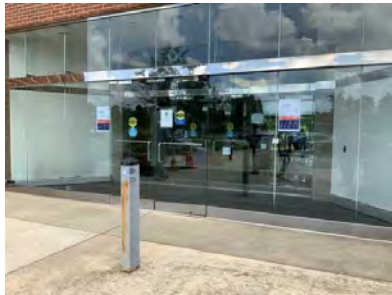
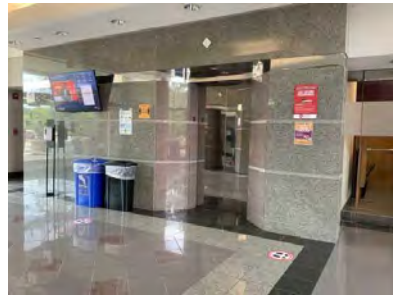
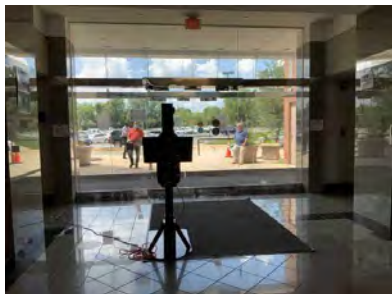
### Photos for Barrier ID: AX240536

<b>Assembly</b>	Amenity Not Evaluated
<b>Type</b>	Amenity Not Evaluated
<b>ADA Standard</b>	None
<b>Barrier Detail</b>	The amenity was not in working order and, therefore, cannot be evaluated.
<b>Location Description</b>	1st Floor Lobby
<b>Observed</b>	Jun 14, 2021 by Ouraccessibleworld@gmail.com
<b>Site Conditions</b>	The automatic openers were not operational at the inspection.

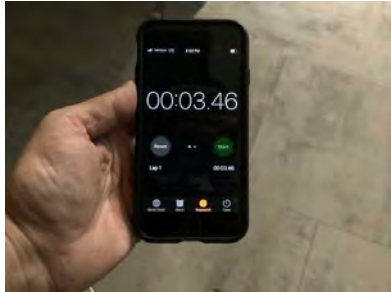
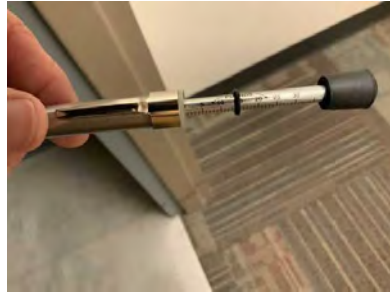
**Photos for Barrier ID: AX240528**

<b>Location Description</b>	1st Floor Conference Room Hallway Entrance
<b>Observed</b>	Jun 14, 2021 by Ouraccessibleworld@gmail.com

Adjust closer or remove and replace closer to ensure that the door has a closure time of at least 5 seconds within 12 degrees of the latch and that requires no more than 5 pounds of force for pushing or pulling the door open. Door closers and gate closers shall be adjusted so that from an open position of 90 degrees, the time required to move the door to a position of 12 degrees from the latch is 5 seconds minimum. The force at the latch, the force to set the door in motion, and the force to fully open the door shall be maximum 5 pounds. These forces do not apply to the force required to retract latch bolts or disengage other devices that hold the door or gate in a closed position.

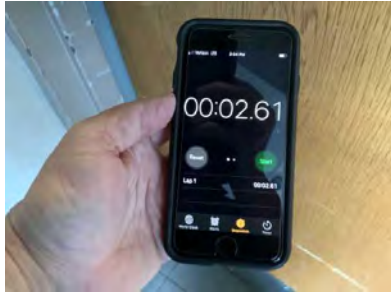
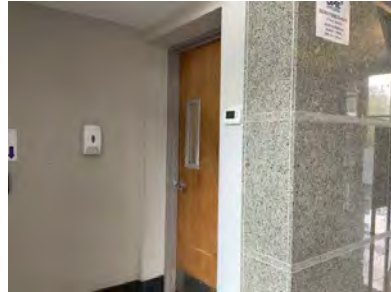
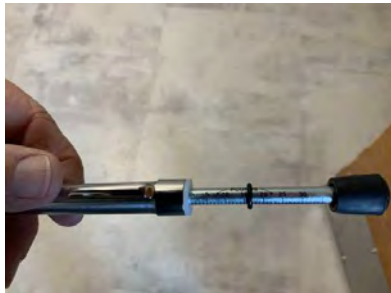
### Photos for Barrier ID: AX240534

<b>Location Description</b>	1st Floor Lobby
<b>Observed</b>	Jun 14, 2021 by Ouraccessibleworld@gmail.com

Adjust closer or remove and replace closer to ensure that the door has a closure time of at least 5 seconds within 12 degrees of the latch and that requires no more than 5 pounds of force for pushing or pulling the door open. Door closers and gate closers shall be adjusted so that from an open position of 90 degrees, the time required to move the door to a position of 12 degrees from the latch is 5 seconds minimum. The force at the latch, the force to set the door in motion, and the force to fully open the door shall be maximum 5 pounds. These forces do not apply to the force required to retract latch bolts or disengage other devices that hold the door or gate in a closed position.

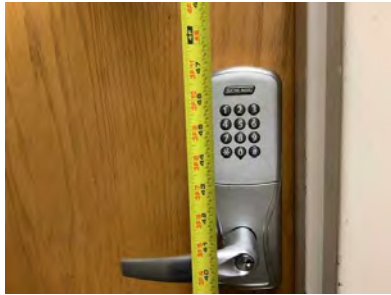
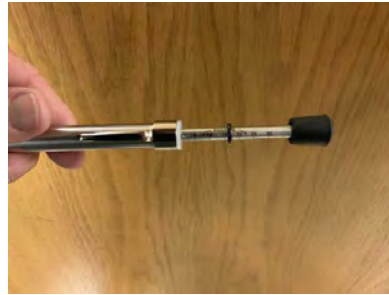
### Photos for Barrier ID: AX240518

<b>Location Description</b>	2nd Floor Breakroom
<b>Observed</b>	Jun 14, 2021 by Ouraccessibleworld@gmail.com
<b>Site Conditions</b>	The door to the breakroom requires up to 16 pounds of force to operate.

Adjust the closer or replace with a door that requires no more than 5 pounds of force for pushing or pulling the door open. The force at the latch, the force to set the door in motion, and the force to fully open the door shall be maximum 5 pounds. These forces do not apply to the force required to retract latch bolts or disengage other devices that hold the door or gate in a closed position.

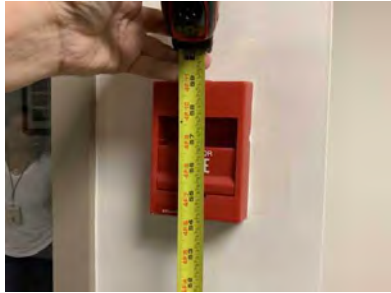
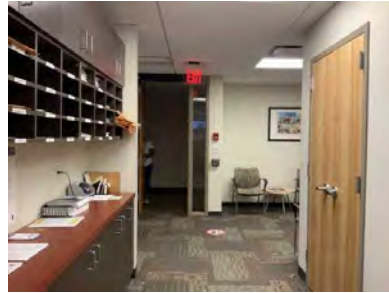
### Photos for Barrier ID: AX240505

<b>Assembly</b>	Interior Access Route
<b>Type</b>	Controls And Dispensers
<b>ADA Standard</b>	308
<b>Barrier Detail</b>	The height of controls throughout the common area are not compliant.
<b>Location Description</b>	3rd Floor Breakroom
<b>Observed</b>	Jun 14, 2021 by Ouraccessibleworld@gmail.com
<b>Site Conditions</b>	The fire alarm pull is mounted at 57" above the floor.

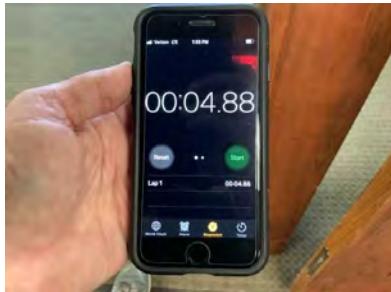
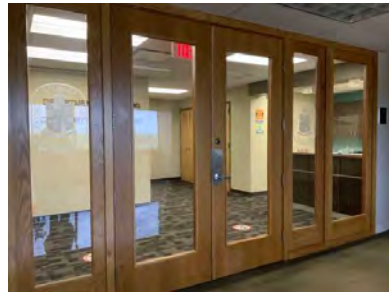
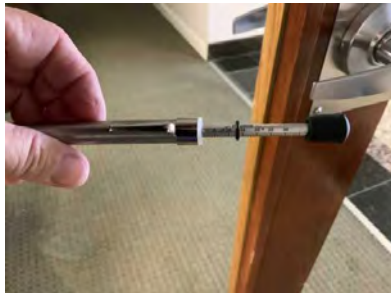
**Photos for Barrier ID: AX240503**

<b>Location Description</b>	5th Floor Office
<b>Observed</b>	Jun 14, 2021 by Ouraccessibleworld@gmail.com

Adjust closer or remove and replace closer to ensure that the door has a closure time of at least 5 seconds within 12 degrees of the latch and that requires no more than 5 pounds of force for pushing or pulling the door open. Door closers and gate closers shall be adjusted so that from an open position of 90 degrees, the time required to move the door to a position of 12 degrees from the latch is 5 seconds minimum. The force at the latch, the force to set the door in motion, and the force to fully open the door shall be maximum 5 pounds. These forces do not apply to the force required to retract latch bolts or disengage other devices that hold the door or gate in a closed position.

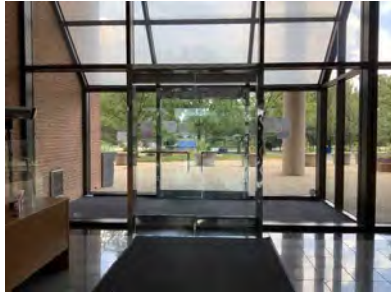
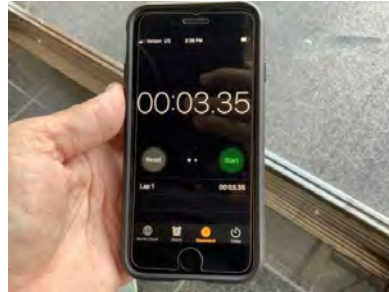
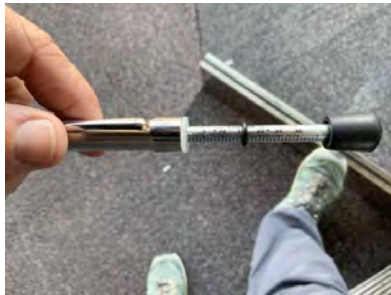
**Photos for Barrier ID: AX240535**

<b>Location Description</b>	Main Entrance
<b>Observed</b>	Jun 14, 2021 by Ouraccessibleworld@gmail.com

Adjust closer or remove and replace closer to ensure that the door has a closure time of at least 5 seconds within 12 degrees of the latch and that requires no more than 5 pounds of force for pushing or pulling the door open. Door closers and gate closers shall be adjusted so that from an open position of 90 degrees, the time required to move the door to a position of 12 degrees from the latch is 5 seconds minimum. The force at the latch, the force to set the door in motion, and the force to fully open the door shall be maximum 5 pounds. These forces do not apply to the force required to retract latch bolts or disengage other devices that hold the door or gate in a closed position.

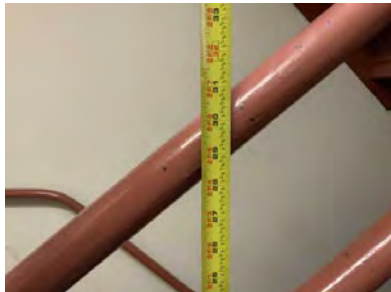
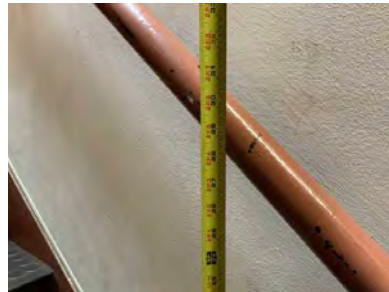
### Photos for Barrier ID: AX240498

<b>Assembly</b>	Interior Access Route
<b>Type</b>	Stairs
<b>ADA Standard</b>	505
<b>Barrier Detail</b>	Handrails are not compliant.
<b>Location Description</b>	Stairwell 2
<b>Observed</b>	Jun 14, 2021 by Ouraccessibleworld@gmail.com

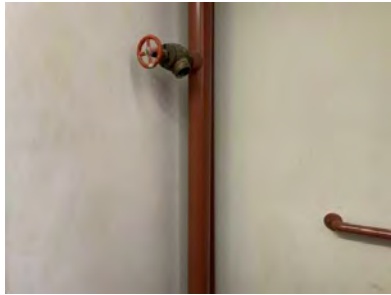
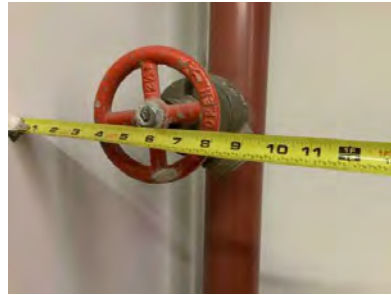
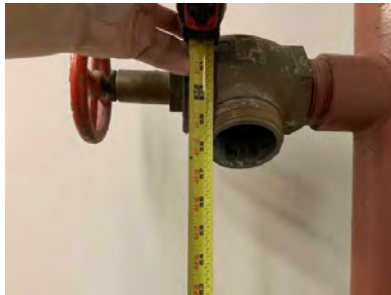
**Photos for Barrier ID: AX240499**

<b>Location Description</b>	Stairwell 2
<b>Observed</b>	Jun 14, 2021 by Ouraccessibleworld@gmail.com
<b>Site Conditions</b>	The standpipe projects into 8" the accessible route at 57" above the floor.

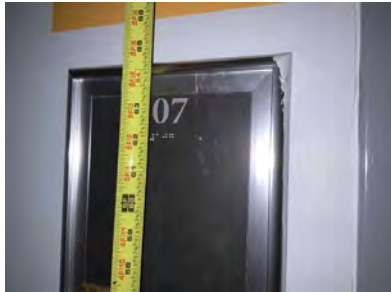
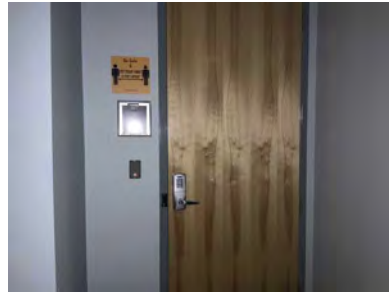
**Photos for Barrier ID: AX240529**

<b>Location Description</b>	1st Floor Conference Room Hallway Entrance
<b>Observed</b>	Jun 14, 2021 by Ouraccessibleworld@gmail.com

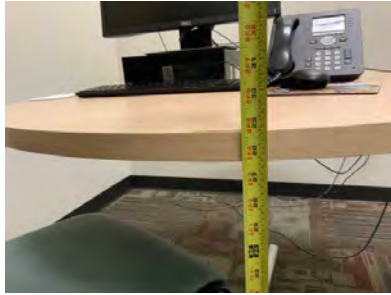
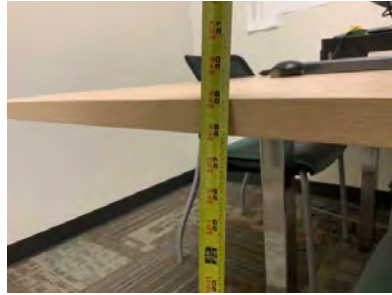
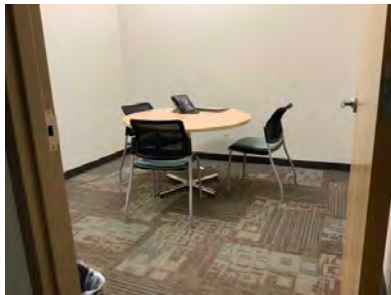
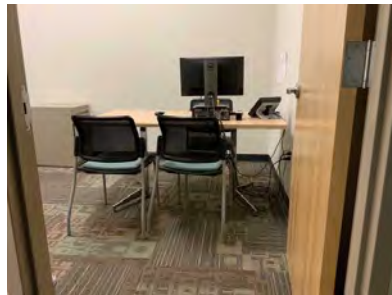
**Photos for Barrier ID: AX240527**

**Observed** Jun 14, 2021 by Ouraccessibleworld@gmail.com

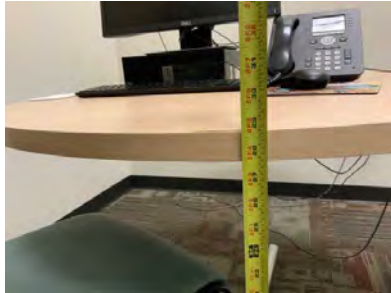
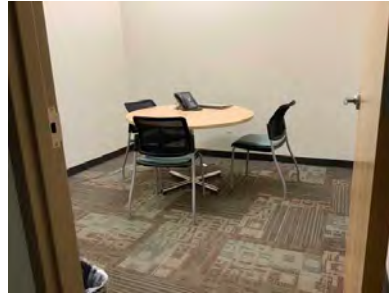
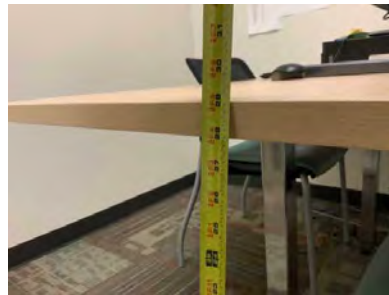
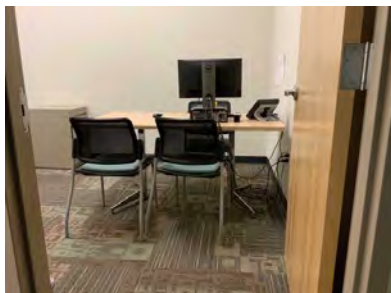
**Photos for Barrier ID: AX242898**

<b>Location Description</b>	1st Floor Conference Rooms
<b>Observed</b>	Jun 14, 2021 by Ouraccessibleworld@gmail.com

Remove and replace signage with compliant signage. The International Symbol of Accessibility shall be compliant. The International Symbol of Accessibility must be used to identify accessible elements, where not all elements of the same type are accessible.

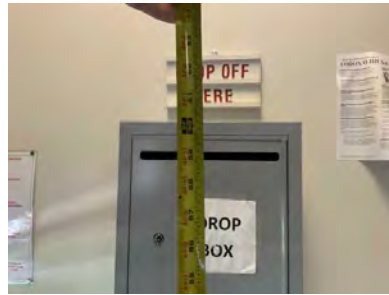
**Photos for Barrier ID: AX240524**

<b>Assembly</b>	Interior Access Route
<b>Type</b>	Reach Range
<b>ADA Standard</b>	308, 309

<b>Location Description</b>	1st Floor Lobby
<b>Observed</b>	Jun 14, 2021 by Ouraccessibleworld@gmail.com
<b>Site Conditions</b>	The drop box slot is mounted at 58" above the floor.

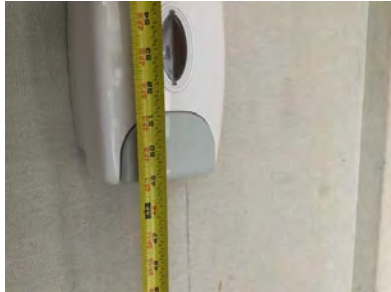
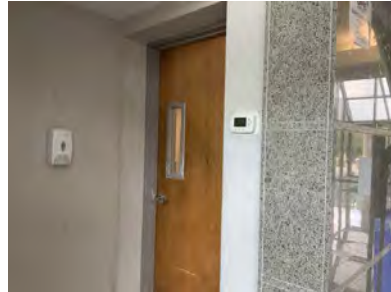
### Photos for Barrier ID: AX240532

<b>Assembly</b>	Interior Access Route
<b>Type</b>	Reach Range
<b>ADA Standard</b>	308
<b>Barrier Detail</b>	Items that require a forward reach motion require more than 48" height reach.
<b>Location Description</b>	1st Floor Lobby
<b>Observed</b>	Jun 14, 2021 by Ouraccessibleworld@gmail.com
<b>Site Conditions</b>	The operable part of the hand sanitizer dispenser is 49" above the floor.

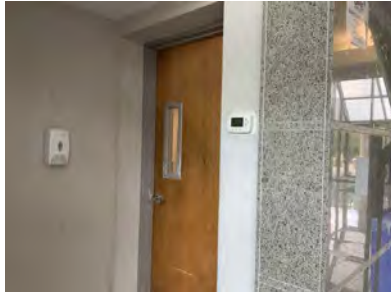
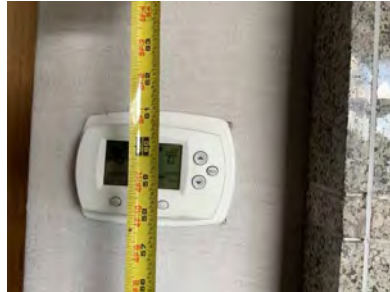
### Photos for Barrier ID: AX241134

<b>Assembly</b>	Interior Access Route
<b>Type</b>	Reach Range
<b>ADA Standard</b>	308
<b>Barrier Detail</b>	Items that require a forward reach motion require more than 48" height reach.
<b>Location Description</b>	1st Floor Lobby
<b>Observed</b>	Jun 14, 2021 by Ouraccessibleworld@gmail.com
<b>Site Conditions</b>	The thermostat controls are 58-1/4" to 59-3/4" above the floor.

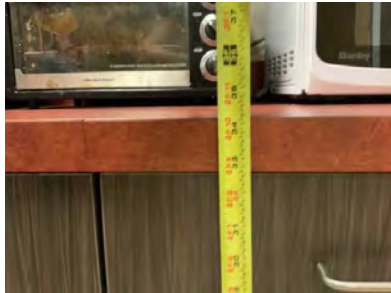
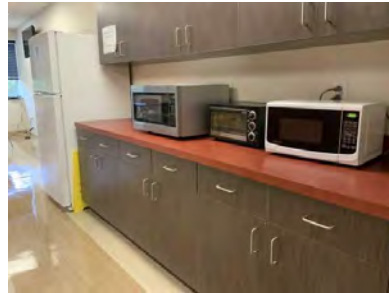
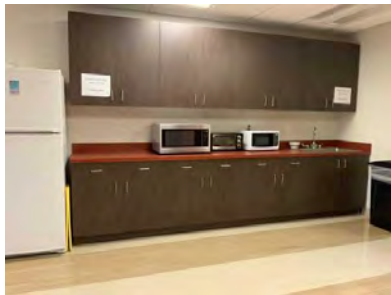
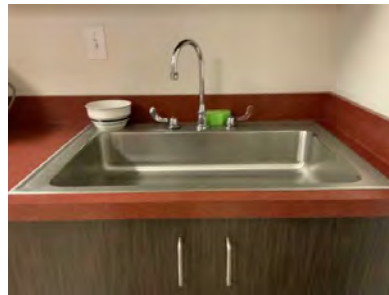
### Photos for Barrier ID: AX240517

<b>Assembly</b>	Kitchen
<b>Type</b>	Kitchen-Residential And Employee-Only Counter
<b>ADA Standard</b>	804.3
<b>Barrier Detail</b>	The height of the counter is greater than 34".
<b>Location Description</b>	2nd Floor Breakroom
<b>Observed</b>	Jun 14, 2021 by Ouraccessibleworld@gmail.com
<b>Site Conditions</b>	The top of the countertop at the breakroom is 34-1/4" above the floor.

Modify or replace counter to provide a minimum 30" section with maximum height 34" with knee and toe clearance. [EXCEPTION: A counter that is adjustable to provide a kitchen work surface at variable heights 29" minimum to 36" maximum shall be permitted.] The work surface shall have knee and toe clearance. [EXCEPTION: Cabinetry shall be permitted under the kitchen work surface provided that (a) cabinetry can be removed with removal or replacement of the kitchen work surface, (b) the finish floor extends under the cabinetry, and (c) the walls behind and surround the cabinetry are finished.] Space under an element between 9" and 27" above the finish floor or ground shall be considered knee clearance and shall comply. Knee clearance shall extend 25" maximum under an element at 9" above the finish floor or ground. Where knee clearance is required under an element as part of a clear floor space, the knee clearance shall be 11" deep minimum at 9" above the finish floor or ground, and 8" deep minimum at 27" above the finish floor or ground. Between 9" and 27" above the finish floor or ground, the knee clearance shall be permitted to reduce at a rate of 1" in depth for each 6" in height. Knee and toe clearance shall be 30" wide minimum.

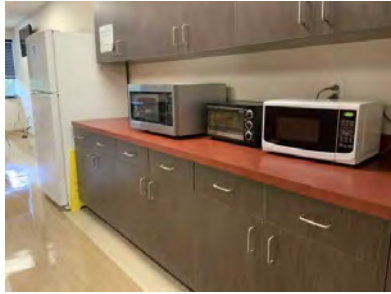
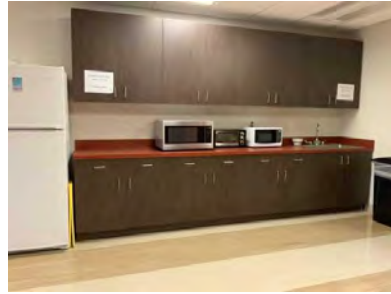
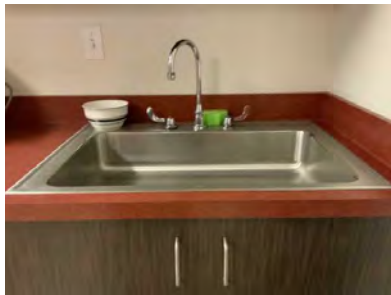
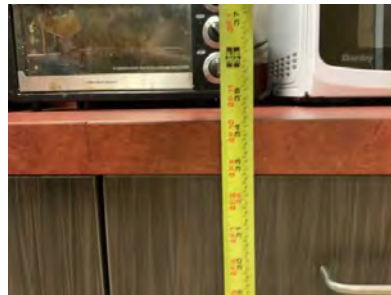
**Photos for Barrier ID: AX241380**

<b>Location Description</b>	2nd Floor Breakroom
<b>Observed</b>	Jun 14, 2021 by Ouraccessibleworld@gmail.com
<b>Site Conditions</b>	The top of the sink rim is 34-1/4" above the floor.

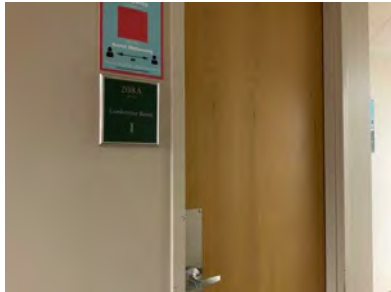
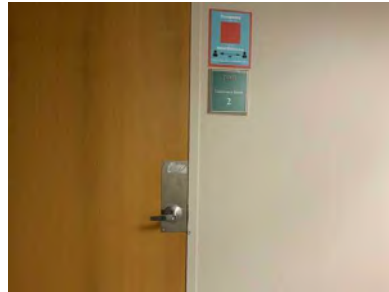
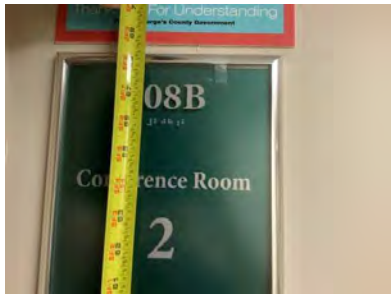
### Photos for Barrier ID: AX240519

<b>Location Description</b>	2nd Floor Conference
<b>Observed</b>	Jun 14, 2021 by Ouraccessibleworld@gmail.com

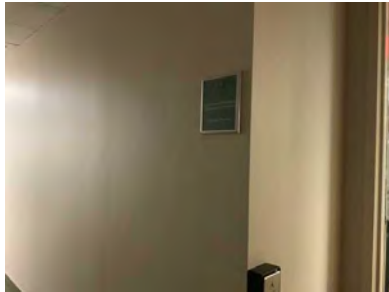
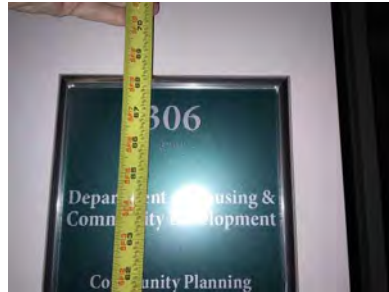
### Photos for Barrier ID: AX240506

<b>Location Description</b>	3rd Floor Breakroom
<b>Observed</b>	Jun 14, 2021 by Ouraccessibleworld@gmail.com

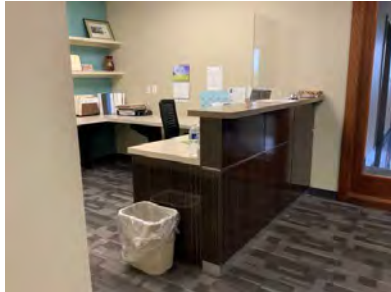
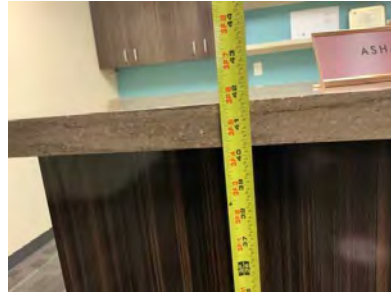
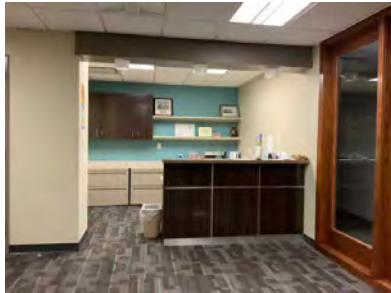
**Photos for Barrier ID: AX240500**

<b>Location Description</b>	5th Floor Office
<b>Observed</b>	Jun 14, 2021 by Ouraccessibleworld@gmail.com

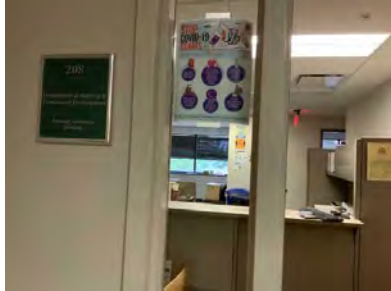
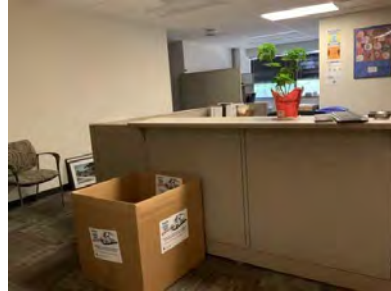
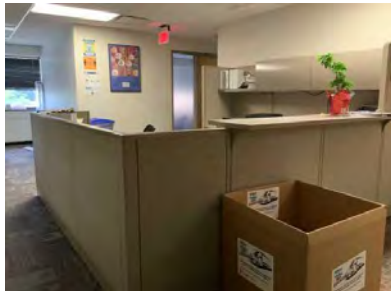
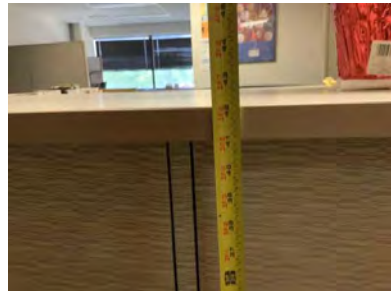
### Photos for Barrier ID: AX240520

<b>Location Description</b>	Room 208 - Housing Assistance
<b>Observed</b>	Jun 14, 2021 by Ouraccessibleworld@gmail.com
<b>Site Conditions</b>	The top of the service counter is 42" above the floor.

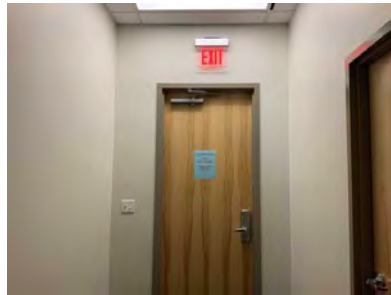
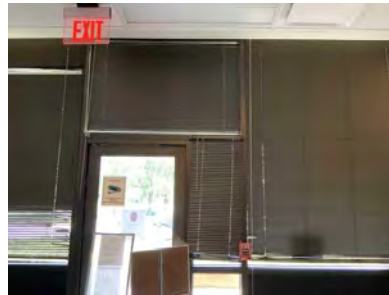
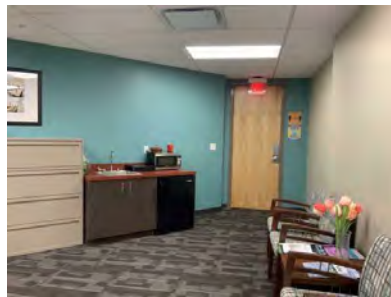
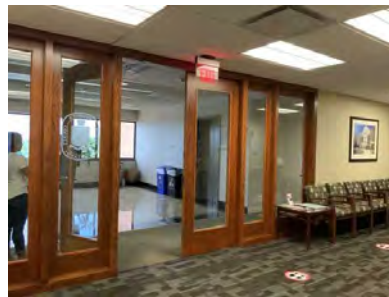
### Photos for Barrier ID: AX240502

<b>Assembly</b>	Interior Access Route
<b>Type</b>	Signage
<b>ADA Standard</b>	216.4, 703.1, 703.4
<b>Barrier Detail</b>	Means of egress signage is not provided.
<b>Location Description</b>	Throughout the Building
<b>Observed</b>	Jun 14, 2021 by Ouraccessibleworld@gmail.com
<b>Site Conditions</b>	Means of egress signage with tactile characters is not provided at the exits.

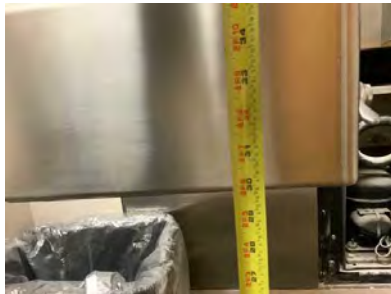
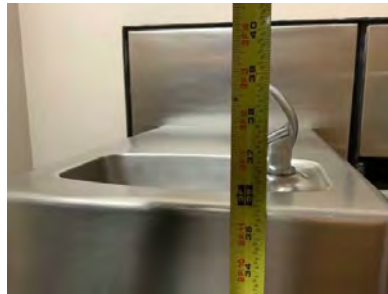
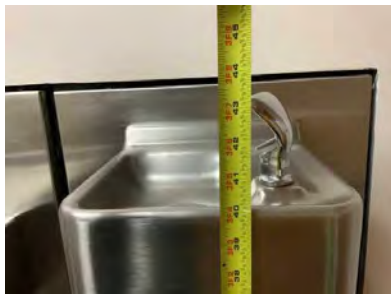
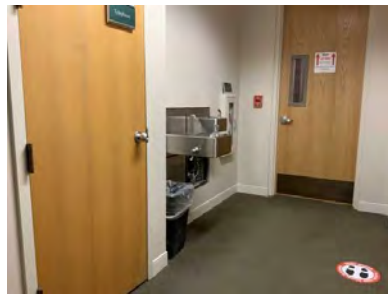
### Photos for Barrier ID: AX240488

<b>Location Description</b>	2nd, 3rd and 5th Floor
<b>Observed</b>	Jun 14, 2021 by Ouraccessibleworld@gmail.com
<b>Site Conditions</b>	The drinking fountain is mounted with the low fountain at 38" to the spout.

Replace the lower level/wheelchair height drinking fountain to ensure that the spout height is no higher than 36" maximum measured from the finish floor or ground to the spout outlet, and provide knee and toe clearance unless the exception applies. Spout outlets shall be 36" maximum above the finish floor or ground, 15" minimum from vertical support, and 5" maximum from front edge. [EXCEPTION: A parallel approach is permitted at units for children's use where the spout is 30" maximum above finish floor or ground and is 3-1/2" maximum from the front edge of the unit, including bumpers.] Knee Clearance: Space under an element between 9" and 27" above the finish floor or ground shall be considered knee clearance. Knee clearance shall extend 25" maximum under an element at 9" above the finish floor or ground. Where knee clearance is required under an element as part of a clear floor space, the knee clearance shall be 11" deep minimum at 9" above the finish floor or ground, and 8" deep minimum at 27" above the finish floor or ground. Between 9" and 27" above the finish floor or ground, the knee clearance shall be permitted to reduce at a rate of 1" in depth for each 6" in height. Knee clearance shall be 30" wide minimum. Toe Clearance: Space under an element between the finish floor or ground and 9" above the finish floor or ground shall be considered toe clearance. Toe clearance shall extend 25" maximum under an element. Where toe clearance is required at an element as part of a clear floor space, the toe clearance shall extend 17" minimum under the element. Space extending greater than 6" beyond the available knee clearance at 9" above the finish floor or ground shall not be considered toe clearance. Toe clearance shall be 30" wide minimum.

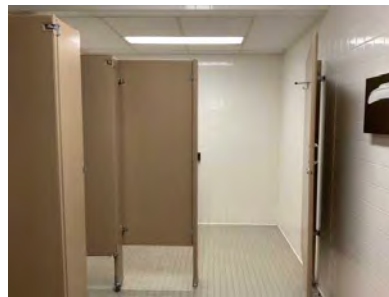
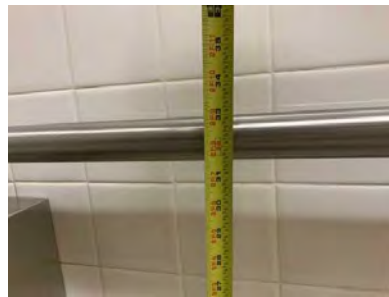
**Photos for Barrier ID: AX240507**

<b>Assembly</b>	Restroom
<b>Type</b>	Restroom/Bathroom - Toilet Stall
<b>ADA Standard</b>	604.5.2
<b>Barrier Detail</b>	The grab bars at the water closet are not compliant.
<b>Location Description</b>	1st and 3rd Floor Men's and Women's Restroom
<b>Observed</b>	Jun 14, 2021 by Ouraccessibleworld@gmail.com

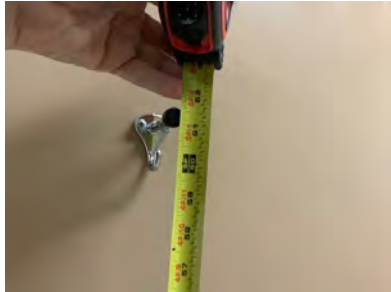
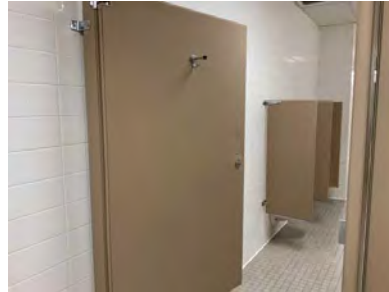
### Photos for Barrier ID: AX240512

<b>Assembly</b>	Restroom
<b>Type</b>	Restroom/Bathroom-Coat Hook
<b>ADA Standard</b>	308
<b>Barrier Detail</b>	The coat hook is not within an allowable reach range.
<b>Location Description</b>	1st and 3rd Floor Men's and Women's Restroom
<b>Observed</b>	Jun 14, 2021 by Ouraccessibleworld@gmail.com
<b>Site Conditions</b>	The coat hooks are mounted 61" above the floor.

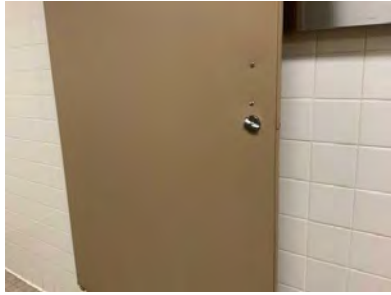
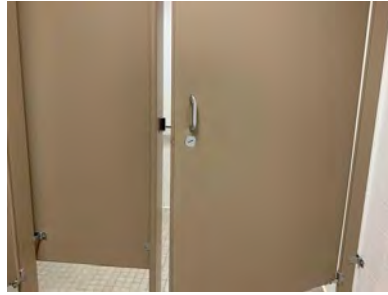
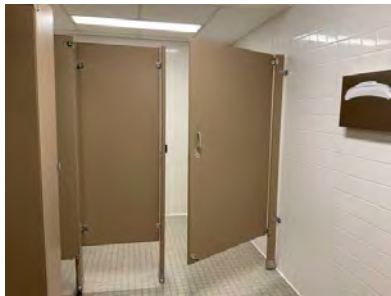
### Photos for Barrier ID: AX240513

<b>Assembly</b>	Restroom
<b>Type</b>	Restroom/Bathroom-Toilet Stall
<b>ADA Standard</b>	309, 404.2.7, 604.8.1.2
<b>Barrier Detail</b>	The wheelchair stall door is not compliant.
<b>Location Description</b>	1st and 3rd Floor Men's and Women's Restroom
<b>Observed</b>	Jun 14, 2021 by Ouraccessibleworld@gmail.com
<b>Site Conditions</b>	Loop handles are not provided on the inside of the stall doors.

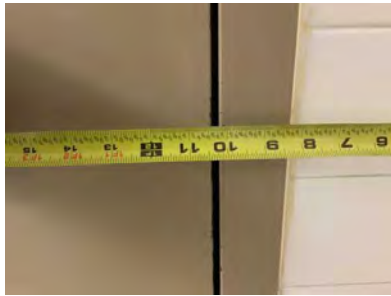
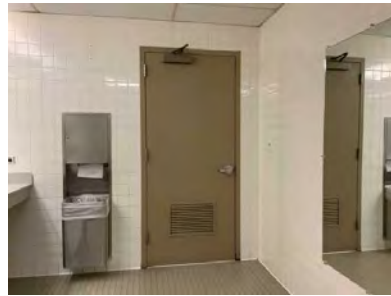
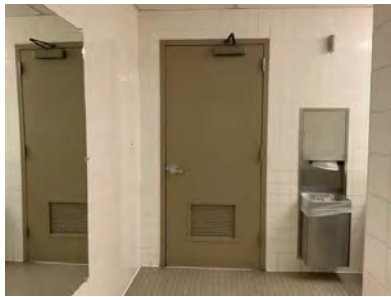
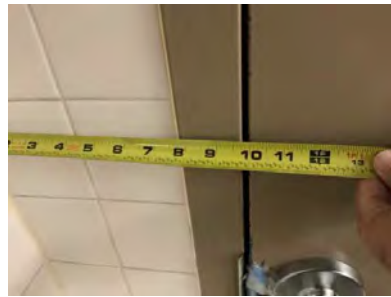
**Photos for Barrier ID: AX240531**

<b>Site Conditions</b>	For a front approach on the pull side the side clearance is 10" .
------------------------	---

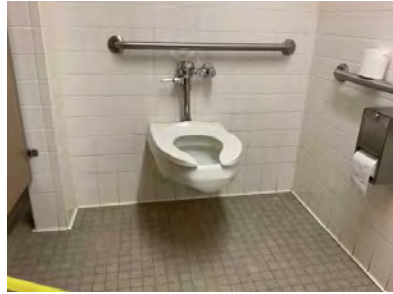
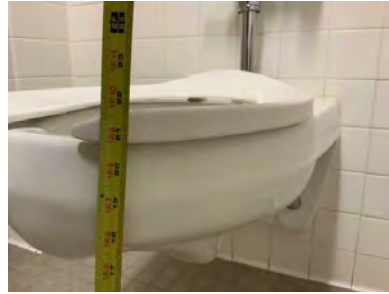
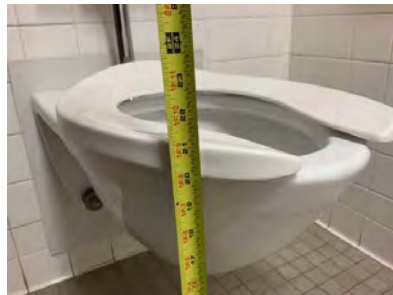
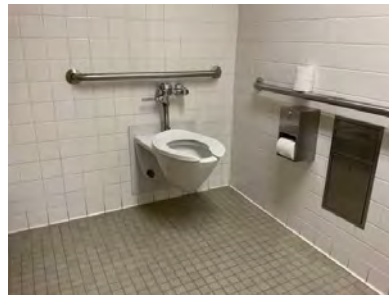
**Photos for Barrier ID: AX240510**

<b>Site Conditions</b>	The top of the water closet seat is 21" to 21-1/2" above the floor.
------------------------	---

Remove and replace with a toilet that has a compliant seat height. The seat height of a water closet shall be 17" minimum and 19" maximum above the finish floor, measured to the top of the seat. Seats shall not be sprung to return to a lifted position. [EXCEPTIONS: 1. A water closet in a toilet room for a single occupant accessed only through a private office and not for common use or public use shall not be required to comply. 2. In residential dwelling units, the height of water closets shall be permitted to be 15" minimum and 19" maximum above the finish floor measured to the top of the seat.] [ADVISORY: It is advisable, but not required, to use the specifications for children where children are the primary users of the restroom. Guidance in applying the specifications for children according to the age group served reflects the differences in the size, stature, and reach ranges of children ages 3 to 12. The specifications chosen should correspond to the age of the primary user group. The specifications of one age group should be applied consistently in the installation of a water closet and related elements. Water Closet Centerline: Ages 3 and 4- 12"; Ages 5 through 8- 12" to 15"; Ages 9 through 12- 15" to 18". Toilet Seat Height: Ages 3 and 4- 11" to 12"; Ages 5 through 8- 12" to 15"; Ages 9 through 12- 15" to 17". Grab Bar Height: Ages 3 and 4- 18" to 20"; Ages 5 through 8- 20" to 25"; Ages 9 through 12- 25" to 27"; Dispenser Height: Ages 3 and 4- 14"; Ages 5 through 8- 14" to 17"; Ages 9 through 12- 17" to 19"].

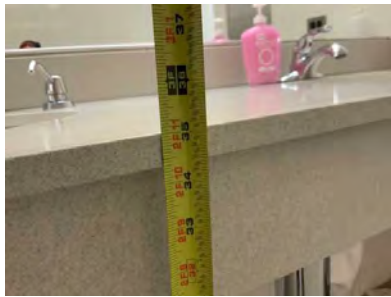
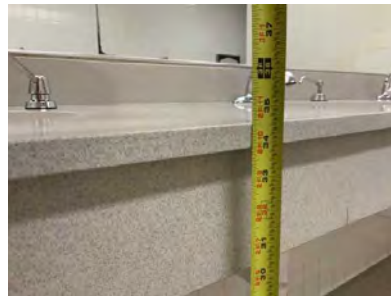
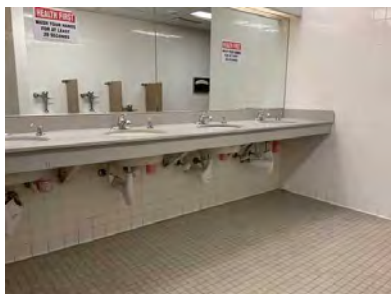
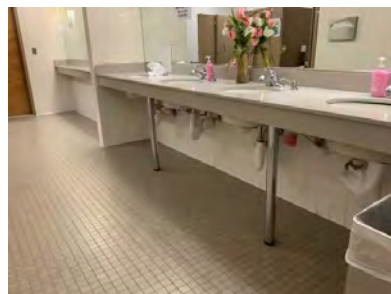
**Photos for Barrier ID: AX240491**

<b>Assembly</b>	Restroom
<b>Type</b>	Restroom/Bathroom-Lavatory
<b>ADA Standard</b>	606.2 and 606.3
<b>Barrier Detail</b>	The lavatory is mounted higher than 34" to the higher of the rim or counter.
<b>Location Description</b>	1st, 2nd, 3rd and 5th Floor Men's and Women's Restroom
<b>Observed</b>	Jun 14, 2021 by Ouraccessibleworld@gmail.com
<b>Site Conditions</b>	The rim of the lavatories is mounted 35" above the floor.

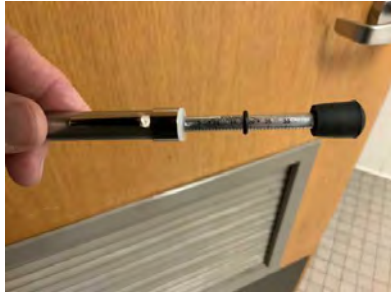
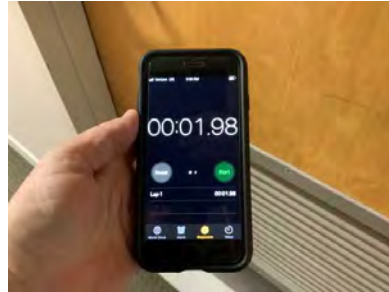
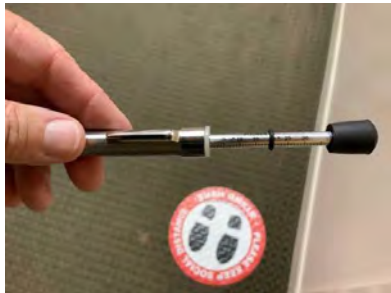
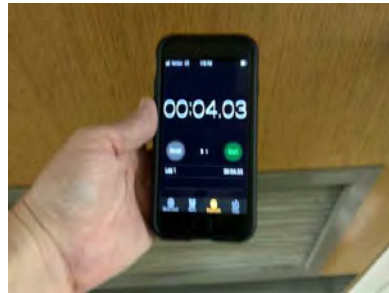
**Photos for Barrier ID: AX240490**

<b>Location Description</b>	1st, 2nd, 3rd and 5th Floor Men's and Women's Restroom
<b>Observed</b>	Jun 14, 2021 by Ouraccessibleworld@gmail.com

Adjust closer or remove and replace closer to ensure that the door has a closure time of at least 5 seconds within 12 degrees of the latch and that requires no more than 5 pounds of force for pushing or pulling the door open. Door closers and gate closers shall be adjusted so that from an open position of 90 degrees, the time required to move the door to a position of 12 degrees from the latch is 5 seconds minimum. The force at the latch, the force to set the door in motion, and the force to fully open the door shall be maximum 5 pounds. These forces do not apply to the force required to retract latch bolts or disengage other devices that hold the door or gate in a closed position.

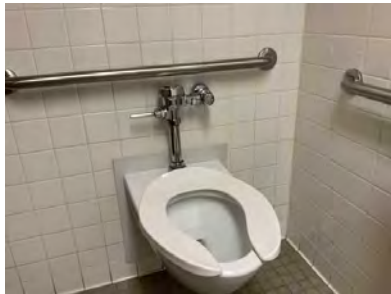
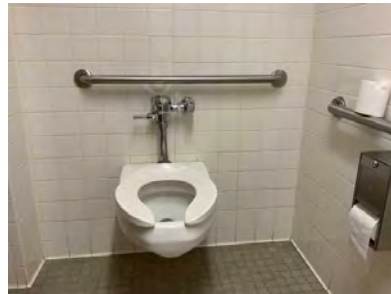
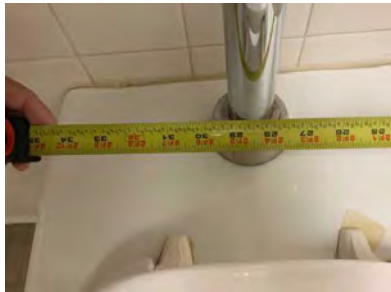
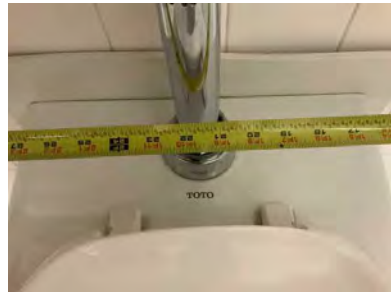
**Photos for Barrier ID: AX240509**

<b>Site Conditions</b>	The centerline of the water closet is 21" to 28" from the side wall.
------------------------	--

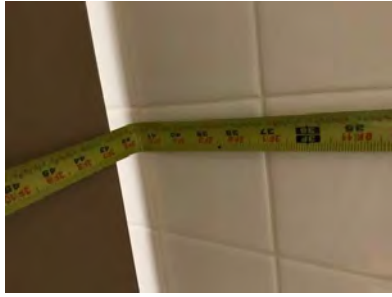
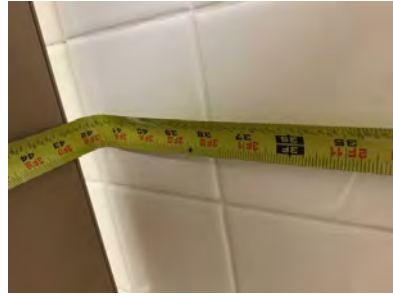
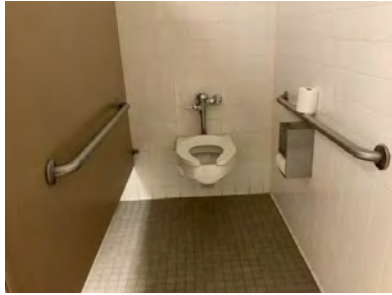
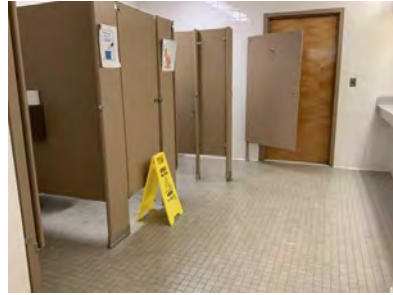
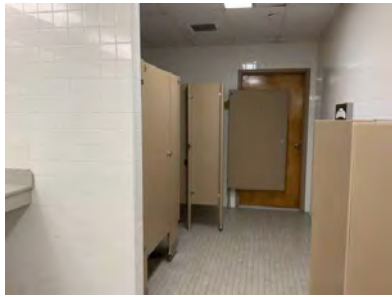
<b>Assembly</b>	Restroom
<b>Type</b>	Restroom/Bathroom-Toilet Stall
<b>ADA Standard</b>	
309, 404.2.7, 604.5.1, 604.6, 604.7, 604.8.1.1, 604.8.1.2, 604.8.1.5, 604.9, 609.3	
<b>Barrier Detail</b>	A wheelchair stall is not provided in a multi-user restroom.
<b>Location Description</b>	2nd and 5th Floor Men's and Women's Restroom
<b>Observed</b>	Jun 14, 2021 by Ouraccessibleworld@gmail.com
<b>Site Conditions</b>	A wheelchair stall is not provided. The existing stall is 41" to 42" wide.

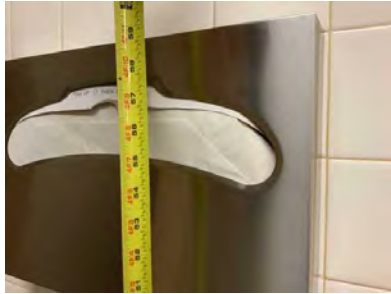
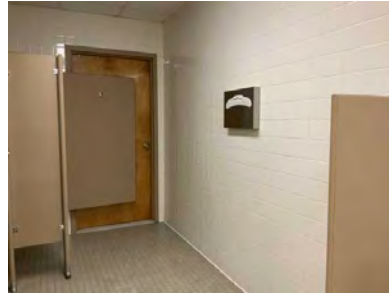
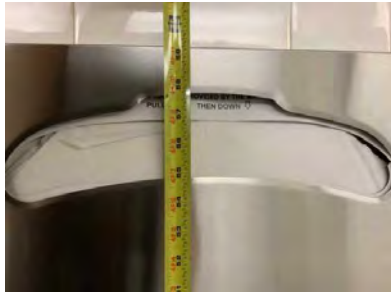
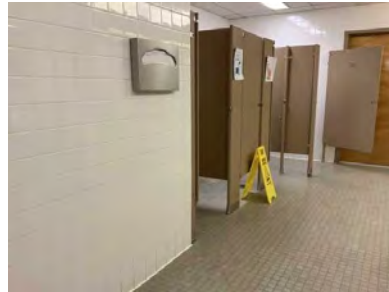
### Photos for Barrier ID: AX240493

<b>Assembly</b>	Restroom
<b>Type</b>	Controls And Dispensers
<b>ADA Standard</b>	606.1; 309.3
<b>Barrier Detail</b>	The height of controls are not compliant.
<b>Location Description</b>	3rd and 5th Floor Men's and Women's Restroom
<b>Observed</b>	Jun 14, 2021 by Ouraccessibleworld@gmail.com
<b>Site Conditions</b>	The seat cover dispensers ate mounted at 56" above the floor.

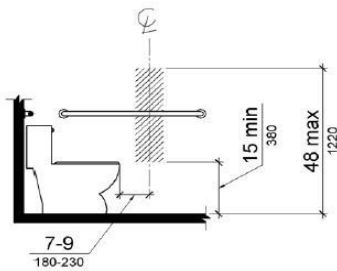
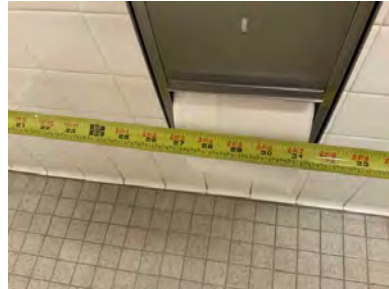
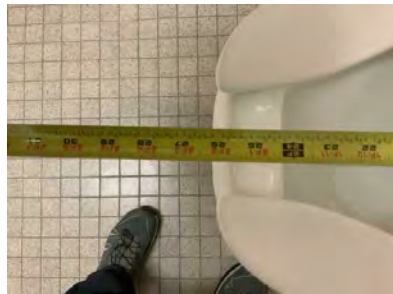
**Photos for Barrier ID: AX240511**

<b>Assembly</b>	Restroom
<b>Type</b>	Restroom/Bathroom-Water Closet
<b>ADA Standard</b>	604.7, 604.9, 609.3
<b>Barrier Detail</b>	The toilet paper dispenser is not at a compliant location.
<b>Location Description</b>	3rd Floor Men's and Women's Restroom
<b>Observed</b>	Jun 14, 2021 by Ouraccessibleworld@gmail.com
