ACCESSIBILITY ASSESSMENT

145366.21R000-002.160

ADA TITLE II ASSESSMENT

Newton Green
5300 Newton Street
Bladensburg, Maryland 20710

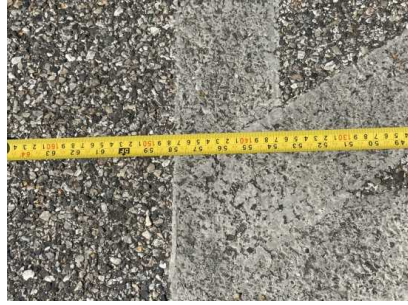
Assembly	Accessible Parking
Type	Parking Space-Car
ADA Standard	UFAS 4.6.3
Barrier Detail	The standard car access aisle is less than 60" wide.
Location Description	Accessible Parking Space P1
Observed	May 18, 2021 by Ouraccessibleworld@gmail.com
Site Conditions	The access aisle is 56" wide.

Restripe with an adjacent access aisle that is at least 60" wide and has a maximum slope of 1:50 (2%) in all directions. Parking spaces for disabled people shall be at least 96" wide and shall have an adjacent access aisle 60" wide minimum (see Fig. 9). [EXCEPTION: If accessible parking spaces for vans are provided, each should have an adjacent access aisle at least 96" wide.] Parking access aisles shall be part of an accessible route to the building or facility entrance. Two accessible parking spaces may share a common access aisle. Parked vehicle overhangs shall not reduce the clear width of an accessible circulation route. Parking spaces and access aisles shall be level with surface slopes not exceeding 1:50 in all directions. The quantity and order of magnitude cost estimate provided for this barrier are limited to the extent of the area identified as non-compliant. Additional costs that may be associated with removal of the barrier are not included.

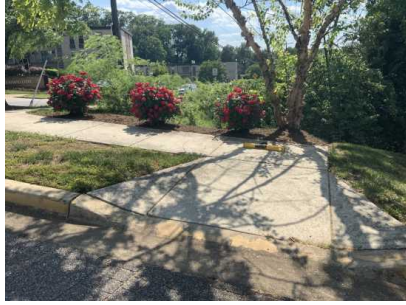
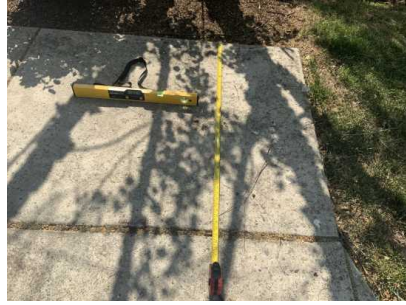
Location Description	Curb Ramp CR1
Observed	May 18, 2021 by Ouraccessibleworld@gmail.com
Site Conditions	The landing at the top of the curb ramp has a cross slope of up to 6.5%.

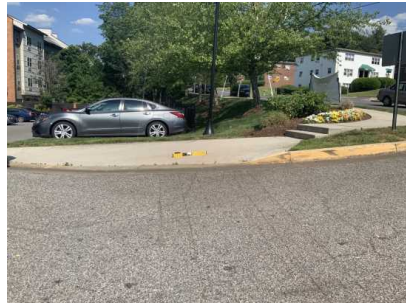
Assembly	Exterior Access Route
Type	Curb Ramp
ADA Standard	405.2; Table 405.2; 406; 406.2
Barrier Detail	The curb ramp does not meet the slope requirements.
Location Description	Curb Ramp CR2a
Observed	May 18, 2021 by Ouraccessibleworld@gmail.com
Site Conditions	The curb ramp has a cross slope of up to 8.8%.

The curb ramp should be removed and replaced with a compliant curb ramp with no greater than the maximum allowable slopes of a ramp. Curb ramp runs shall have a running slope not steeper than 1:12 (8.33%). Cross slope of curb ramp runs shall not be steeper than 1:48. The running slope in new construction shall be 1:12 (8.33%) maximum. [EXCEPTION: In existing sites, buildings, and facilities built before 1/26/92, ramps and curb ramps shall be permitted to have running slopes steeper than 1:12 where such slopes are necessary due to space limitations. In facilities built before 1/26/92, the running slope can be 1:10 to 1:8 (10% to 12.5%) for a maximum rise of 3" OR 1:10 to 1:12 (8.3% to 10%) for a maximum rise of 6".] Where flares are provided, flare slopes shall not be greater than 1:10 (10%). [EXCEPTION: In alterations, where there is no landing at the top of curb ramps, curb ramp flares shall be provided and shall not be steeper than 1:12.]

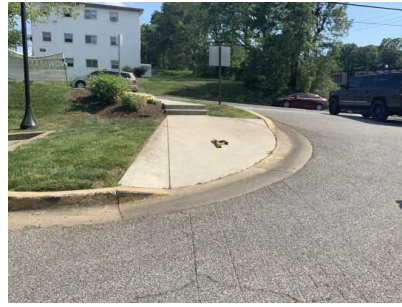
Assembly	Exterior Access Route
Type	Curb Ramp
ADA Standard	405.2; Table 405.2; 406; 406.2
Barrier Detail	The curb ramp does not meet the slope requirements.
Location Description	Curb Ramp CR2b
Observed	May 18, 2021 by Ouraccessibleworld@gmail.com

The curb ramp should be removed and replaced with a compliant curb ramp with no greater than the maximum allowable slopes of a ramp. Curb ramp runs shall have a running slope not steeper than 1:12 (8.33%). Cross slope of curb ramp runs shall not be steeper than 1:48. The running slope in new construction shall be 1:12 (8.33%) maximum. [EXCEPTION: In existing sites, buildings, and facilities built before 1/26/92, ramps and curb ramps shall be permitted to have running slopes steeper than 1:12 where such slopes are necessary due to space limitations. In facilities built before 1/26/92, the running slope can be 1:10 to 1:8 (10% to 12.5%) for a maximum rise of 3" OR 1:10 to 1:12 (8.3% to 10%) for a maximum rise of 6".] Where flares are provided, flare slopes shall not be greater than 1:10 (10%). [EXCEPTION: In alterations, where there is no landing at the top of curb ramps, curb ramp flares shall be provided and shall not be steeper than 1:12.]

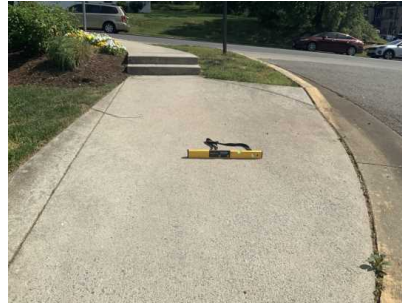
Assembly	Exterior Access Route
Type	Curb Ramp
ADA Standard	405.2; Table 405.2; 406; 406.2
Barrier Detail	The curb ramp does not meet the slope requirements.
Location Description	Curb Ramp CR4
Observed	May 18, 2021 by Ouraccessibleworld@gmail.com
Site Conditions	The curb ramp has a running slope of up to 9.0%.

The curb ramp should be removed and replaced with a compliant curb ramp with no greater than the maximum allowable slopes of a ramp. Curb ramp runs shall have a running slope not steeper than 1:12 (8.33%). Cross slope of curb ramp runs shall not be steeper than 1:48. The running slope in new construction shall be 1:12 (8.33%) maximum. [EXCEPTION: In existing sites, buildings, and facilities built before 1/26/92, ramps and curb ramps shall be permitted to have running slopes steeper than 1:12 where such slopes are necessary due to space limitations. In facilities built before 1/26/92, the running slope can be 1:10 to 1:8 (10% to 12.5%) for a maximum rise of 3" OR 1:10 to 1:12 (8.3% to 10%) for a maximum rise of 6".] Where flares are provided, flare slopes shall not be greater than 1:10 (10%). [EXCEPTION: In alterations, where there is no landing at the top of curb ramps, curb ramp flares shall be provided and shall not be steeper than 1:12.]

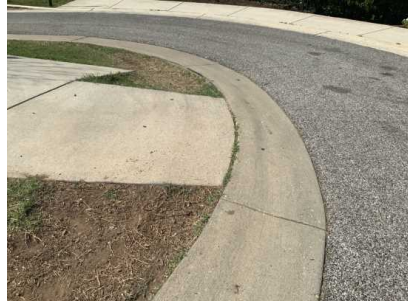
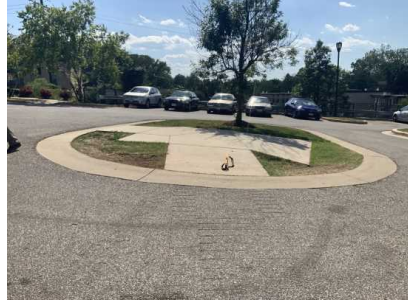
Location Description	Curb Ramp CR4
Observed	May 18, 2021 by Ouraccessibleworld@gmail.com

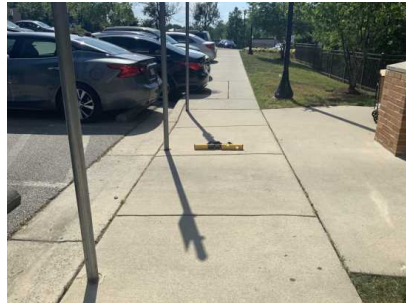
Assembly	Exterior Access Route
Type	Curb Ramp
ADA Standard	304, 406.4
Barrier Detail	The parallel curb ramp landing is not compliant.
Location Description	Curb Ramp CR5
Observed	May 18, 2021 by Ouraccessibleworld@gmail.com
Site Conditions	The bottom landing of the parallel curb ramp has a slope of up to 4.5%.

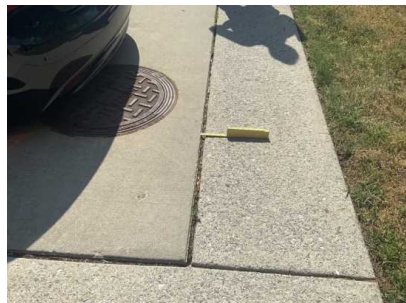
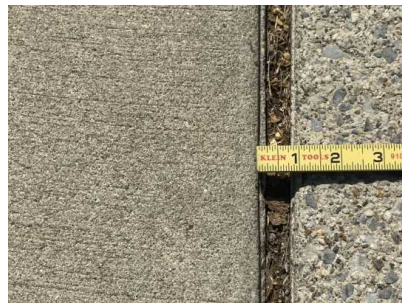
Photos for Barrier ID: AX239886

Assembly	Exterior Access Route
Type	Exterior Accessible Route
ADA Standard	302.3
Barrier Detail	The accessible route has gaps in the surface greater than 1/2" wide.
Location Description	Sidewalk from CR3
Observed	May 18, 2021 by Ouraccessibleworld@gmail.com
Site Conditions	The accessible route has gaps of up to 1".

Repair the accessible route to eliminate openings in the surface greater than 1/2" wide. Openings in the ground surface of the accessible route shall not allow passage of a sphere more than 1/2" diameter. Elongated openings shall be placed so that the long dimension is perpendicular to the dominant direction of travel.

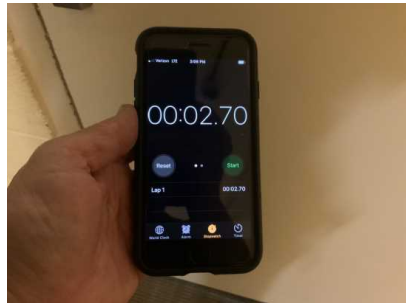
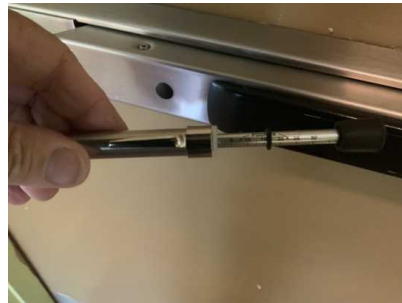
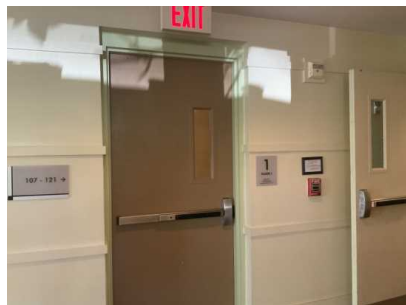
Photos for Barrier ID: AX239857

Location Description	Stairwell 1
Observed	May 18, 2021 by Ouraccessibleworld@gmail.com

Adjust closer or remove and replace closer to ensure that the door has a closure time of at least 5 seconds within 12 degrees of the latch. Door closers and gate closers shall be adjusted so that from an open position of 90 degrees, the time required to move the door to a position of 12 degrees from the latch is 5 seconds minimum.

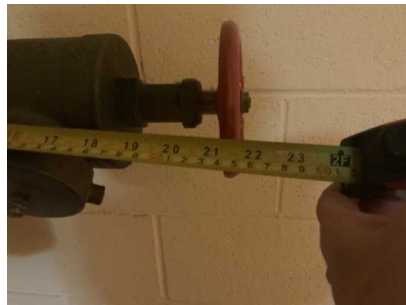
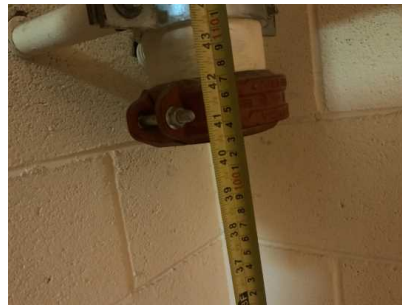
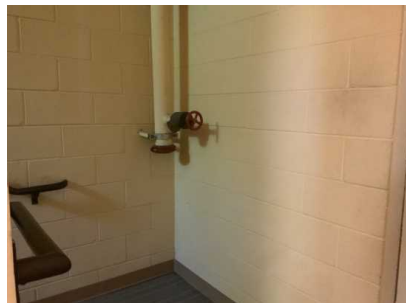
Photos for Barrier ID: AX239858

Location Description	Stairwell 1
Observed	May 18, 2021 by Ouraccessibleworld@gmail.com
Site Conditions	The stanpipe protrudes into the accessible route by 22" at a height of 40 1/2".

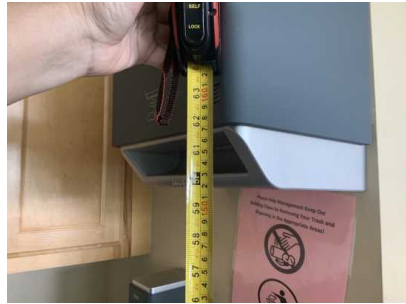
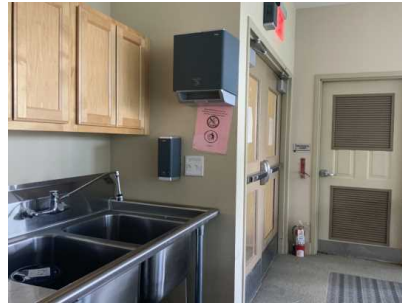
Photos for Barrier ID: AX239867

Location Description	2nd Floor Community Room
Observed	May 18, 2021 by Ouraccessibleworld@gmail.com
Site Conditions	The paper towel dispenser is mounted at 60" above the floor.

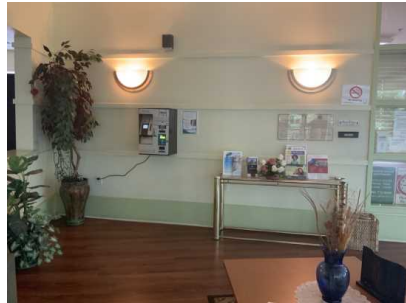
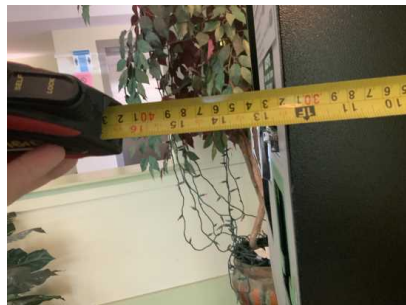
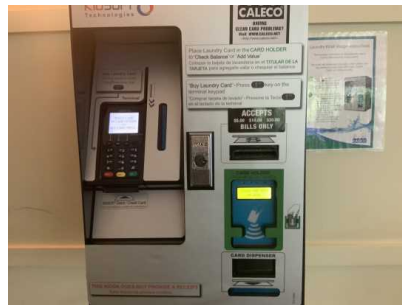
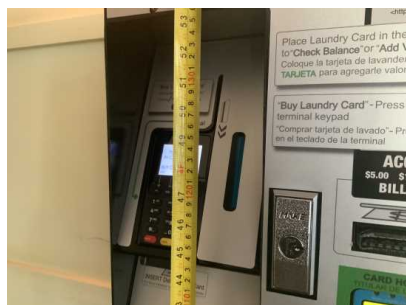
Photos for Barrier ID: AX239860

Location Description	Lobby
Observed	May 18, 2021 by Ouraccessibleworld@gmail.com

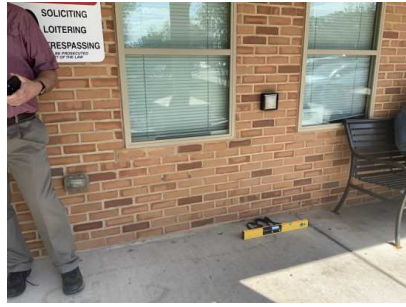
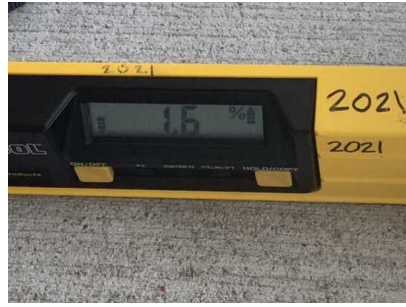
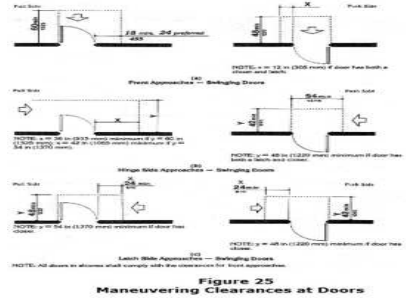
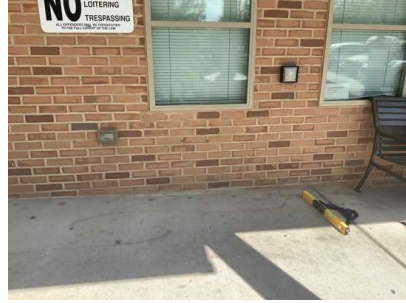
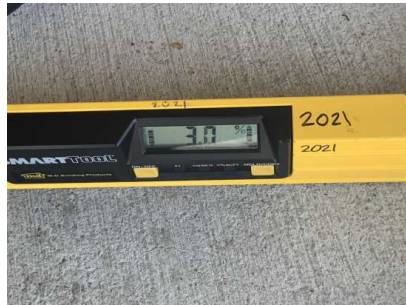
Assembly	Exterior Access Route
Type	Exterior Accessible Route
ADA Standard	305, 309
Barrier Detail	Clear ground space is not provided at the operable part.
Location Description	Main Entrance
Observed	May 18, 2021 by Ouraccessibleworld@gmail.com
Site Conditions	The clear space at the door opener has a slope of up to 3.0%.

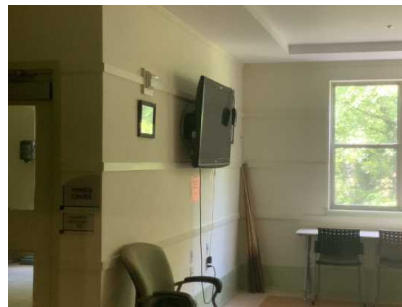
Photos for Barrier ID: AX239868

Location Description	Room 111
Observed	May 18, 2021 by Ouraccessibleworld@gmail.com
Site Conditions	The provided signage does not have tactile characters.

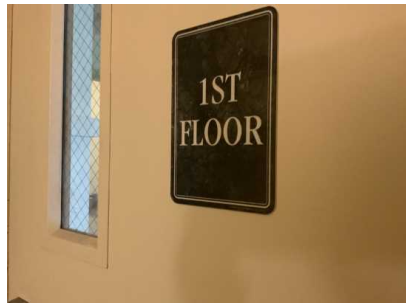
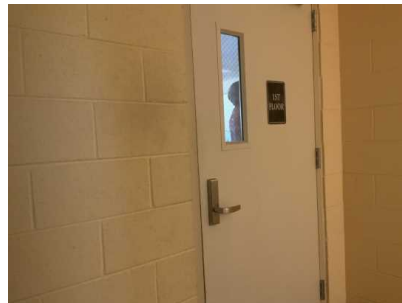
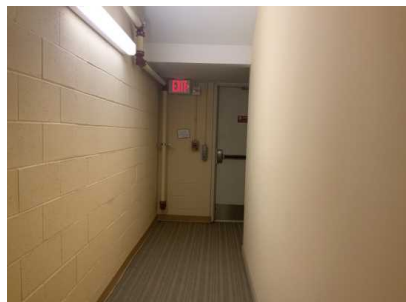
Photos for Barrier ID: AX239859

Location Description	Stairwell 1
Observed	May 18, 2021 by Ouraccessibleworld@gmail.com

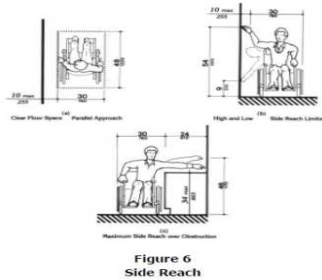
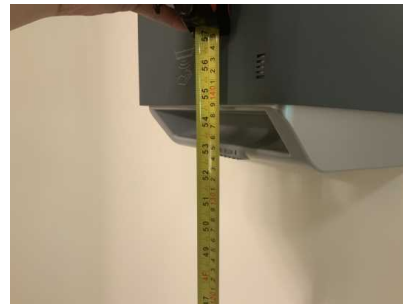
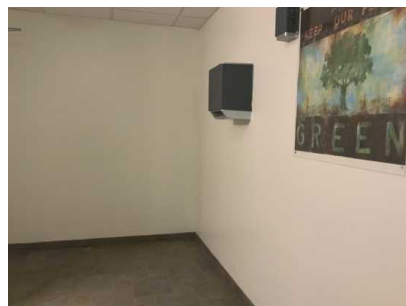
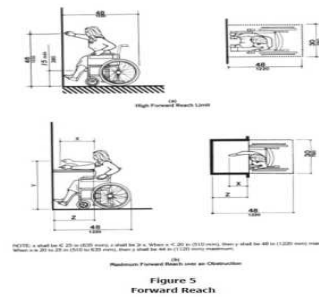
Photos for Barrier ID: AX239881

Assembly	Common Areas
Type	Vending Machine
ADA Standard	228.1; 305; 308; 309
Barrier Detail	The vending machines have operable parts which are not within reach range.
Location Description	Vending machine
Observed	May 18, 2021 by Ouraccessibleworld@gmail.com
Site Conditions	The vending machine has controls up to 54" above the floor.

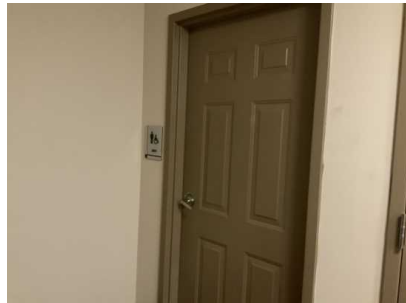
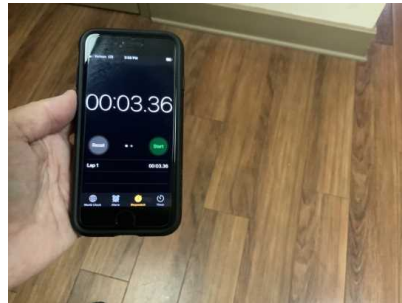
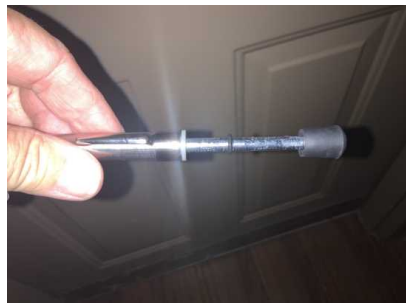
Photos for Barrier ID: AX239871

Assembly	Restroom
Type	Restroom/Bathroom-Door
ADA Standard	404.2.8

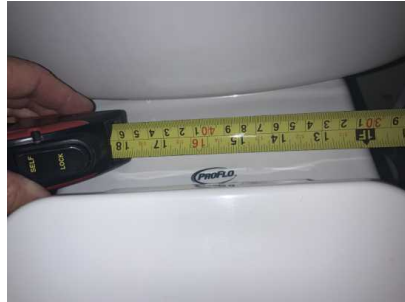
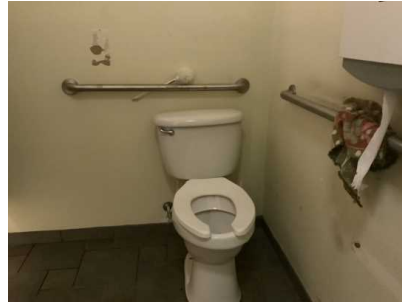
Photos for Barrier ID: AX239873

Location Description	Lobby Men's Restroom
Observed	May 18, 2021 by Ouraccessibleworld@gmail.com
Site Conditions	The centerline of the water closet is 15-1/2" away from the side wall.

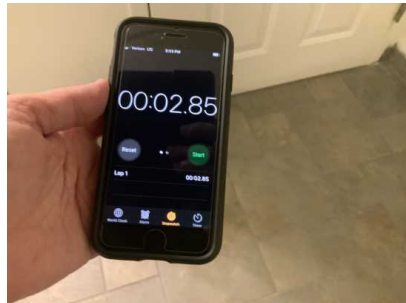
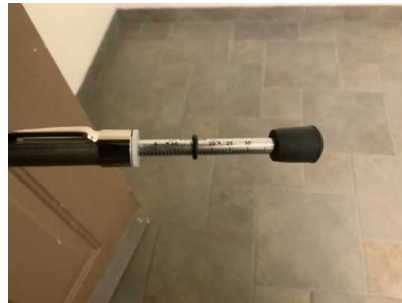
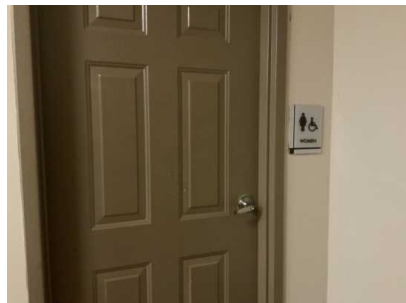
Photos for Barrier ID: AX239870

Location Description	Lobby Women's Restroom
Observed	May 18, 2021 by Ouraccessibleworld@gmail.com

Adjust closer or remove and replace closer to ensure that the door has a closure time of at least 5 seconds within 12 degrees of the latch and that requires no more than 5 pounds of force for pushing or pulling the door open. Door closers and gate closers shall be adjusted so that from an open position of 90 degrees, the time required to move the door to a position of 12 degrees from the latch is 5 seconds minimum. The force at the latch, the force to set the door in motion, and the force to fully open the door shall be maximum 5 pounds. These forces do not apply to the force required to retract latch bolts or disengage other devices that hold the door or gate in a closed position.

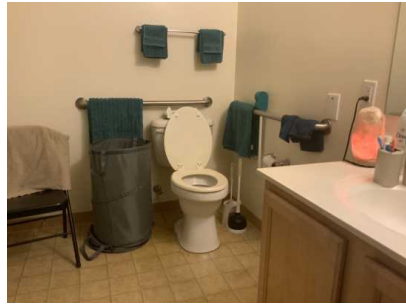
Assembly	Residential Dwelling
Type	Restroom/Bathroom-Water Closet
ADA Standard	UFAS 4.16.4, 4.34.5.2 (3)
Barrier Detail	The side grab bar is not compliant.
Location Description	Unit 215 and 405
Observed	May 18, 2021 by Ouraccessibleworld@gmail.com
Site Conditions	The side grab bar extends 45" from the rear wall.

Install a compliant grab bar at the water closet. Grab bars not located in stalls shall comply with Figure 29. A 42" minimum length grab bar shall be located on the side wall of the water closet. The grab bar shall be spaced 12" maximum from the back wall behind the water closet, and extend minimum 54" from the back wall. Horizontal grab bars shall be located between 33" and 36" above the finished floor. Adaptable residential units shall have structural reinforcement or other provisions that will allow installation of grab bars. Structural reinforcement shall be provided in the locations shown in Figure 47 (b). If provided in adaptable dwelling units, grab bars shall be installed as shown in Figure 29. The diameter or width of the gripping surfaces of a handrail or grab bar shall be 1-1/4" to 1-1/2", or the shape shall provide an equivalent gripping surface. If handrails or grab bars are mounted adjacent to a wall, the space between the wall and the grab bar shall be 1-1/2" (see Figure 39 (a), (b), and (c)). Handrails may be located in a recess if the recess is a maximum of 3" deep and extend at least 18" above the top of the rail (see Figure 39 (d)). The structural strength of grab bars shall meet the following specification: (1) Bending stress in a grab bar or seat induced by the maximum bending moment from the application of 250 lbf (1112N) shall be less than the allowable stress for the material of the grab bar or seat. (2) Shear stress induced in a grab bar or seat by the application of 250 lbf (1112N) shall be less than the allowable shear stress for the material of the grab bar or seat. If the connection between the grab bar or seat and its mounting bracket or other support is considered to be fully restrained, then direct and torsional shear stresses shall be totaled for the combined shear stress, which shall not exceed the allowable shear stress. (3) Shear force induced in a fastener or mounting device from the application of 250 lbf (1112N) shall be less than the allowable lateral load of either the fastener or mounting device or the supporting structure, whichever is the smaller allowable load. (4) Tensile force induced in a fastener by a direct tension force of 250 lbf (1112N) plus the maximum moment from the application of 250 lbf (1112N) shall be less than the allowable withdrawal and the supporting structure. (5) Grab bars shall not rotate within their fittings.

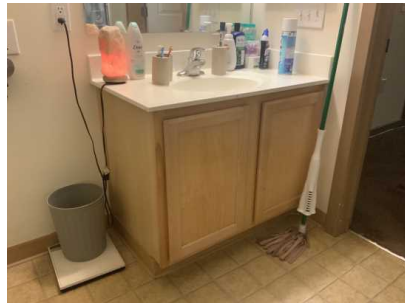
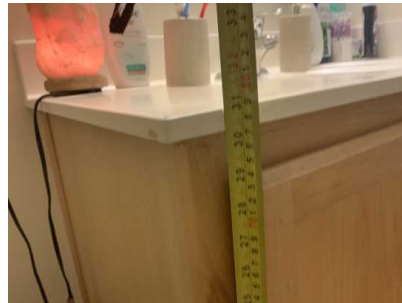
Photos for Barrier ID: AX239837

Assembly	Residential Dwelling
Type	Restroom/Bathroom-Lavatory
ADA Standard	UFAS 4.19.2, 4.34.5.3
Barrier Detail	The lavatory does not have knee and toe clearance.
Location Description	Unit 215 and 405
Observed	May 18, 2021 by Ouraccessibleworld@gmail.com

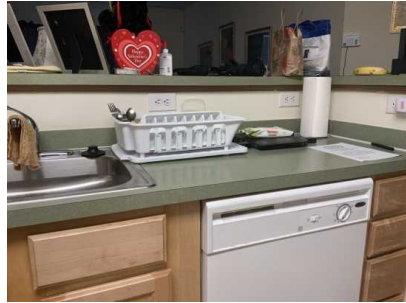
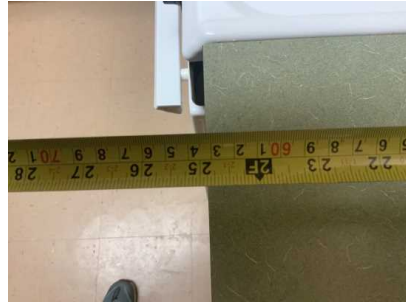
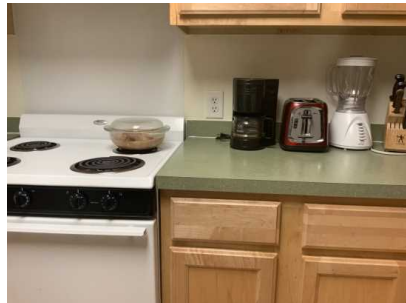
Assembly	Residential Dwelling
Type	Controls And Dispensers
ADA Standard	UFAS 4.2.5, 4.2.6, 4.27
Barrier Detail	The controls and operable parts are not within an allowable reach range.
Location Description	Unit 215 and 405
Observed	May 18, 2021 by Ouraccessibleworld@gmail.com
Site Conditions	The reach range for the outlets is 25" over the kitchen counters.

Provide controls and operable parts within an allowable reach range. A clear floor space 30" by 48" shall be provided that allows either a front approach or a parallel approach by a person using a wheelchair at controls, dispensers, receptacles, and other operable equipment. If the clear floor space only allows forward approach to an object, the maximum high forward reach allowed shall be 48" (see Figure 5(a)). The minimum low forward reach is 15". If the high forward reach is over an obstruction, where the horizontal obstruction is less than 20" the maximum high forward reach is 48". Where the horizontal obstruction is from 20" to maximum 25", the high forward reach shall be 44" maximum. Forward obstructed reaches shall comply with Figure 5(b). If the clear floor space allows parallel approach by a person in a wheelchair, the maximum high side reach allowed shall be 54", and the low side reach shall be no less than 9" above the floor (Figure 6(a) and (b)). If the side reach is over an obstruction, the maximum horizontal reach shall be 24" and the high side reach shall be 46" maximum. Side obstructed clearances shall be as shown in Figure 6(c). Those portions of heating, ventilating and air conditioning equipment requiring regular, periodic maintenance and adjustment by the resident of a dwelling shall be accessible people in wheelchairs. If air distribution registers must be placed in or close to ceiling for proper air circulation, this specification shall not apply to the registers.

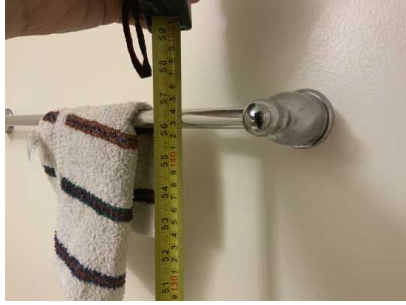
Assembly	Residential Dwelling
Type	Restroom/Bathroom-Water Closet
ADA Standard	UFAS 4.34.5.2 (3)
Barrier Detail	The rear grab bar is not compliant.
Location Description	Unit 405
Observed	May 18, 2021 by Ouraccessibleworld@gmail.com
Site Conditions	A rear grab bar is not provided.

Install a 36" minimum length grab bar behind the water closet. The grab bar must extend a minimum of 12" beyond the center of the water closet toward the side wall and a minimum of 24" toward the open side for either a left or right side approach. Grab bars not located in stalls shall comply with Figure 29. A 42" minimum length grab bar shall be located on the side wall of the water closet. The side grab bar shall be spaced 12" maximum from the back wall behind the water closet, and extend minimum 54" from the back wall. Horizontal grab bars shall be located between 33" and 36" above the finished floor. Adaptable residential units shall have structural reinforcement or other provisions that will allow installation of grab bars. Structural reinforcement shall be provided in the locations shown in Figure 47 (b). If provided in adaptable dwelling units, grab bars shall be installed as shown in Figure 29. The diameter or width of the gripping surfaces of a handrail or grab bar shall be 1-1/4" to 1-1/2", or the shape shall provide an equivalent gripping surface. If handrails or grab bars are mounted adjacent to a wall, the space between the wall and the grab bar shall be 1-1/2" (see Figure 39 (a), (b), and (c)). Handrails may be located in a recess if the recess is a maximum of 3" deep and extend at least 18" above the top of the rail (see Figure 39 (d)). The structural strength of grab bars shall meet the following specification: (1) Bending stress in a grab bar or seat induced by the maximum bending moment from the application of 250 lbf (1112N) shall be less than the allowable stress for the material of the grab bar or seat. (2) Shear stress induced in a grab bar or seat by the application of 250 lbf (1112N) shall be less than the allowable shear stress for the material of the grab bar or seat. If the connection between the grab bar or seat and its mounting bracket or other support is considered to be fully restrained, then direct and torsional shear stresses shall be totaled for the combined shear stress, which shall not exceed the allowable shear stress. (3) Shear force induced in a fastener or mounting device from the application of 250 lbf (1112N) shall be less than the allowable lateral load of either the fastener or mounting device or the supporting structure, whichever is the smaller allowable load. (4) Tensile force induced in a fastener by a direct tension force of 250 lbf (1112N) plus the maximum moment from the application of 250 lbf (1112N) shall be less than the allowable withdrawal and the supporting structure. (5) Grab bars shall not rotate within their fittings.

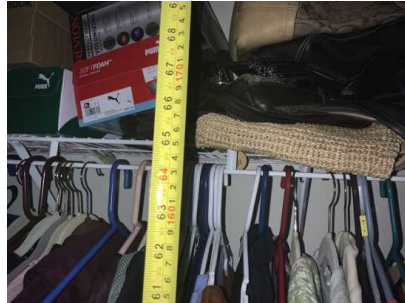
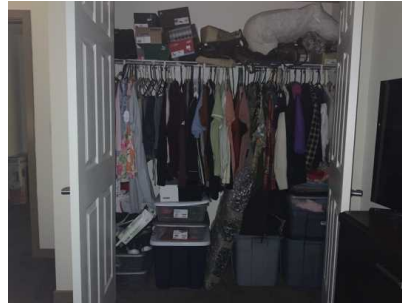
Photos for Barrier ID: AX239840

Assembly	Residential Dwelling
Type	Reach Range
ADA Standard	UFAS 4.25.3
Barrier Detail	The clothes rod is mounted higher than 54".
Location Description	Unit 215 and 405
Observed	May 18, 2021 by Ouraccessibleworld@gmail.com
Site Conditions	The closet rods and shelves are mounted up to 65" above the floor.
