ACCESSIBILITY ASSESSMENT

ADA TITLE II ASSESSMENT

Owens Road
1100 Owens Road
Oxen Hill, Maryland 20745

July 14, 2021

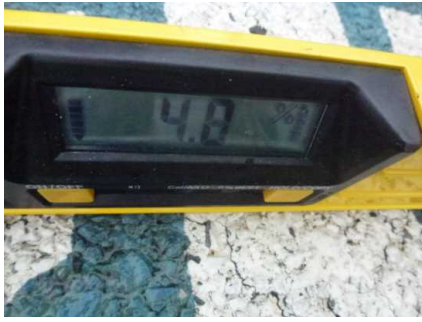
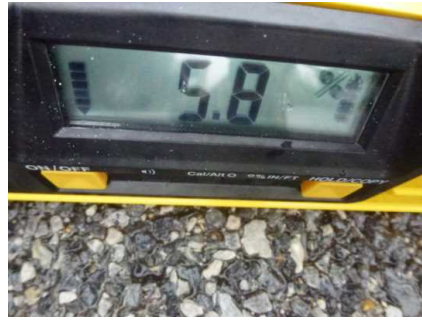
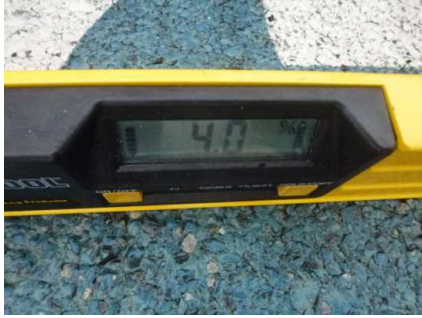
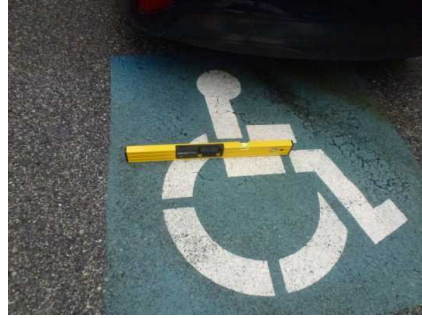
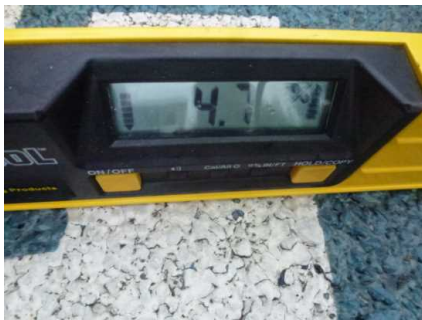
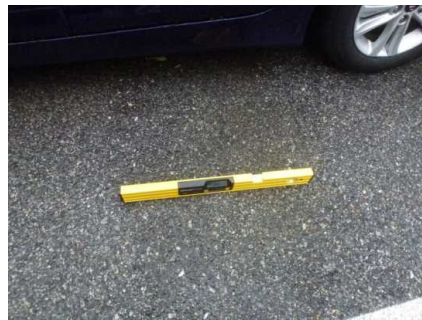
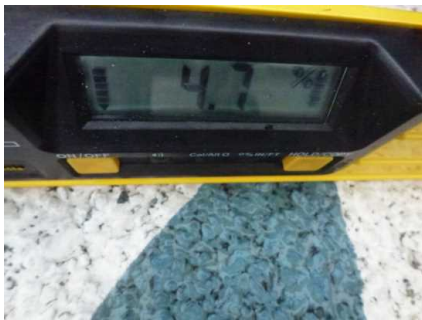
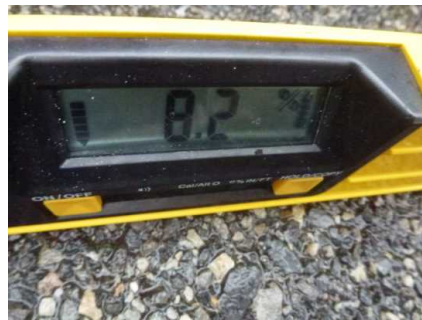
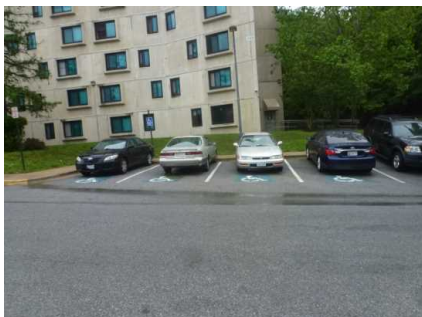
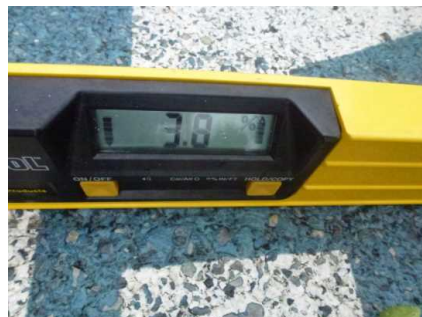
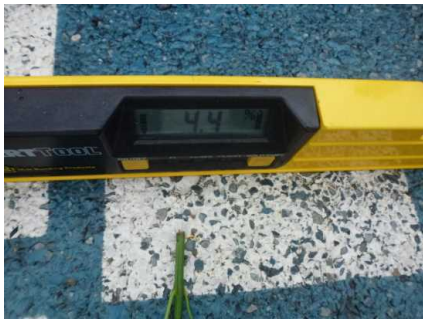
Assembly	Accessible Parking
Type	Parking Space-Car
ADA Standard	UFAS 4.6.3
Barrier Detail	An access aisle is not provided.
Location Description	Parking Lot A - Space P1-A, P1-B, P1-C, P1-D
Observed	May 16, 2018 by silloyd
Site Conditions	The parking space does not have an access aisle.

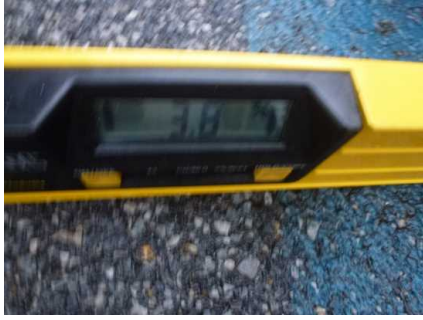
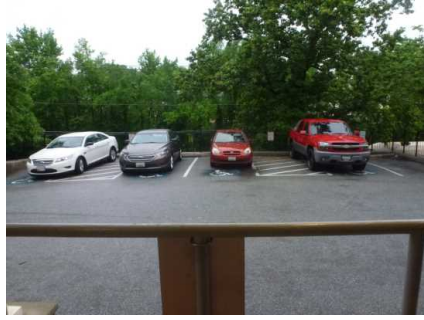
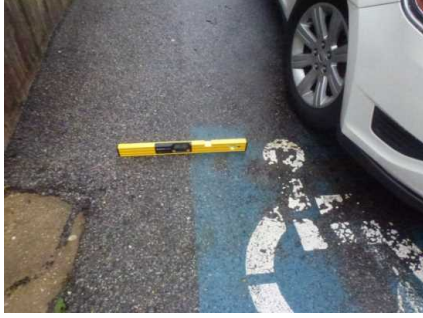
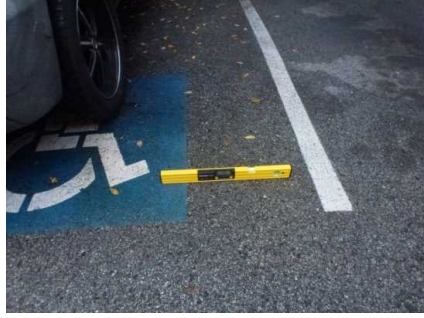
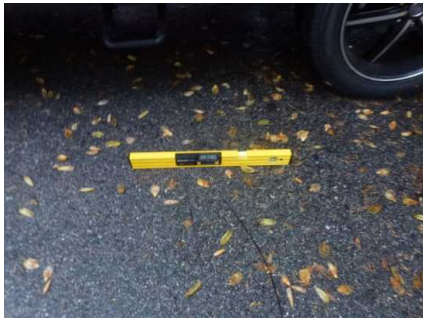
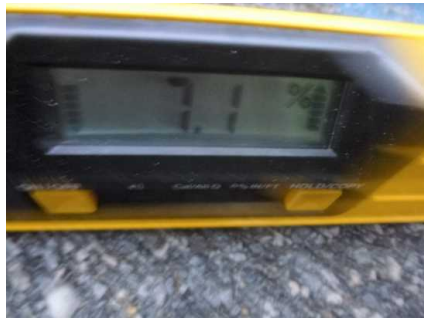
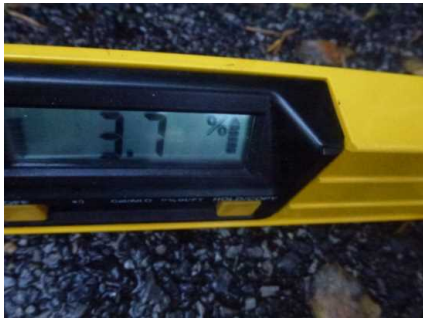
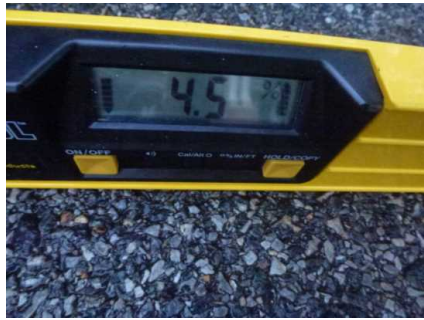
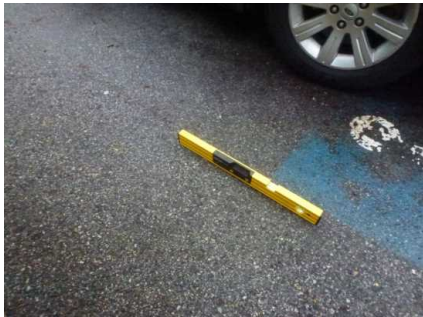
Assembly	Exterior Access Route
Type	Ramp
ADA Standard	405.2

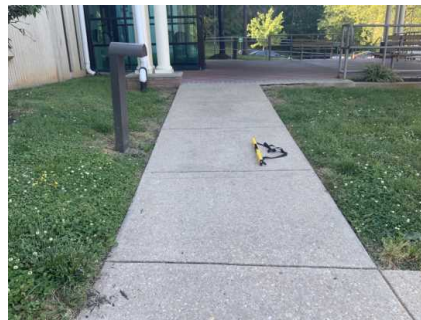
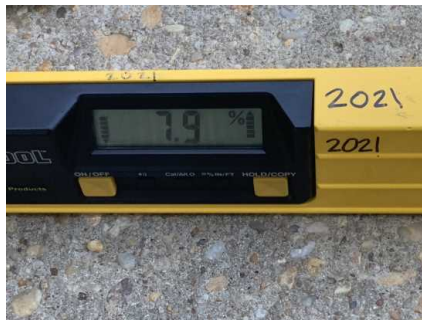
Location Description	Ramp R1
Observed	May 20, 2021 by Ouraccessibleworld@gmail.com

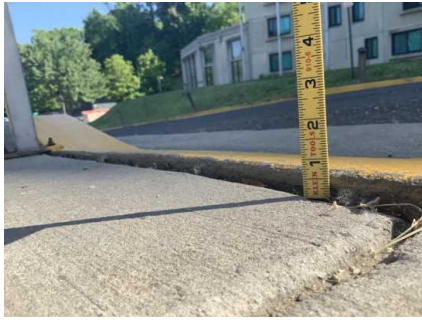
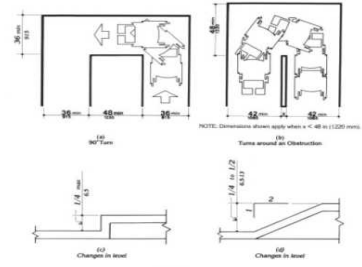
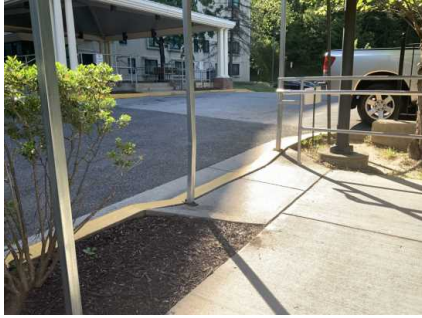
124 +38.822807, -76.989460

Site Conditions The accessible route has vertical change of up to 1" for a length of 5'.

The accessible route should be repaired to eliminate vertical level changes greater than 1/4". Changes in level of 1/4" high maximum shall be permitted to be vertical. Changes in level between 1/4" high minimum and 1/2" high maximum shall be beveled with a slope not steeper than 1:2. Changes in level greater than 1/2" shall be ramped.

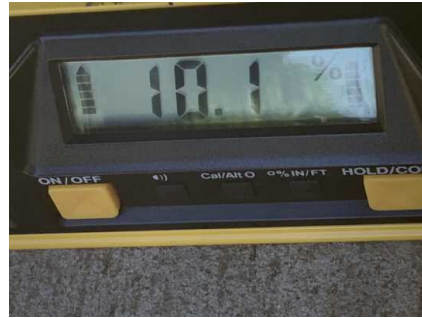
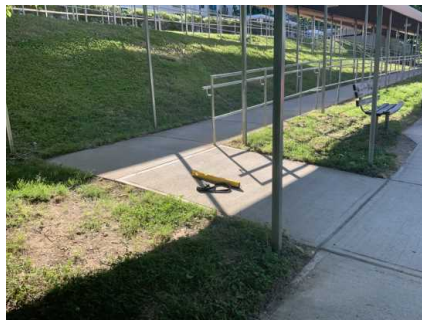
168 +38.822841, -76.989809

Assembly	Exterior Access Route
Type	Ramp
ADA Standard	405.8 and 505
Barrier Detail	The ramp run has a rise greater than 6"; however, handrails are not provided.
Location Description	Sidewalk to Street street landing
Observed	May 20, 2021 by Ouraccessibleworld@gmail.com
Site Conditions	The ramp has a rise of 12" and does not have handrails.

Provide compliant handrails or provide ramp runs with maximum 6" rise. Handrails are required on ramp runs which rise more than 6". Replace with continuous handrails at a consistent height above the ramp on both sides of the ramp. Inside handrails on switchback or dogleg stairs and ramps shall be continuous between runs. Top of gripping surfaces of handrails shall be 34" minimum and 38" maximum vertically above ramp surfaces. Handrails shall be at a consistent height above ramp surfaces. Clearance between handrail gripping surfaces and adjacent surfaces shall be 1-1/2" minimum. Handrail gripping surfaces shall be continuous along their length and shall not be obstructed along their tops or sides. The bottoms of handrail gripping surfaces shall not be obstructed for more than 20% of their length. Where provided, horizontal projections shall occur 1-1/2" minimum below the bottom of the handrail gripping surface. [EXCEPTIONS: 1. Where handrails are provided along walking surfaces with slopes not steeper than 1:20, the bottoms of handrail gripping surfaces shall be permitted to be obstructed along their entire length where they are integral to crash rails or bumper guards. 2. The distance between horizontal projections and the bottom of the gripping surface shall be permitted to be reduced by 1/8" for each 1/2" of additional handrail perimeter dimension that exceeds 4".] Handrail gripping surfaces with a circular cross section shall have an outside diameter of 1-1/4" minimum and 2" maximum. Handrail gripping surfaces with a non-circular cross section shall have a perimeter dimension of 4" minimum and 6-1/4" maximum, and a cross-section dimension of 2-1/4" maximum. Handrail gripping surfaces and any surfaces adjacent to them shall be free of sharp or abrasive elements and shall have rounded edges. Handrails shall not rotate within their fittings. Handrail gripping surfaces shall extend beyond and in the same direction of ramp runs. [EXCEPTIONS: 1. Extensions shall not be required for continuous handrails at the inside turn of switchback or dogleg ramps AND 3. In alterations, full extensions of handrails shall not be required where such extensions would be hazardous due to plan configuration.] Ramp handrails shall extend horizontally above the landing for 12" minimum beyond the top and bottom of ramp runs. Extensions shall return to a wall, guard, or the landing surface, or shall be continuous to the handrail of an adjacent ramp run.

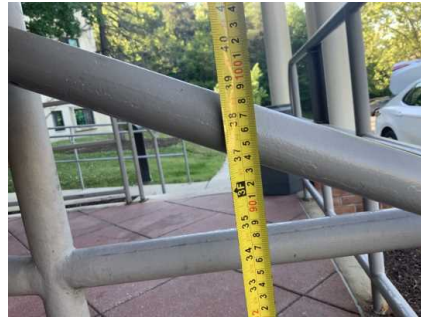
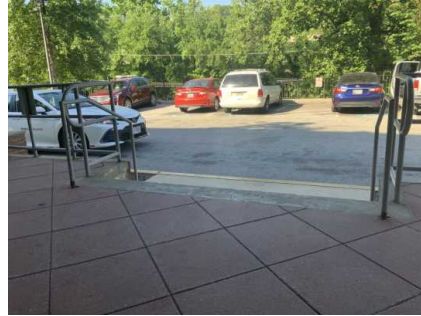
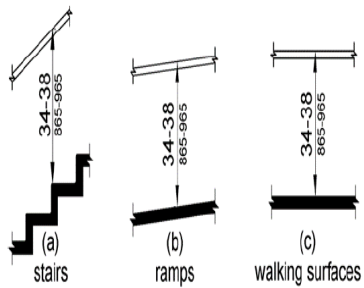
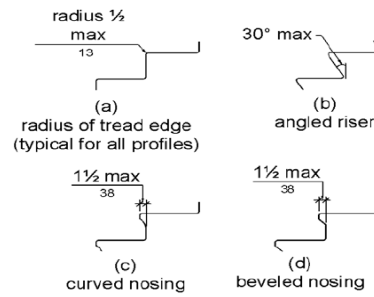
132 +38.822561, -76.989417

Assembly	Exterior Access Route
Type	Stairs
ADA Standard	505
Barrier Detail	Handrails are not compliant.
Location Description	Stairs from Parking to Main Entrance
Observed	May 20, 2021 by Ouraccessibleworld@gmail.com

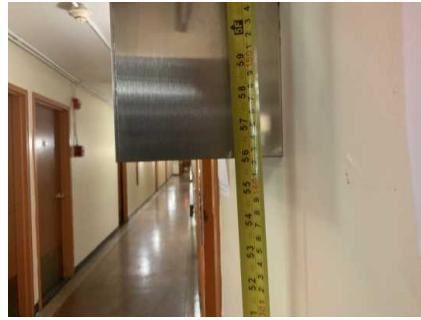
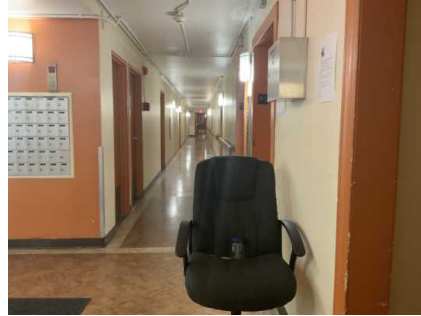
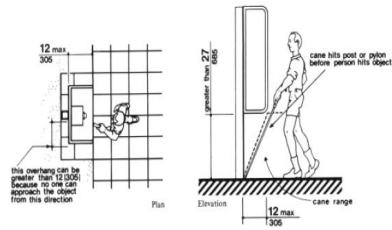
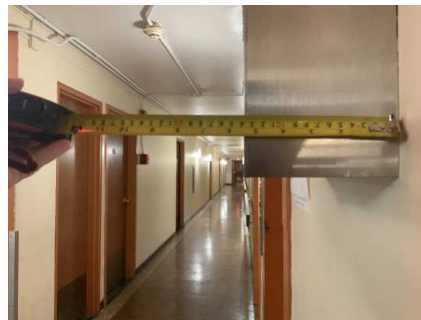
Location Description	Office
Observed	May 20, 2021 by Ouraccessibleworld@gmail.com
Site Conditions	The thermostat is mounted 55-1/2" above the floor.

Lower object so that the bottom leading edge is maximum 27" above finish floor, replace with a non-protruding model, or install cane detectors. Objects projecting from walls (for example, telephones) with their leading edges between 27" and 80" above the finished floor shall protrude no more than 4" into walks, halls, corridors, passageways, or aisles (see Fig. 8(a)). Objects mounted with their leading edges at or below 27" above the finished floor may protrude any amount (see Fig. 8(a) and (b)). Free-standing objects mounted on posts or pylons may overhang 12" maximum from 27" to 80" above the ground or finished floor (see Fig. 8(c) and (d)). Protruding objects shall not reduce the clear width of an accessible route or maneuvering space (see Fig. 8(e)). Ensure objects do not protrude more than 4" into the accessible route when mounted at 27" or above from the finished floor to their leading edge. Wall- and post-mounted cantilevered units shall have a clear knee space between the bottom of the apron and the floor or ground at least 27" high, 30" wide, and 17" to 19" deep. Such units shall also have a minimum clear floor space 30" by 48" to allow a person in a wheelchair to approach the unit facing forward.

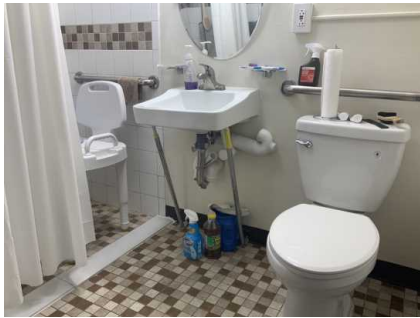
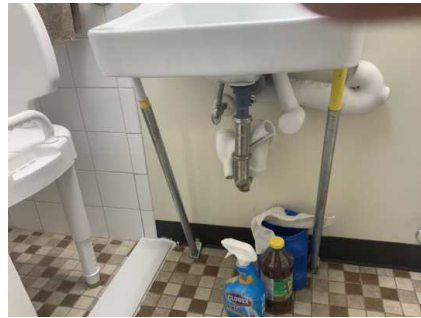
Photos for Barrier ID: AX239983

Assembly	Residential Dwelling
Type	Restroom/Bathroom-Lavatory
ADA Standard	UFAS 4.19.4
Barrier Detail	Lavatory hot water and drain pipes are not insulated.
Location Description	Unit 601
Observed	May 20, 2021 by Ouraccessibleworld@gmail.com
Site Conditions	The lavatory drain pipes and water supply lines are not insulated.

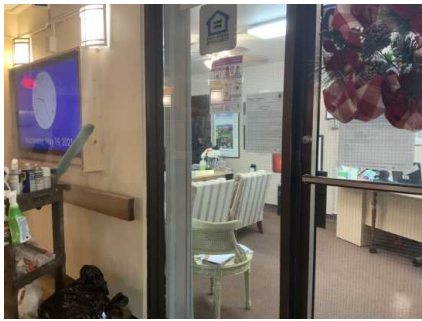
Photos for Barrier ID: AX239968

Assembly	Interior Access Route
Type	Signage
ADA Standard	UFAS 4.30.5; Fig. 43
Barrier Detail	Compliant interior signage indicating a space or facility is not provided.
Location Description	Office
Observed	May 20, 2021 by Ouraccessibleworld@gmail.com
Site Conditions	Signage with tactile characters is not provided at the office.

Provide compliant interior signage for the space. If signs are provided, the signs shall comply with character proportion and color contrast, and permanent interior signage that identifies interior rooms and spaces shall also comply with raised characters and mounting location and height. [EXCEPTION: The provisions for raised characters or symbols are not mandatory for temporary information on room and space signage, such as current occupant's name, provided the permanent room or space identification complies with raised characters or symbols.] Where the signage is indicating an accessible entrance to a facility or space, the signage shall include the International Symbol of Accessibility (see Figure 43). CHARACTER PROPORTION. Letters and numbers on signs shall have a width-to-height ratio between 3:5 and 1:1 and a stroke width-to-height ratio between 1:5 and 1:10. COLOR CONTRAST. Characters and symbols shall contrast with their background - either light characters on a dark background or dark characters on a light background. RAISED CHARACTERS OR SYMBOLS. Letters and numbers on signs shall be raised 1/32" minimum and shall be sans serif characters. Raised characters or symbols shall be at least 5/8" high, but no higher than 2". Symbols or pictographs on signs shall be raised 1/32" minimum. SYMBOLS OF ACCESSIBILITY. Accessible facilities required to be identified as accessible shall use the international symbol of accessibility. The symbol shall be displayed as shown in Fig. 43. Mount interior signage alongside the latch side of the door, mounted at a height between 54" and 66" above the finished floor.
