ACCESSIBILITY ASSESSMENT

145366.21R000-007.160

ADA TITLE II ASSESSMENT

Rollingcrest Village
5631 Sargent Road
Hyattsville, Maryland 20782

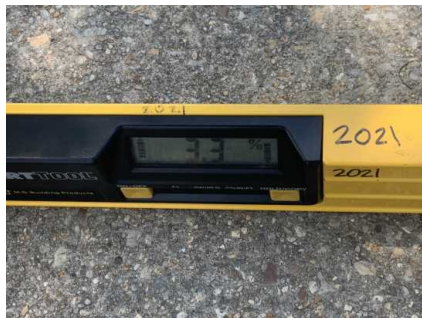
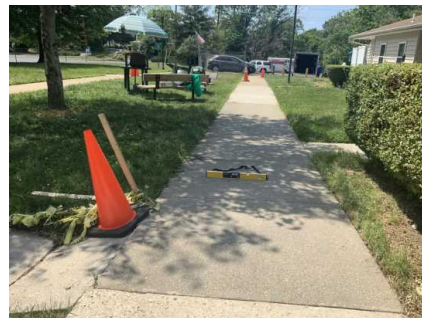
Photos for Barrier ID: AX239912

Rollingcrest Village EXTERIOR

Assembly Exterior Access Route

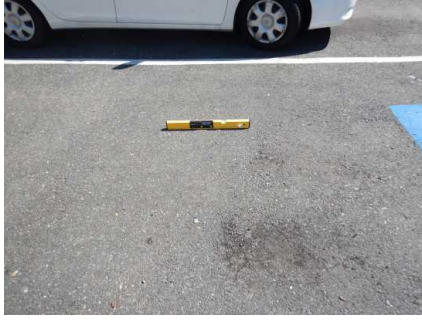
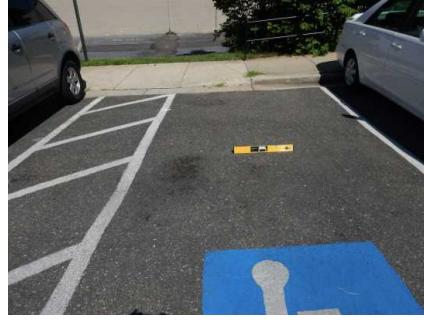
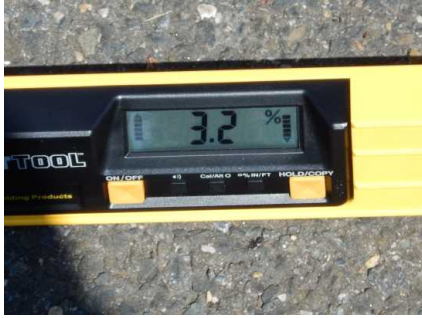
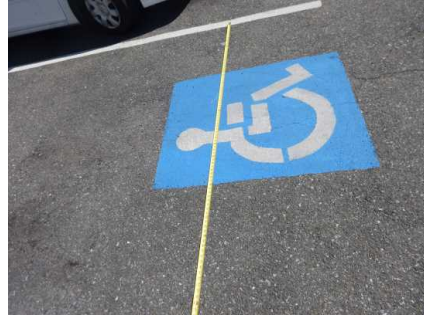
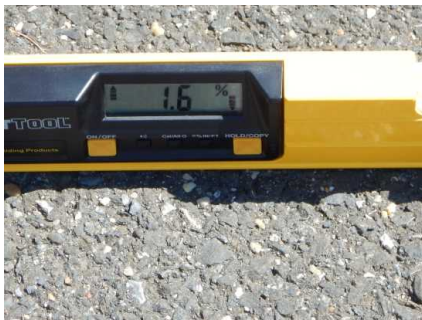
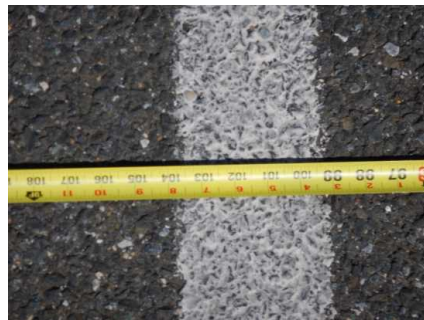
Rollingcrest Village EXTERIOR

Assembly	Accessible Parking
Type	Parking Space-Car
ADA Standard	State of MD 05.07.D (2)(a)and (b),(3) & (6)
Barrier Detail	MARYLAND: Compliant signage is not provided at the space.
Location Description	Parking Lot B - Space P2-B
Observed	May 8, 2018 by ouraccessibleworld
Site Conditions	Parking signage provided at the standard car accessible space.

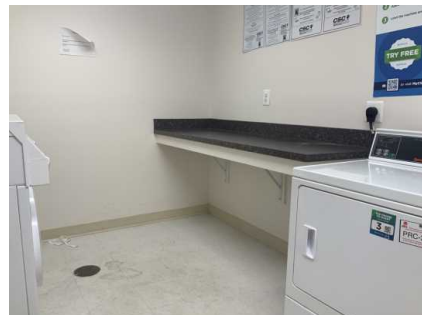
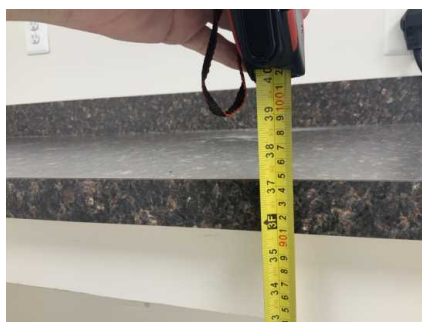
Photos for Barrier ID: AX239909

Rollingcrest Village EXTERIOR

Assembly	Exterior Access Route
Type	Reach Range
ADA Standard	308

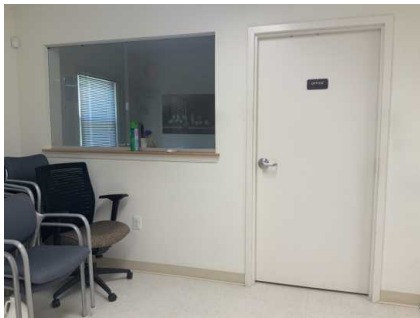
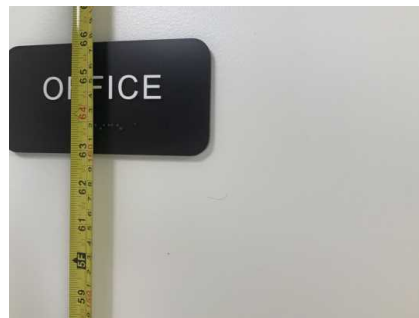
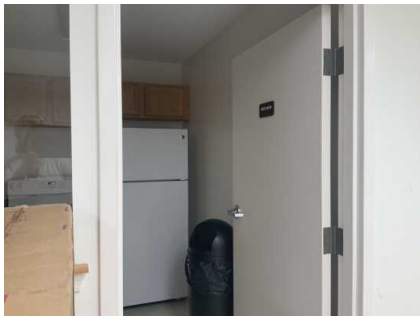
Photos for Barrier ID: AX239898

Site Conditions The signage is mounted on the door surface at a height of 63".
