# Mount Rainier Artist Lofts Capital Needs Assessment Phase I

MARCH 20, 2026

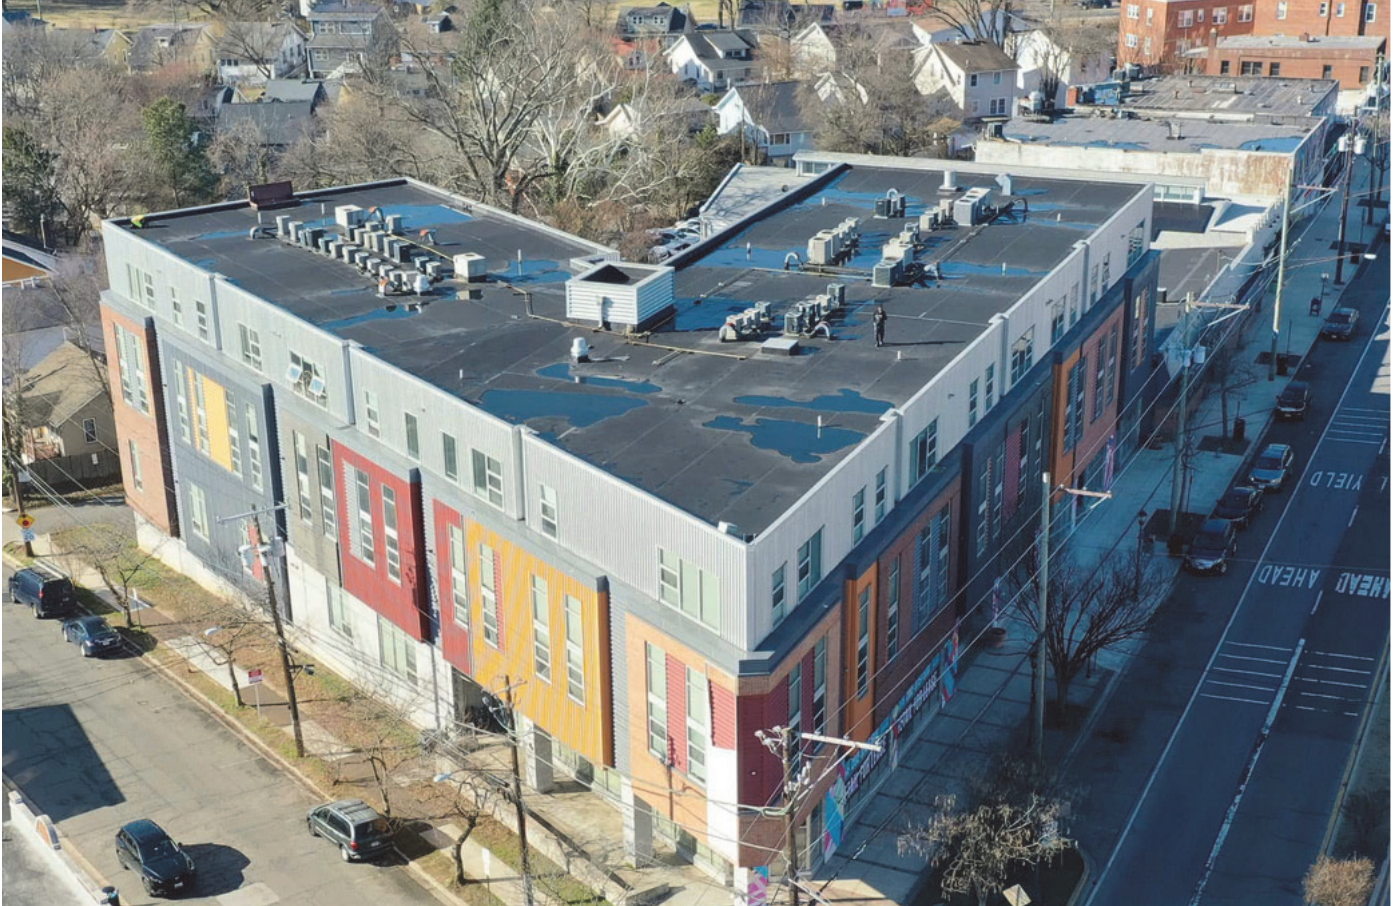
Inspection of the third-floor framing system identified failure of several wood floor trusses at the metal connector plate joints. These failures have compromised the structural integrity of portions of the floor system and have created conditions that may present a significant life-safety hazard to occupants.

Picture showing temporary support of failed ceiling trusses

**Based on these observations, it is the professional opinion of the structural engineer that all residential units located on the second and third floors should be evacuated until a comprehensive structural investigation is completed and adequate structural repairs and reinforcements are designed and implemented.**

- A detailed structural engineering investigation of the floor framing system
- Exposure of concealed structural elements to further determine the extent of truss failure
- Development of engineered repair/replacement or reinforcement details
- Implementation of structural stabilization measures prior to re-occupancy
