## 3311 Rhode Island Ave. Structural Assessment

Report of Findings

**Subject:** **Structural Assessment**  
3311 Rhode Island Ave  
My. Ranier, MD 20712  
Project Number: P0100066584

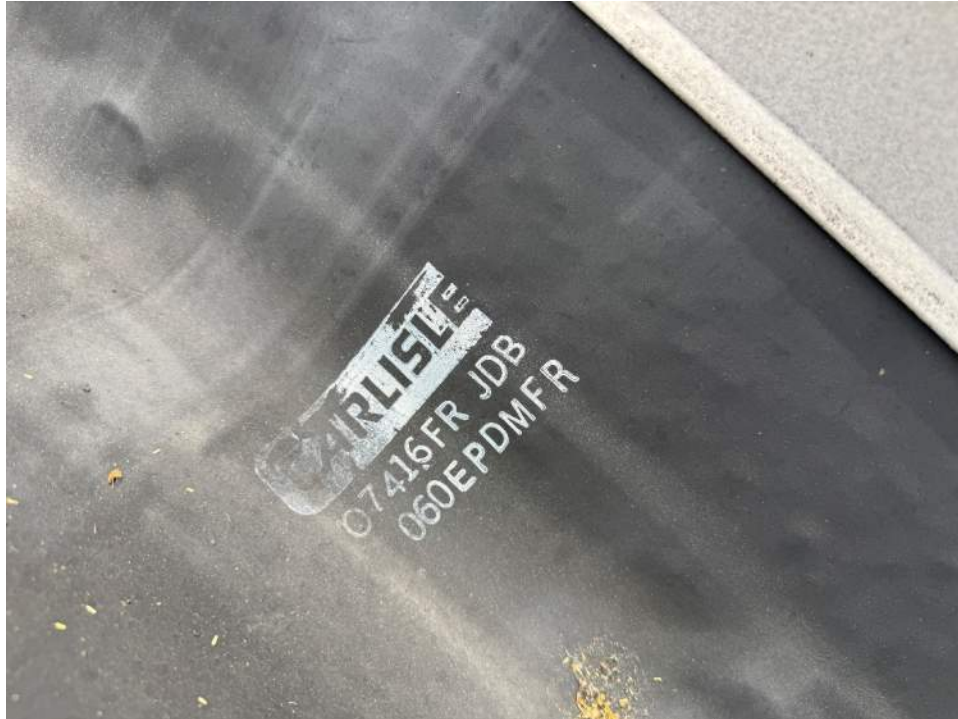
Photo 13 – Roofing system manufacturer information

BECS also performed a limited visual assessment of exterior elements, including a brief walkthrough of rooftop areas and a ground level perimeter walkthrough to observe façade elements that may be exhibiting signs of structural movement. The roofing system was a Carlisle EPDM fully reinforced (membrane thickness of 60 mil) roofing system with tapered insulation that appears to have exceeded its service life, as evidenced by several reports of Level 3 leaks and multiple patch repairs throughout the roof (Photos 13 and 14). The roof drains towards exterior scuppers along the roof perimeter. The Level 3 hallway had several ceiling lights with water staining, and Unit 305 also had extensive damage from previous roof failures. While roofing observation failures do not directly correlate to observed structural distress items, it is noted that leaks can result in wood rot, and if left unaddressed, cause failures in the roofing system. Roof leaks should not be left to persist.
